TRANSISTOR DEVICES, INC

Report number: FR-061201

ISOLATION AMPLIFIERS

Part Number: ISO124U

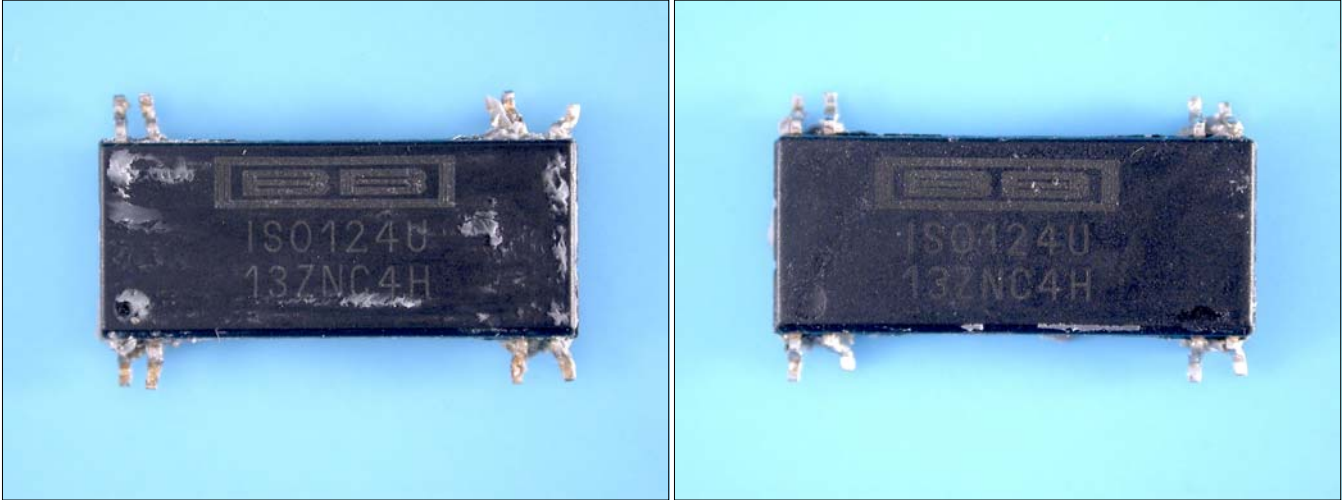
Visual inspection of the devices as received revealed no gross anomalies.

Figure 1. Optical macrograph of sample 1 as received. Figure 2. Optical macrograph of sample 2 as received.

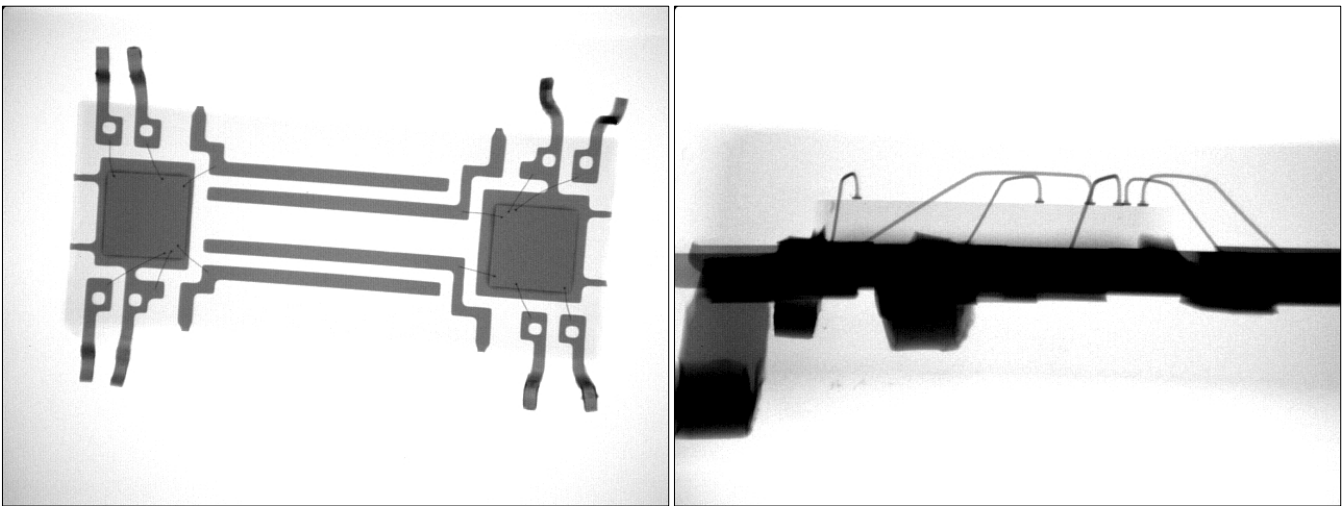
Radiographic inspection was performed using a Fein Focus 160.24 Radiographic Inspection System. Inspection revealed no obvious anomalies.

Figure 3. X-Ray image of sample 1 as received.

Figure 4. Side view image of the pin 1 die in sample 1.

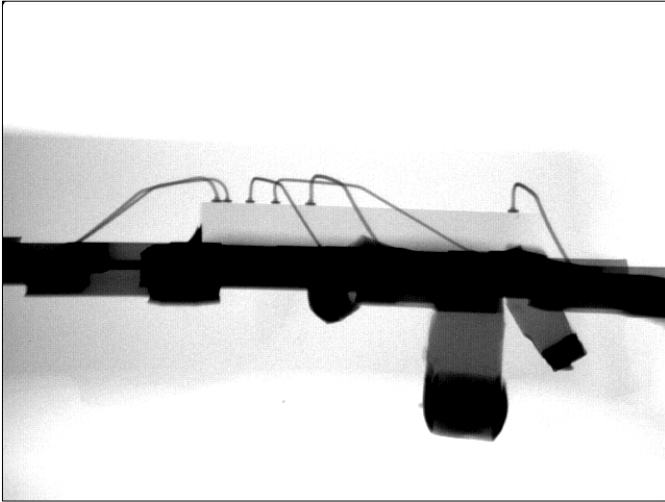
Figure 5. Side view image of the pin 14 die in sample 1.

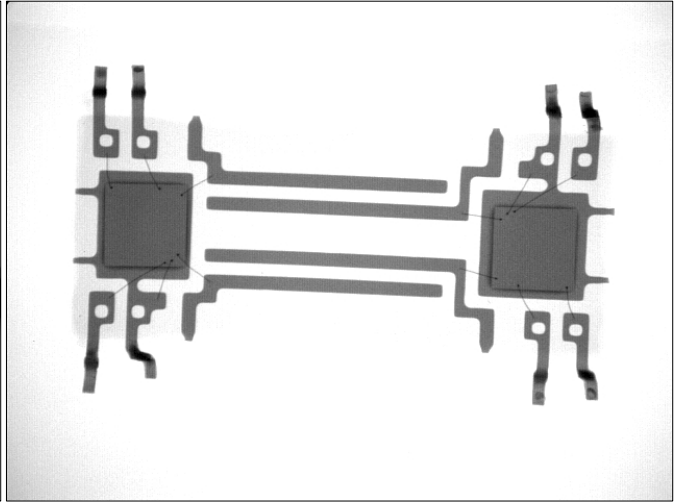
Figure 6. X-Ray image of sample 2 as received.

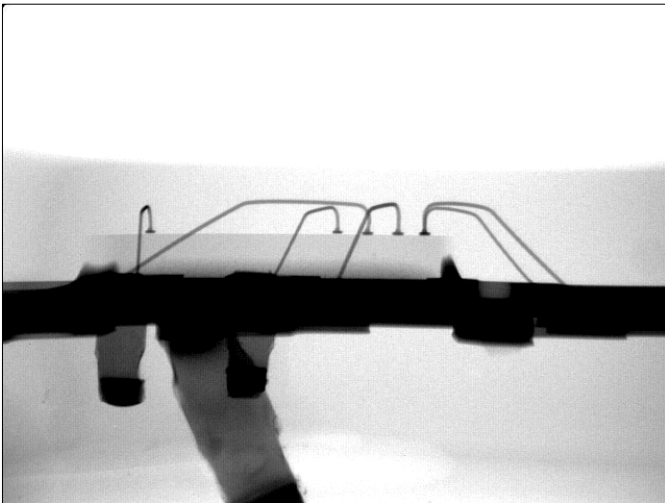
Figure 7. Side view image of the pin 1 die in sample 2.

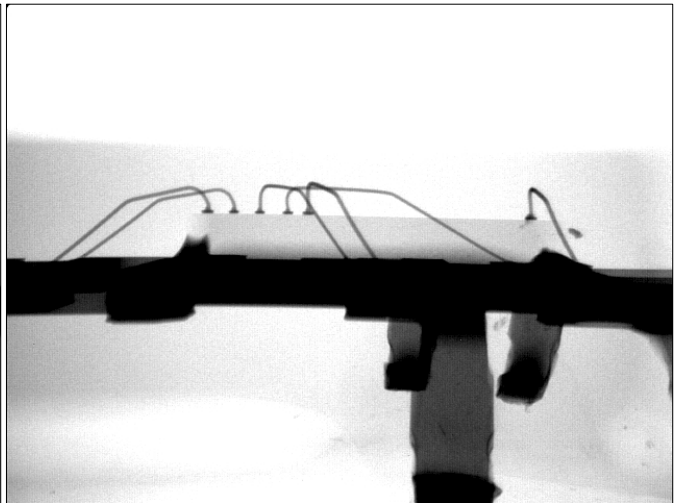
Figure 8. Side view image of the pin 14 die in sample 2. Note the possible alloy site.

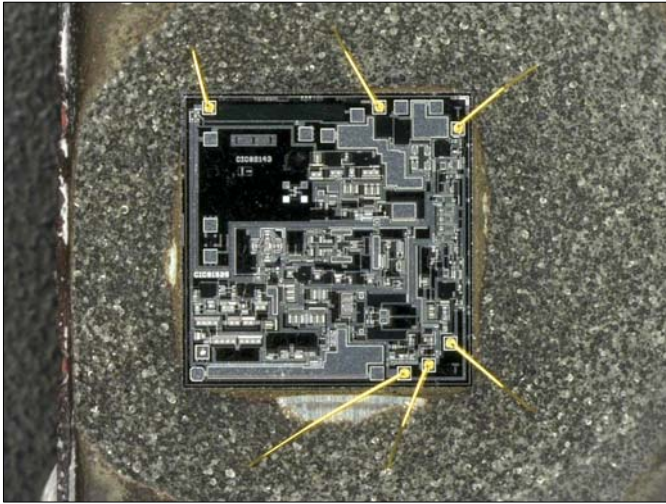
Figure 9. Optical micrograph of the pin 1 die in sample 1 after decapsulation.

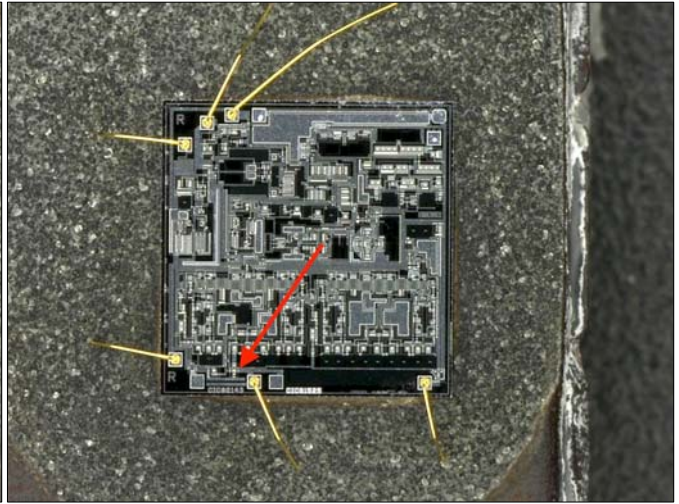
Decapsulation was performed using hot fuming nitric acid to dissolve the encapsulant over the dice. Optical inspection of the devices revealed a damaged junction connected to pin 13 (Vout) in both samples. The damage in sample 2 was more extensive and included fused metallization lines connected to the power supply pins.

Figure 10. Optical micrograph of the pin 14 die in sample 1 after decapsulation. The arrow indicates the damaged area.

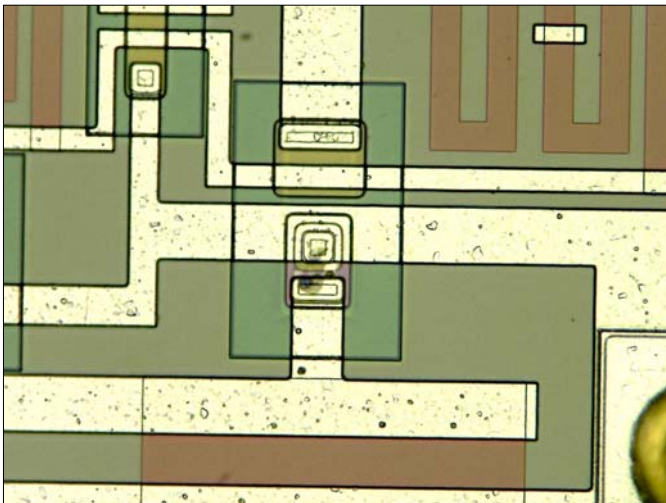
Figure 11. Detailed view of the damage junction connected to pin 13 in sample 1.

The failure of the isolation amplifiers was due to a voltage transient on pin 13 (Vout). In sample 2, the failure event was longer in duration than sample 1 and subsequently caused the fusing of the metallization connected to the power supply pins.

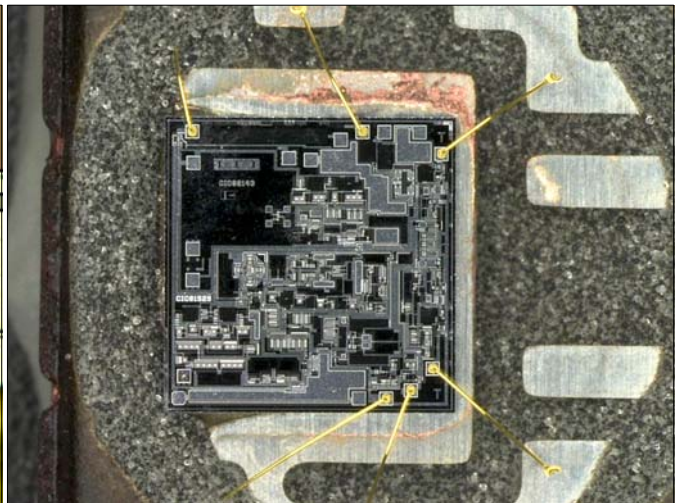
Figure 12. Optical micrograph of the pin 1 die in sample 2.

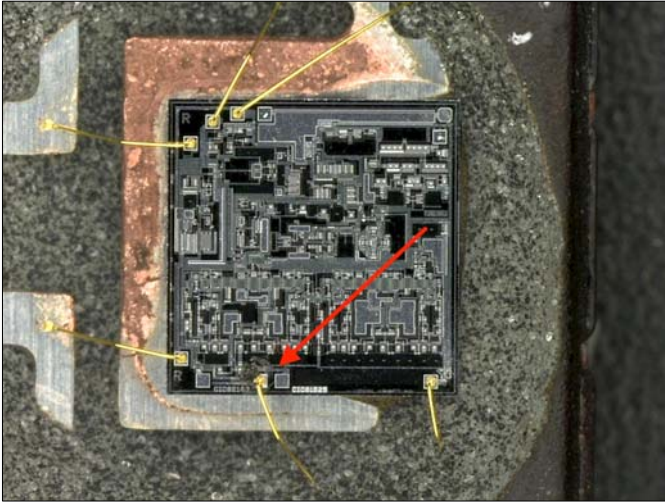
Figure 13. Optical micrograph of the pin 14 die in sample 2 after decapsulation. The arrow indicates the damaged area.

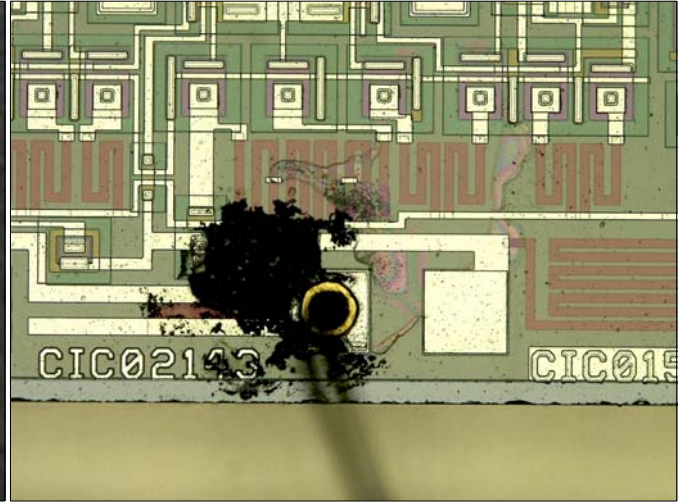
Figure 14. Close up view of the damage to the pin 13 area in sample 2.

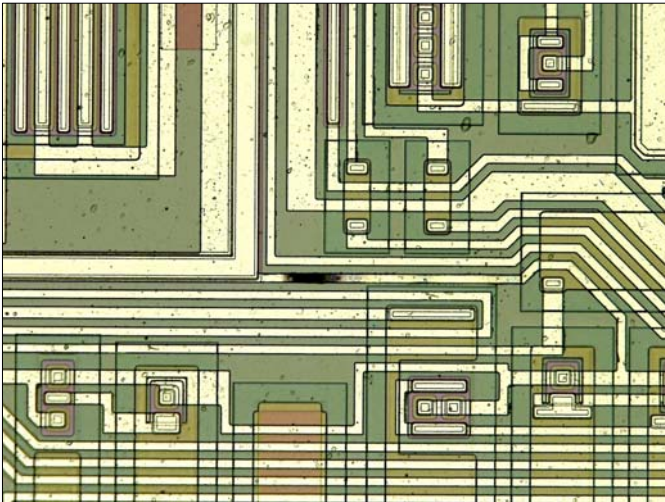
Figure 15. Close up view of the fused metallization line connected to pin 16 (-Vs2).

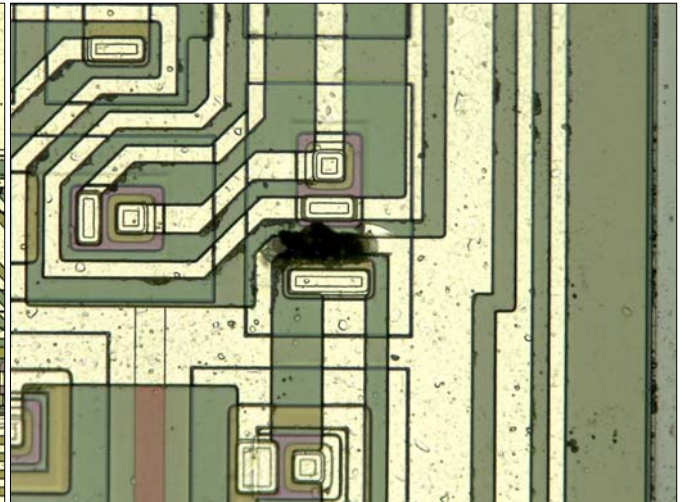
Figure 16. Close up view of the fused metallization connected to pin 14 (Gnd).
