PCN Number:	20100910003			PCN Date:	
Title:	MSP430F54xxA and MSP430F55xx Device Derivatives: Flash Read Error Susceptibility				
Customer Contact:	PCN Manager	Phone:	+1(214) 480-6037	Dept:	Quality Services
Proposed 1st Ship Date:		Estimated Sample Availability:			
Change Type:					
<input type="checkbox"/>	Assembly Site	<input type="checkbox"/>	Assembly Process	<input type="checkbox"/>	Assembly Materials
<input checked="" type="checkbox"/>	Design	<input type="checkbox"/>	Electrical Specification	<input type="checkbox"/>	Mechanical Specification
<input type="checkbox"/>	Test Site	<input type="checkbox"/>	Packing/Shipping/Labeling	<input type="checkbox"/>	Test Process
<input type="checkbox"/>	Wafer Bump Site	<input type="checkbox"/>	Wafer Bump Material	<input type="checkbox"/>	Wafer Bump Process
<input type="checkbox"/>	Wafer Fab Site	<input type="checkbox"/>	Wafer Fab Materials	<input type="checkbox"/>	Wafer Fab Process

MSP430F54xxA Device Derivatives Technical Assessment: Flash Read Error & Susceptibility

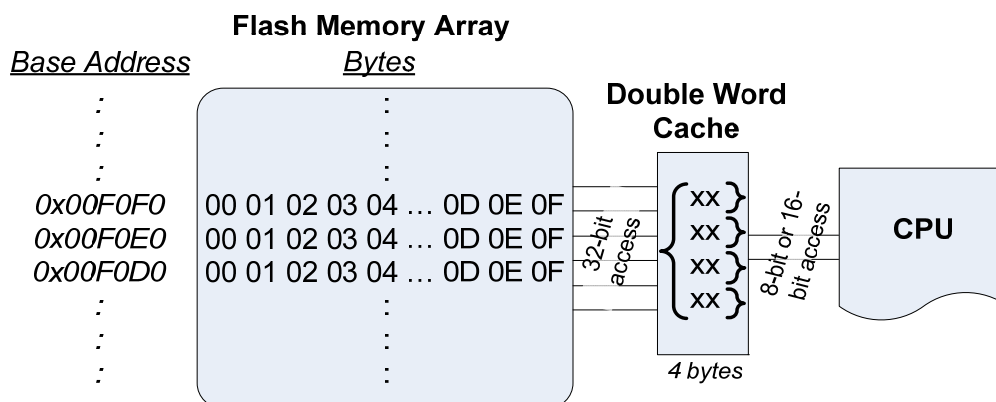
Figure 1. Simplified Cache Architecture and CPU Access

To better describe the flash read error mechanism, it is important to understand the device architecture. The MSP430F54xxA implements a 32-bit cache for memory read operation – e.g. a physical read of the flash memory is performed on 32-bit boundaries; every 4 bytes, which is stored in a cache logic array. These 32-bit values are referred to as “double words”. Memory access by the CPU to individual bytes and words is then done by accessing the cache. This cache architecture is shown in Figure 1.

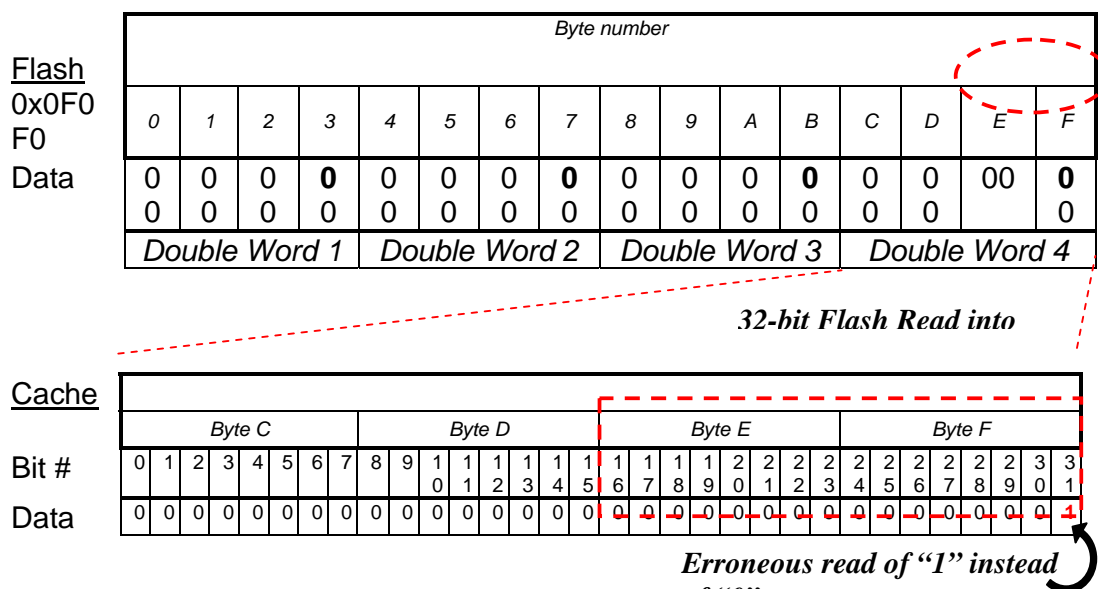
Figure 2. Error illustration for MSB of double word #4

Example: This illustration considers 16 bytes of flash data starting at address 0x0F0F0 and all contain the value 0x00. A CPU instruction execution triggers an access of the Flash word (at 0x0F0FE) and saves it to CPU register R5:

Result: Valid: R5= 0000h
Invalid: R5= 8000h

The read operation by the CPU of address 0x0F0FE will actually trigger the reading of double word #4 from flash (data from 0x0F0FC to 0x0F0FF), which is then stored into the 32-bit cache. The uppermost two bytes (0x0F0FE and 0x0F0FF) make up the 16-bit word located at 0x0F0FE. The result of the read in the case of a flash read error is an invalid readout of the MSB for the given double word access. Instead of the expected logic "0", a logic "1" may be erroneously read out and stored in the cache for CPU computation: 0x8000 is erroneously read out and moved to R5 instead of 0x0000. This potential error applies to the MSB for each double word as indicated by the bold "0"s in Figure 2 at each 4th byte.

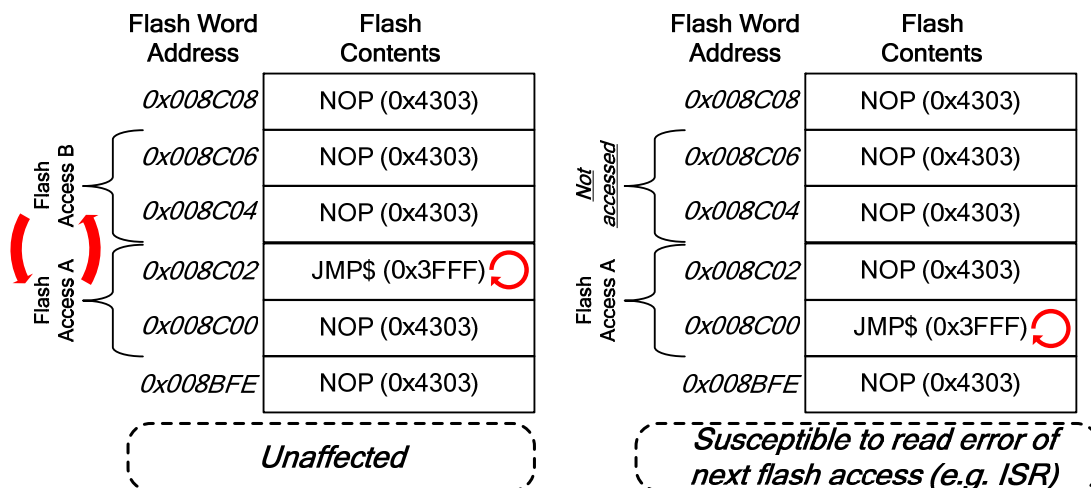
Figure 3. JMP\$ alignment and read error behavior

Figure 3 shows the relationship of the `JMP$` instruction position in memory and the behavior of the Flash access. On the right, the `JMP$` is at the lower word of the double word fetched from flash. This placement results in the CPU being able to execute entirely from the cached double word containing the `JMP$` instruction which stops flash access activity. Execution of the `JMP$` in such a memory alignment for a time exceeding the IDLE time discussed in section 3.4 can result in a read error on the next flash access – e.g. servicing an active ISR.

However, when the `JMP$` instruction resides in the upper word of the double word memory fetch, as shown in the left portion of Figure 3, the cache continuously alternates between flash accesses A and B which keeps the flash access constant and unaffected by the read error on a subsequent ISR service fetch.

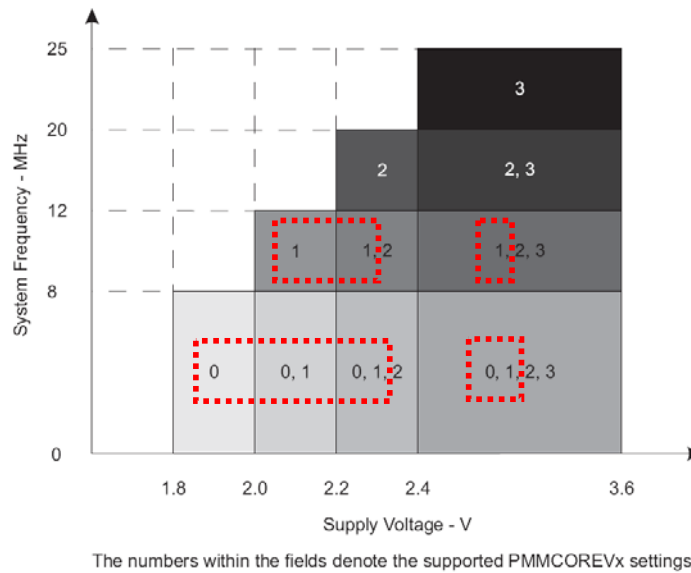
Figure 4. Core voltage settings with reduced susceptibility

The Vcore settings 0 and 1 and corresponding operating ranges are highlighted in the figure. These Vcore level settings result in reduced susceptibility to the flash read issue vs levels 2 and 3.

While all Vcore settings when used under the proper Vcc and clock frequency ranges are valid for device operation, usage of Vcore level 2 and 3 settings are twice as likely to result in flash read errors at susceptible bit locations compared to levels 0 and 1.

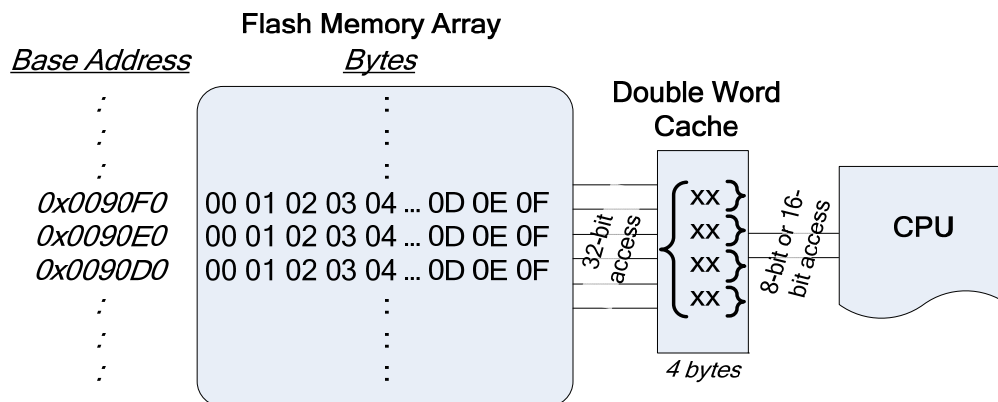
Figure 5. Simplified Cache Architecture and CPU Access

To better describe the flash read error mechanism, it is important to understand the device architecture. The MSP430F55xx implements a 32-bit cache for memory read operation – e.g. a physical read of the flash memory is performed on 32-bit boundaries; every 4 bytes, which is stored in a cache logic array. These 32-bit values are referred to as “double words”. Memory access by the CPU to individual bytes and words is then done by accessing the cache. This cache architecture is shown in Figure 1.

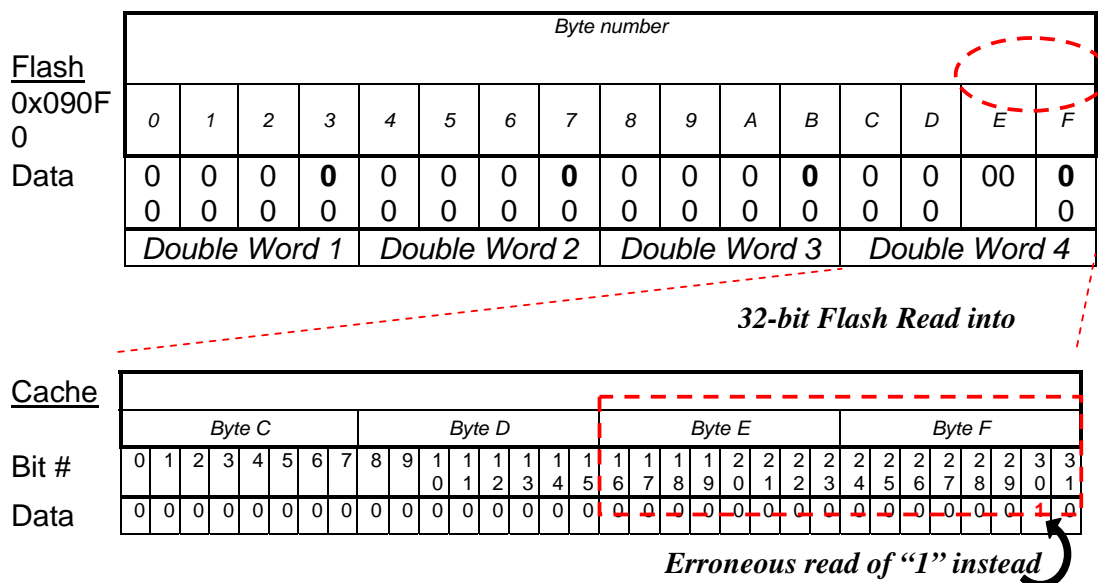
Figure 6. Error illustration for MSB-1 of double word #4

Result: Valid: R5= 0000h
Invalid: R5= 4000h

The read operation by the CPU of address 0x090FE will actually trigger the reading of double word #4 from flash (data from 0x090FC to 0x090FF), which is then stored into the 32-bit cache. The uppermost two bytes (0x090FE and 0x090FF) make up the 16-bit word located at 0x090FE. The result of the read in the case of a flash read error is an invalid readout of the MSB-1 for the given double word access. Instead of the expected logic "0", a logic "1" may be erroneously read out and stored in the cache for CPU computation: 0x4000 is erroneously read out and moved to R5 instead of 0x0000. This potential error applies to the MSB-1 for each double word as indicated by the bold "0"s in Figure 2 at each 4th byte.

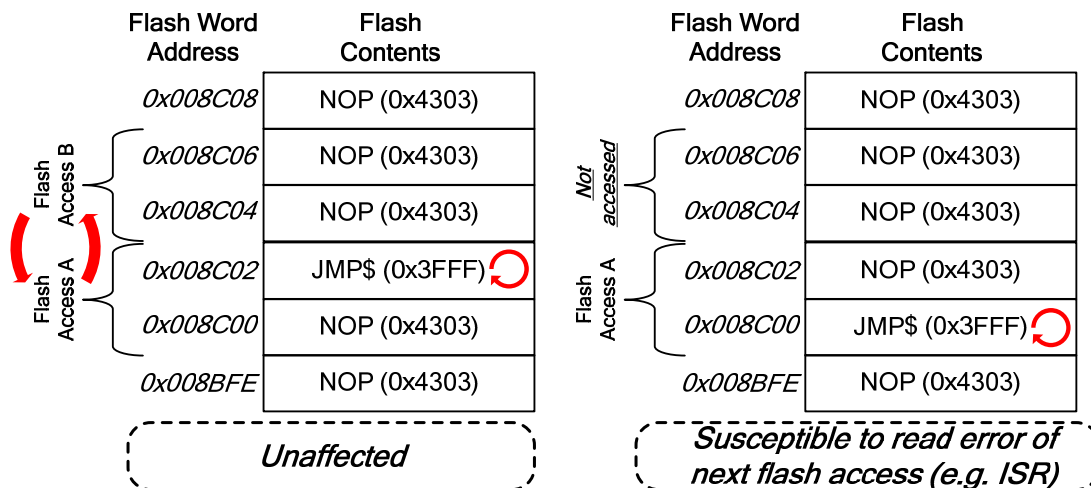
Figure 7. JMP\$ alignment and read error behavior

Figure 3 shows the relationship of the JMP\$ instruction position in memory and the behavior of the Flash access. On the right, the JMP\$ is at the lower word of the double word fetched from flash. This placement results in the CPU being able to execute entirely from the cached double word containing the JMP\$ instruction which stops flash access activity.

When the JMP\$ instruction resides in the upper word of the double word memory fetch, as shown in the left portion of Figure 3, the cache continuously alternates between flash accesses A and B which keeps the flash access constant.

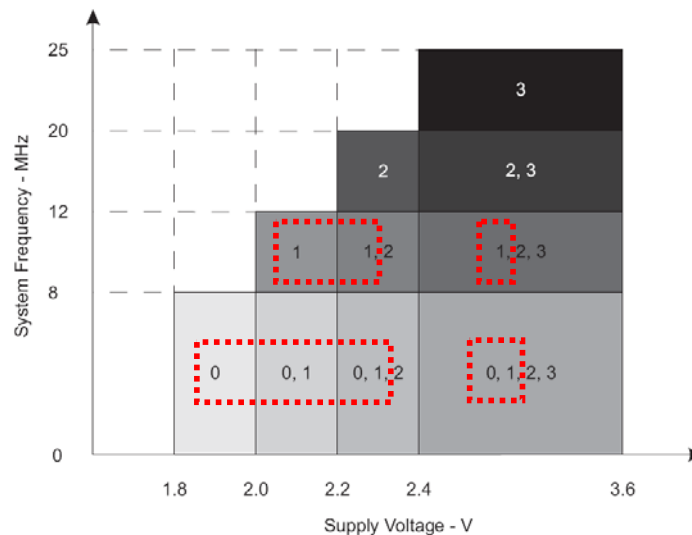
Figure 8. Core voltage settings with reduced susceptibility

External supply voltage (DVcc, AVcc) and internal core voltage (Vcore) also have an influence on likelihood of whether the flash read error may occur. Figure 5 shows Vcc vs System (CPU) clock vs Vcore valid operating conditions per the device datasheet.
