TLV2374IPWR: Connection diagram

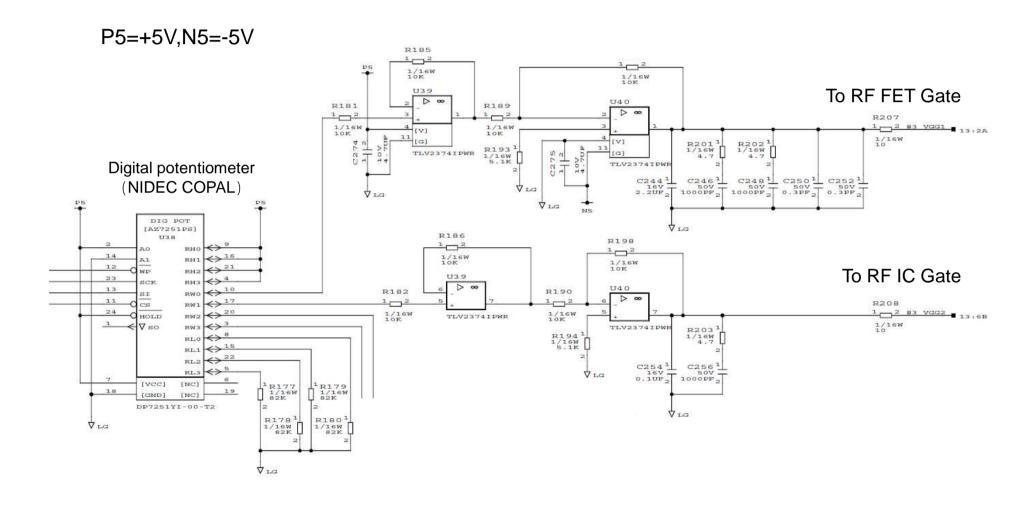
- U40 breaks down in the short mode.
- U39 has no abnormalities.

- It was normal although examinations various about several months were done.
- Abnormalities were checked, as a result of changing the evaluation system of a trial product and performing power supply starting.
- Those with a possibility that humidity management was not enough at that time, and dew condensation occurred inside the trial product although the low temperature test was carried out before the examination.
- At the time of change of evaluation, a signal wire has a wiring mistake in part, and the trial product carried out unusual operation.
- Those with a possibility that the gate portion of the semiconductor of high frequency drew current greatly at this time.
