5. Harmonic Content

5.1. Development Notes

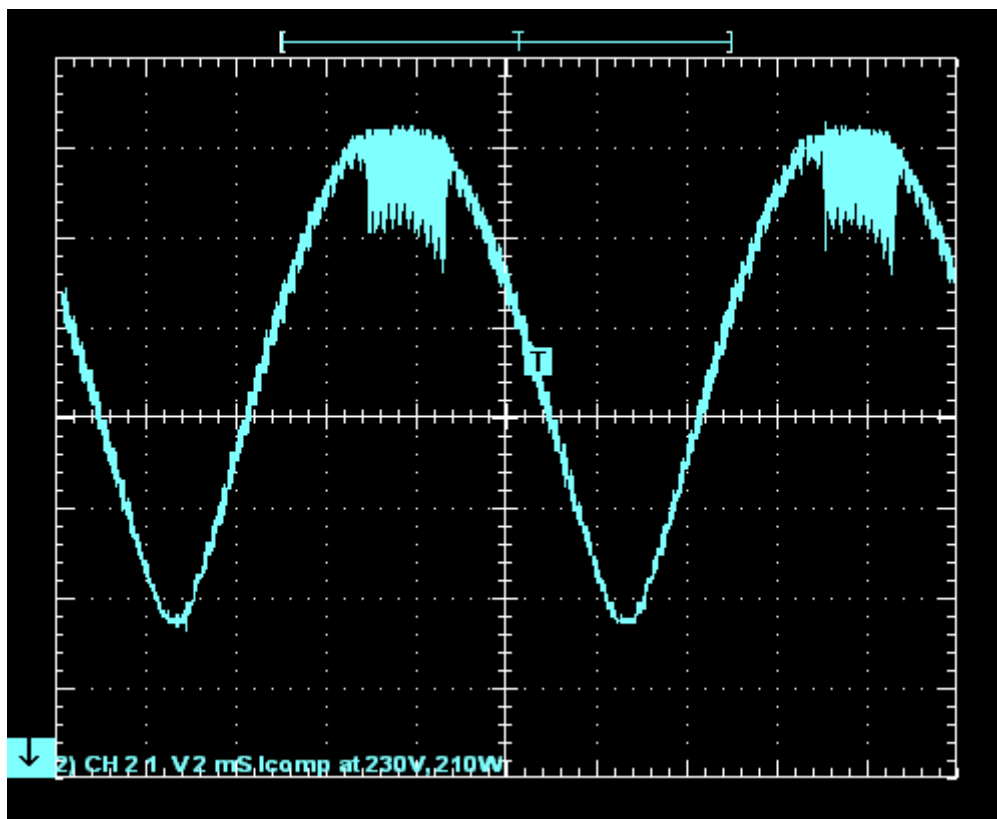
Figure 5.1.6.2 Icomp voltage at 230V 210W

The figure above shows the disturbance to the signal on Icomp that causes missing pulses in the drive train, that cause a disturbance on Isense, resulting in a disturbance on Icomp: positive feedback.

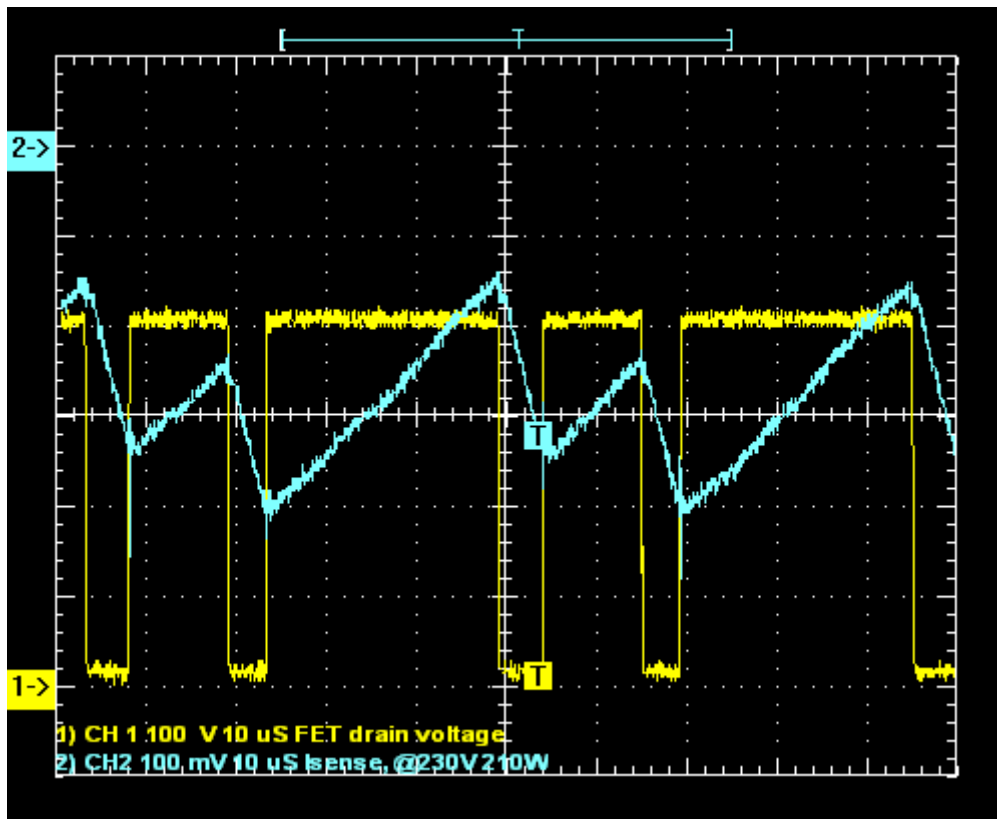
Figure 5.1.6.3 Isense voltage Vs Fet drain

Note that in the trace above the I sense signal is free of spikes and is well away from the peak protection level of -0.7V.
