TPS56121 soft start slew rate trouble

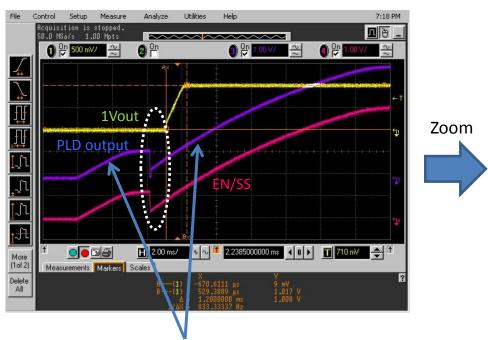
At these point, EN/SS source current must be difference. However slew rate seems to be the same.

PLD voltage is lower than EN/SS. So EN/SS pin voltage drops by PLD sink current.

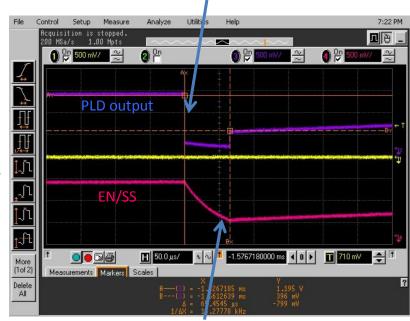
EN/SS pin voltage drops.

But it doesn't reach to disable threshold.

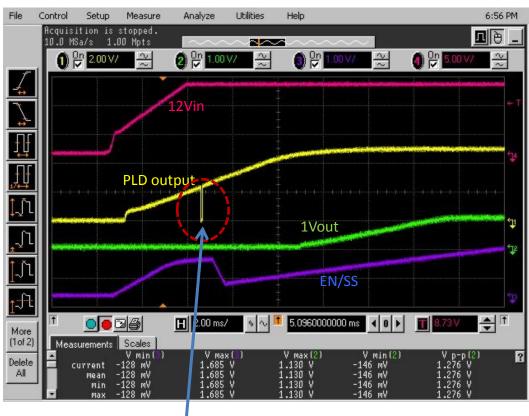
PLD output pulls to low level during calibration operation.
