FAILURE ANALYSIS REPORT

Device Analysis Services FA405534-1

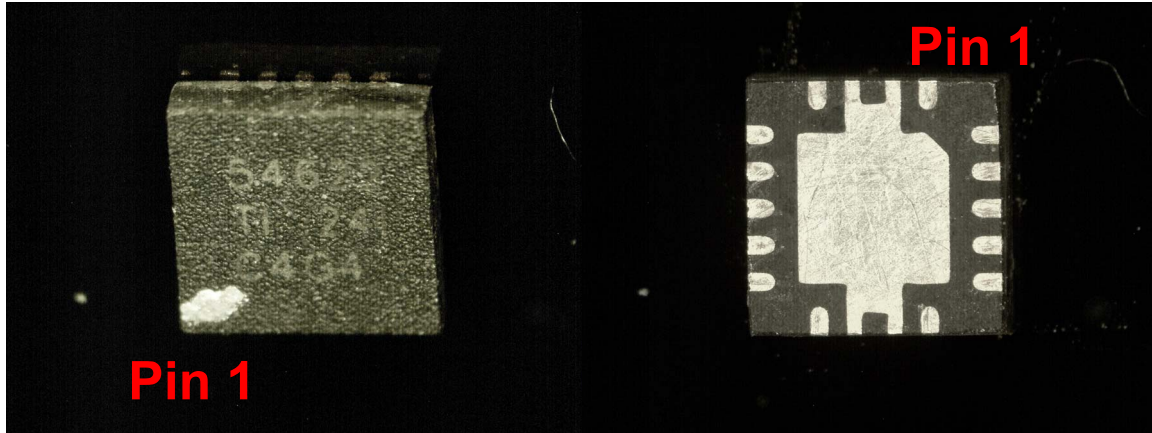
External visual examination showed no abnormalities that would contribute to device failure (see Figure 1).

Figure 1: Unit 2 as received, representative of Unit 1. Top view is on the left. Bottom view is on the right. No obvious evidence of damage or defect.

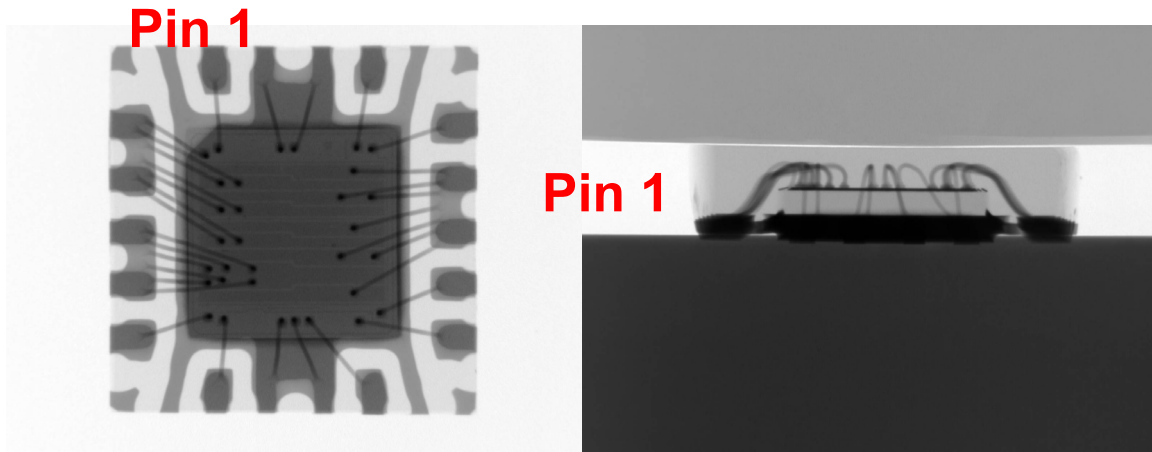
Internal x-ray examination did not reveal any obvious evidence of damage or defect (see Figure 2).

Figure 2: X-ray of Unit 2 as received, representative of Unit 1. Top view is on the left. Edge view is on the right. No obvious evidence of damage or defect.

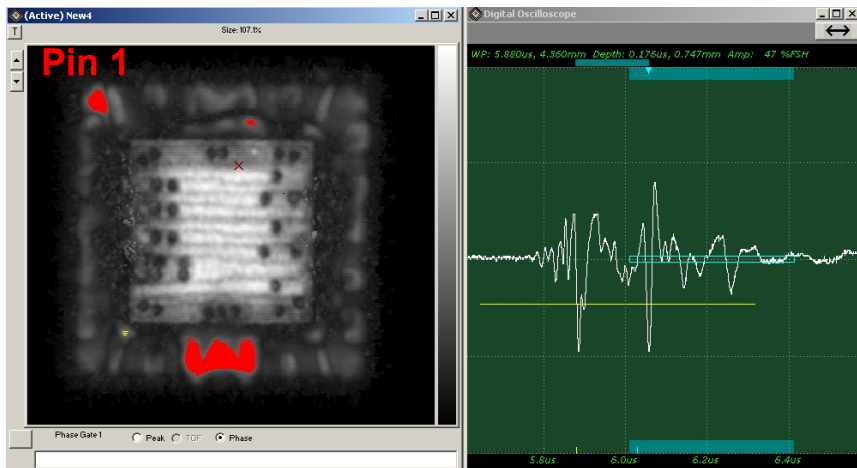
Scanning Acoustic Microscopy examination revealed delamination on the lead frame not related to device failure (see Figure 3).

Figure 3: Unit 2 SAM analysis, representative of Unit 1, analysis revealed delamination on the lead frame not related to device failure.

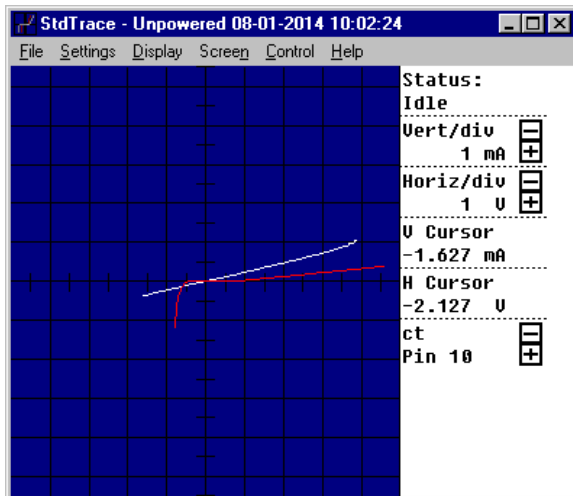
Pin to pin curve tracer analysis of the returned units revealed anomalous characteristics when compared to a standard unit. Unit 1 and Unit 2 exhibited a resistive open between device pin EN (Pin 10) and all other pins. Unit 2 additionally exhibited a resistive leakage between device pin VIN (Pin 6) and GND (Pins 2 and 3) (see Figure 4 and Figure 5).

Figure 4: Unit 1 and Unit 2, EN (Pin 10) referenced to all other pins. White is returned units. Red is good unit.

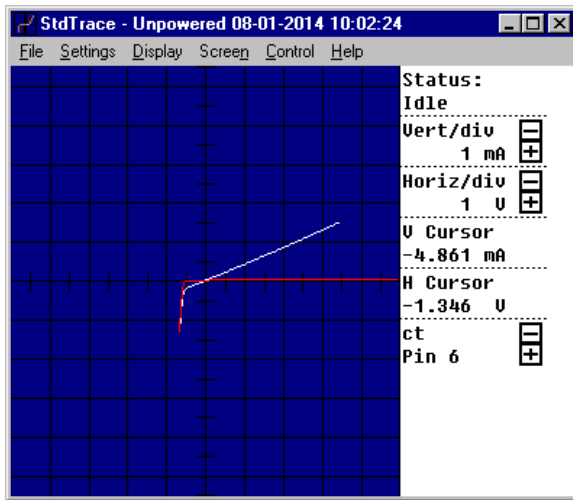
Figure 5: Unit 2, VIN (Pin 6) referenced to GND (Pins 2 and 3). White is returned unit. Red is good unit.

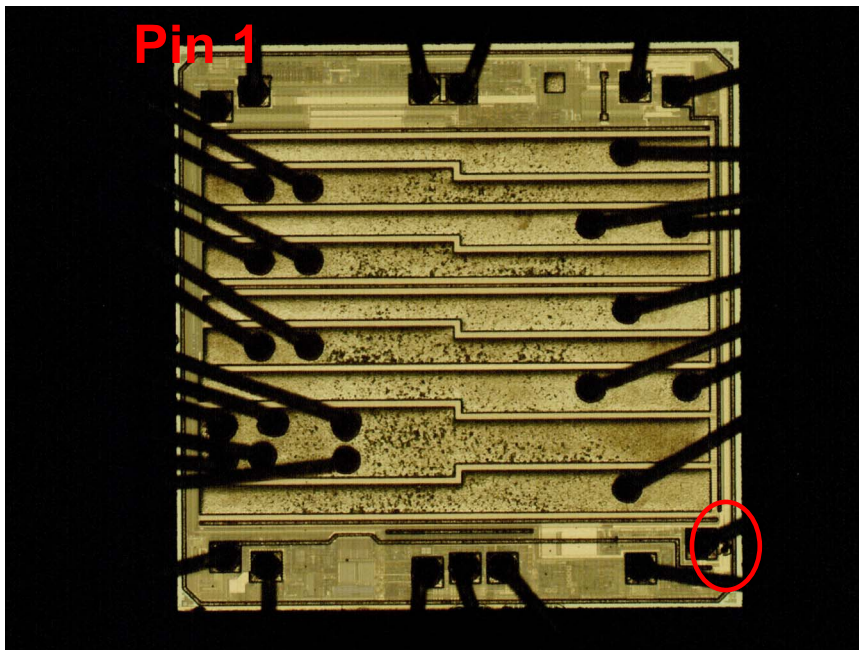
Internal visual examination revealed obvious thermal damage to the EN (Pin 10) circuitry (see Figure 6).

The failure of two TPS54622RHLLR was confirmed. Unit 1 and Unit 2 exhibited a resistive open between device pin EN and all other pins. Unit 2 additionally exhibited a resistive leakage between device pin VIN and GND. Internal visual examination revealed obvious thermal damage to the EN circuitry. Damage of this nature is typically caused by an applied electrical overstress (EOS) event.

Figure 6: Unit 2 as decapsulated, representative of Unit 1. Circled is the area of thermal damage to the EN (Pin 10) circuitry.

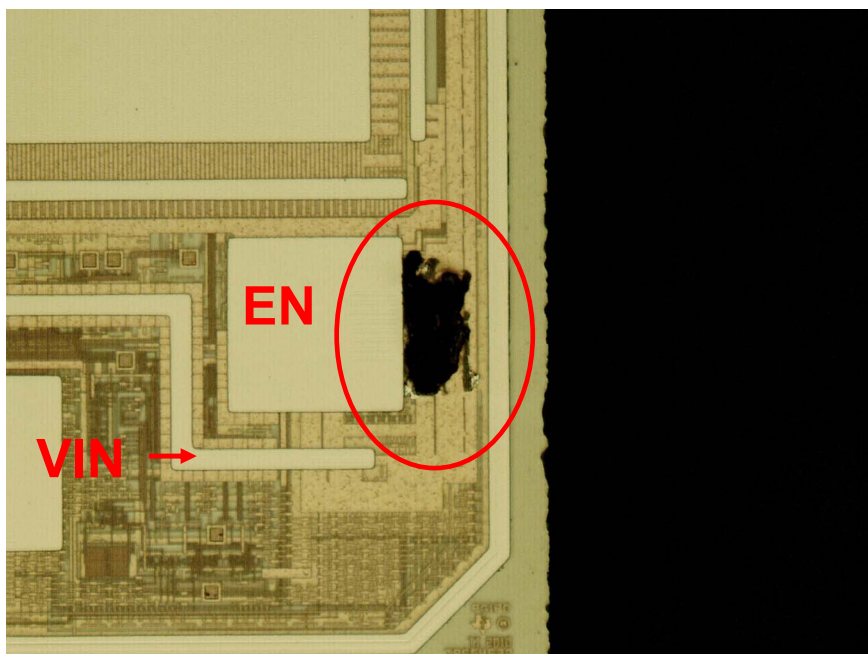
Unit 1 and Unit 2 were deprocessed removing the copper metal layer to expose thermal damage to the EN (Pin 10) circuitry (see Figure 7 and Figure 8).

Thermal damage was identified by metal flash-over.

Figure 7: Unit 1 as deprocessed with copper metal layer removed, close-up of the thermal damage to the EN (Pin 10) circuitry.

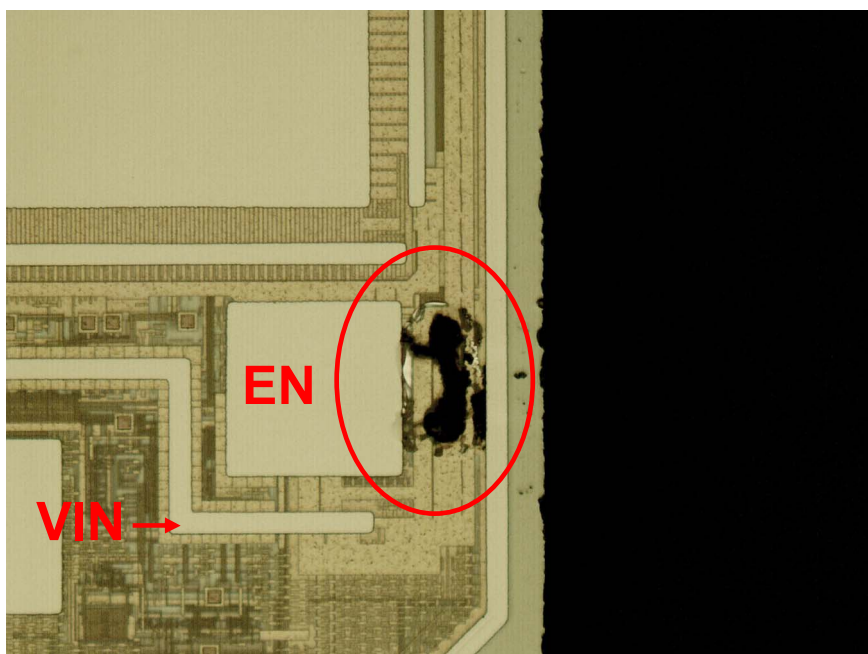
Figure 8: Unit 2 as deprocessed with copper metal layer removed, close-up of the thermal damage to the EN (Pin 10) circuitry.
