Tiva™ C Series TM4C129x Microcontrollers Silicon Revisions 1, 2, and 3

Silicon Errata

Literature Number: SPMZ850B
October 2013–Revised March 2014

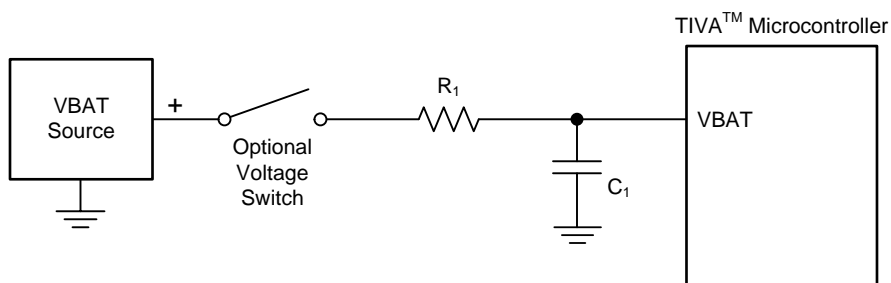
Figure 2. RC Circuit

ELEC#02
 V_{BAT} Supply pin may be Damaged if the pin Voltage Ramps Faster Than 0.7 V/ μ s
Revision(s) Affected: 1, 2, and 3.

Description The V_{BAT} supply pin may be damaged if the pin voltage ramps faster than 0.7 V/ μ s. Fast V_{BAT} ramps are a concern when a battery is being connected or the V_{BAT} supply is hard switched.

Workaround(s) An RC circuit as shown should be added to the V_{BAT} pin to prevent the damage. The R_1 and C_1 should be placed close to the microcontroller for best protection. In systems that do not require Hibernate when the VDD supply is off, the V_{BAT} pin should be tied to the VDD supply, which typically ramps at a rate slower than 0.7 V/ μ s. The R_1 and C_1 components are not required for a V_{BAT} supply ramp less than 0.7 V/ μ s.

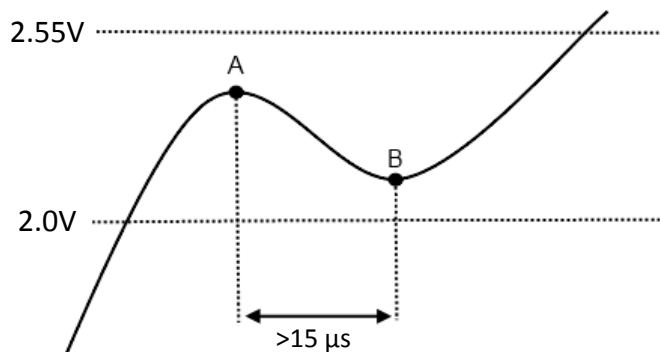
Figure 3. VDDA Waveform to Avoid Between V_{POR} min and V_{POR} max

Description: In very rare cases, a non-monotonic voltage rise of VDDA between the minimum and maximum Power-On Reset Threshold (V_{POR}) voltage range, 2.0 V and 2.55 V, can cause the on-chip LDO to not start up. Because the LDO controls the core voltage (VDDC), the device cannot start up correctly in this situation. If the LDO fails to start, power cycle the device until a successful power up occurs. A software or hardware reset cannot restart the LDO.

Workaround(s): A monotonic voltage rise of VDDA prevents this issue from occurring; however, a perfect monotonic ramp is difficult to achieve, particularly during LDO inrush. The risk of encountering this issue can be minimized by performing one of the following:

- If the VDD and VDDA pins are connected directly to the same power source, at every possible point A and point B along the VDDA waveform between 2.0 V and 2.55 V, point B must never fall below point A after 15 μ s, as shown in [Figure 3](#).
- Use a separate power supply for VDDA to reduce noise and isolate it from the effects of LDO inrush. At every possible point A and point B along the VDDA waveform between 2.0 V and 2.55 V, point B must never fall below point A after 15 μ s, as shown in [Figure 3](#). The separate power supply will make it easier to avoid this condition.
