MDIO interface Access Issue Debug

Capture of waveforms at Phy end

Version 0.3

02 Dec 2022

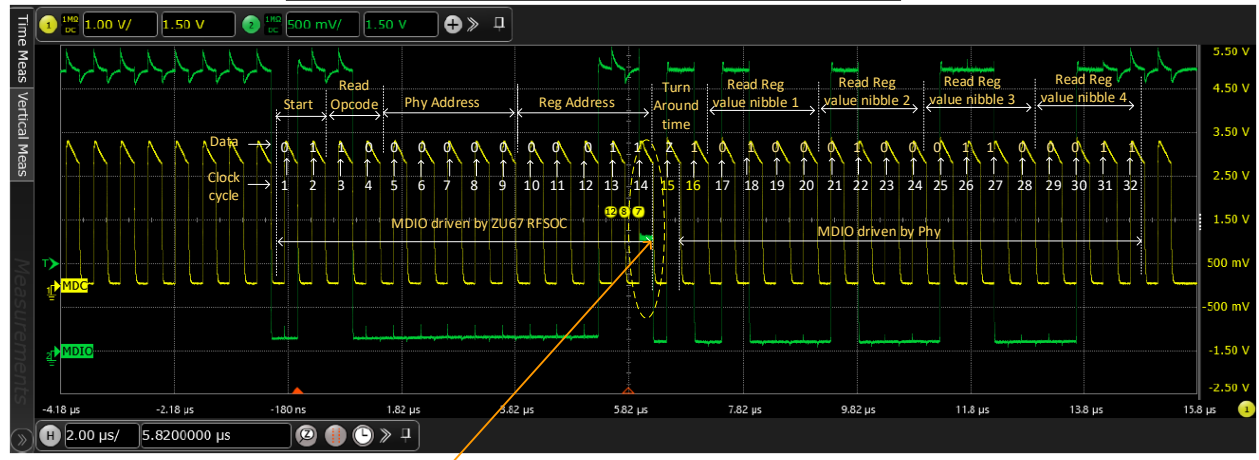
Fail Case: Phy ID2: 30Nov: JP95_PHYID2_READ_FAIL2@HTB.pdf

MDIO read access to PHYID2 register

Register address: 0x3
Register data: 0xA231

In fail case value read is 0x4463
(bits shifted to left by 1)

Observation: Between the 14th Clock cycle rising edge and 15th Clock cycle rising edge, ZU67 and Phy device are expected to tristate the bus. However in the Fail case, it appears the Phy device is driving 0 (seems to have started driving the read response 1 clock cycle early)

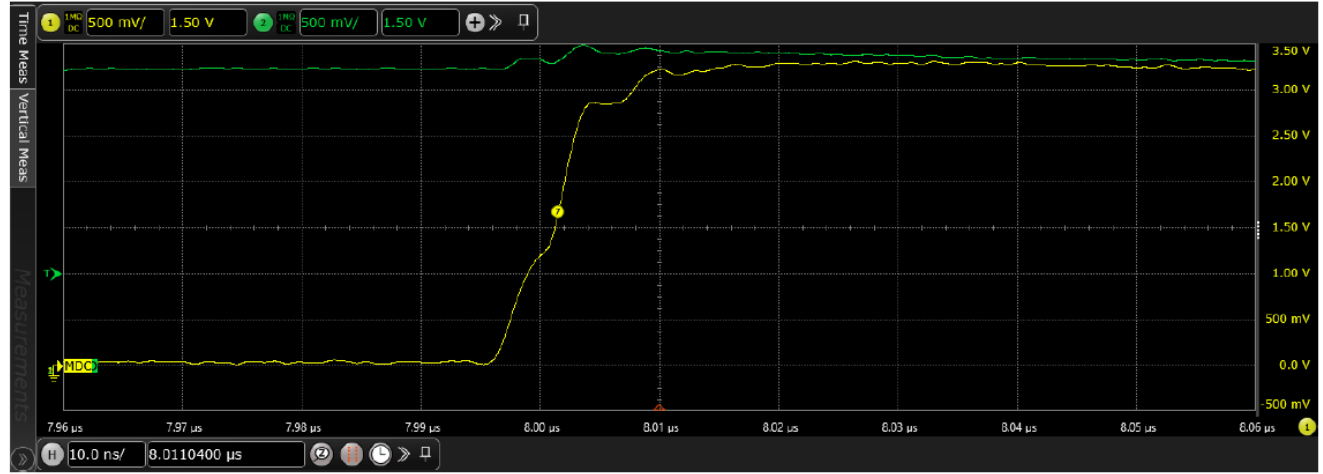
Pass Case: Phy ID2: 30Nov: JP95_PHYID2 READ_CLK14a_@HTB.pdf

In Passing case at 14th
Clock cycle rising edge
MDIO is high.
After 15th Clock cycle rising
edge MDIO is driven Low
by PHY

[Zoom in on MDC rising edge 14](#)

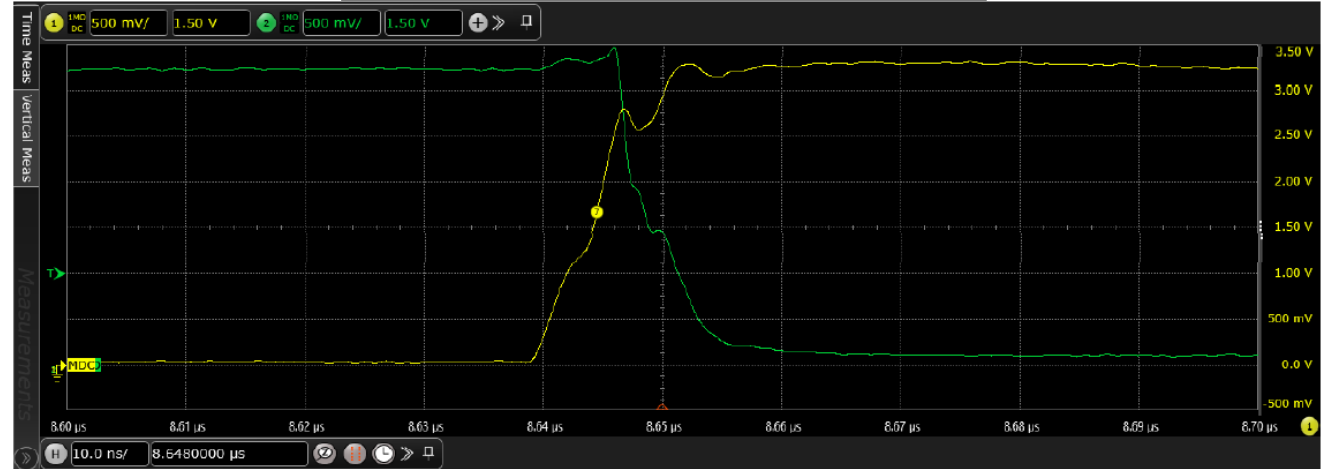
Pass Case: Phy ID2: 30Nov: JP95_PHYID2 READ_CLK15a_@HTB.pdf

[Zoom in on MDC rising edge 15](#)

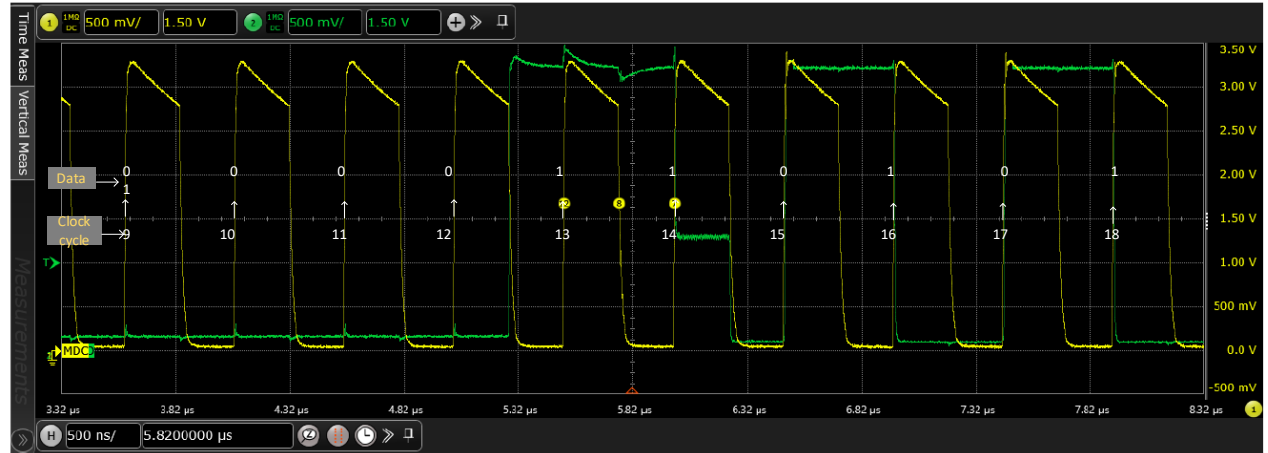
Fail Case: Phy ID2: 30Nov: JP95_PHYID2_READ_FAIL1_CLK10toCLK19@HTB.pdf

In fail case value read is 0x4463
(bits shifted to left by 1)

In Failing case immediately after 14th MDC Clock cycle rising edge and next falling edge MDIO is at 1.5V indicating contention on the MDIO signal.

It appears Phy is unexpectedly driving 0 on MDIO at 14th MDC clock cycle falling edge which is in contention with the 1 being driven by ZU67.

After 15th Clock cycle rising edge MDIO is driven High by PHY

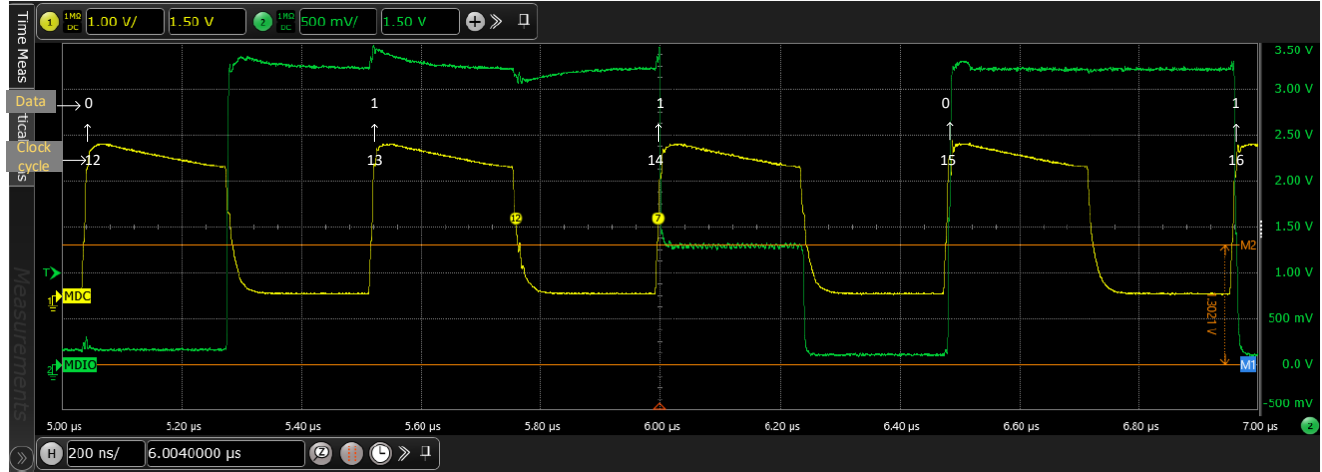
Fail Case: Phy ID2: 30Nov: JP95_PHYID2_READ_FAIL_CLK14 & 15_@HTB.pdf

In Failing case immediately after 14th MDC Clock cycle rising edge and next falling edge MDIO is at 1.5V indicating contention on the MDIO signal.

It appears Phy is unexpectedly driving 0 on MDIO at 14th MDC clock cycle falling edge which is in contention with the 1 being driven by ZU67

[Zoom in on MDC rising edges 12 to 16](#)

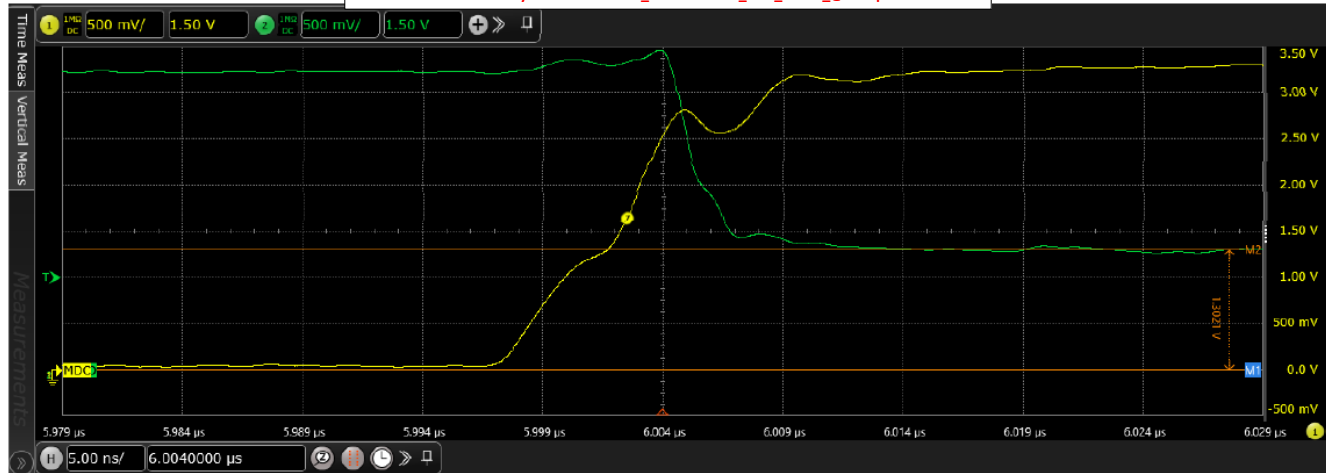
Fail Case: Phy ID2: 30Nov: JP95_PHYID2_READ_FAIL_CLK14_@HTB.pdf

[Zoom in on MDC rising edge 14](#)

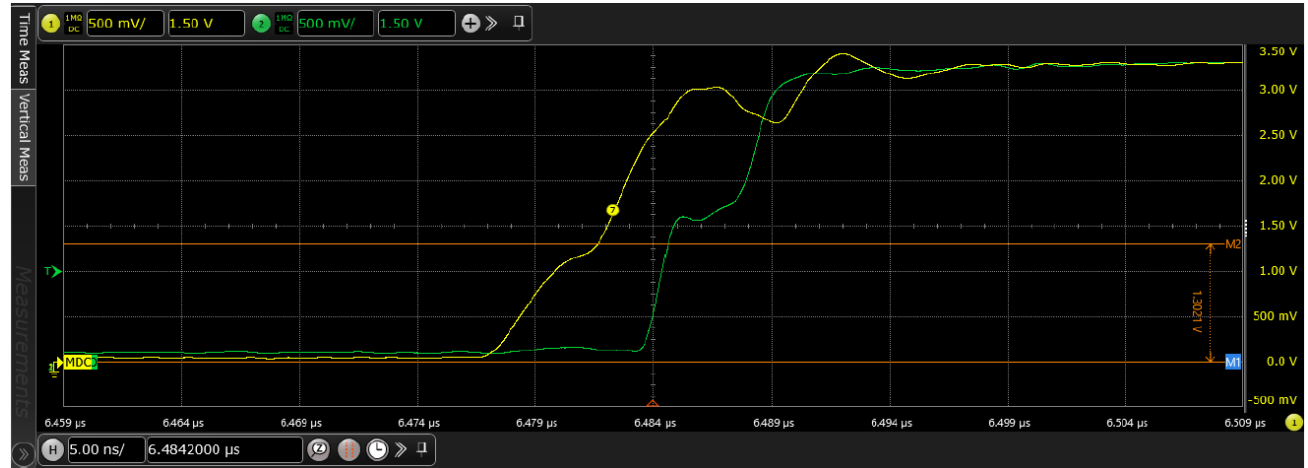
Fail Case: Phy ID2: 30Nov: JP95_PHYID2_READ_FAIL_CLK15a_@HTB.pdf

[Zoom in on MDC rising edge 15](#)

In fail case value read is
0x4463
(bits shifted to left by 1)

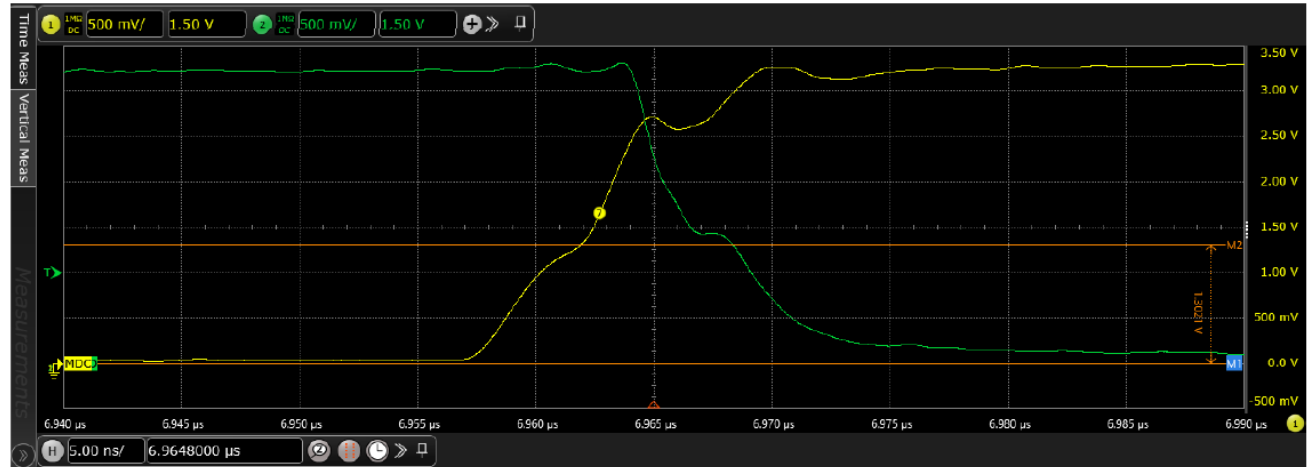
Fail Case: Phy ID2: 30Nov: JP95_PHYID2_READ_FAIL_CLK16_@HTB.pdf

[Zoom in on MDC rising edge 16](#)
