SN65176 Communication issue

Problem Description

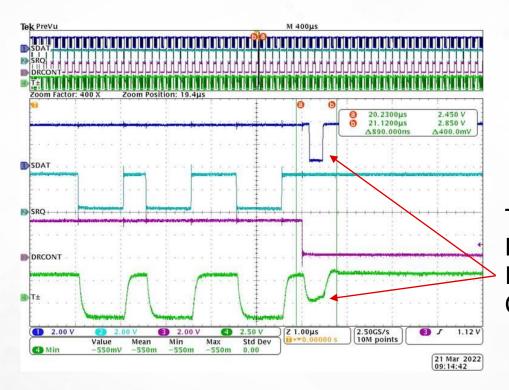
Probe Measurement_NG

The V_AB differential voltage is Dropping to -550mV and the R pin of RS485 is pulled low. It could cause the Communication error.

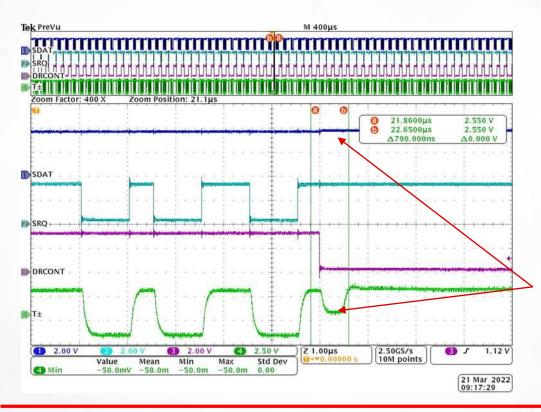
Probe Measurement_Good

The V_AB differential voltage is Dropping to -50mV only and the R pin of RS485 is kept high. It's ok during RS485 communication.
