# 1. 问题需求

当使用 DP83867ISRGZ 芯片时，出现了如下所示的异常波形。我们初步判断的原因是由于该芯片引脚驱动能力的不足。目前我们有如下两个问题：

### 2. 1 U13 (DP83867ISRGZ) 测试图片

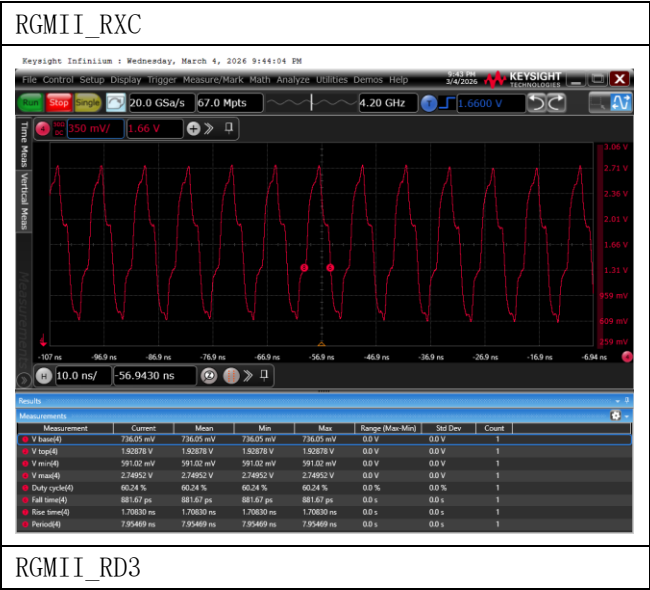
由上图所示，引脚的驱动能力不足。想咨询一下该芯片是否有寄存器可以增加引脚驱动能力。

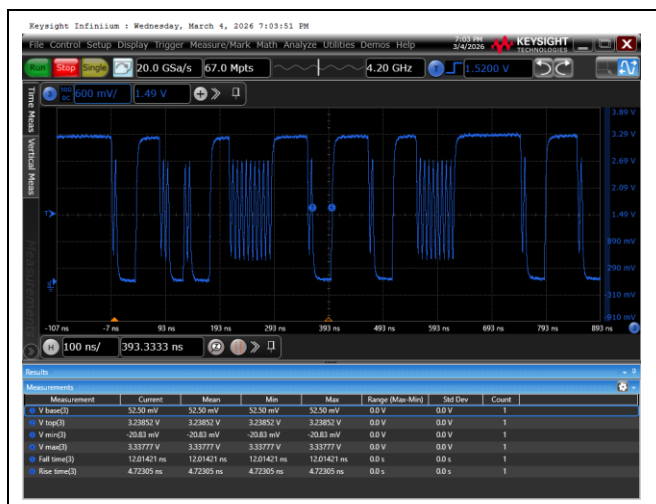
由上图所示，引脚的驱动能力不足。想咨询一下该芯片是否有寄存器可以增加引脚驱动能力。
