1. 4 units from 20 units, screen went dark after 2 days or 2 weeks running, playing image pattern;

sn65dsi86 registers								
Sample Unit	0xf0	0xf1	0xf2	0xf3	0xf4	0xf5	0xf6	0xf7	0xf8
1	0x00	0x20	0x00	0x00	0x01	0x00	0x41	0x00	0x01
2	0x00	0x03	0x00	0x00	0x01	0x00	0x02	0x00	0x01
3	0x00	0x00	0x00	0x00	0x01	0x00	0x40	0x00	0x01
4	0x00	0x24	0x00	0x00	0x41	0x00	0x41	0x01	0x01

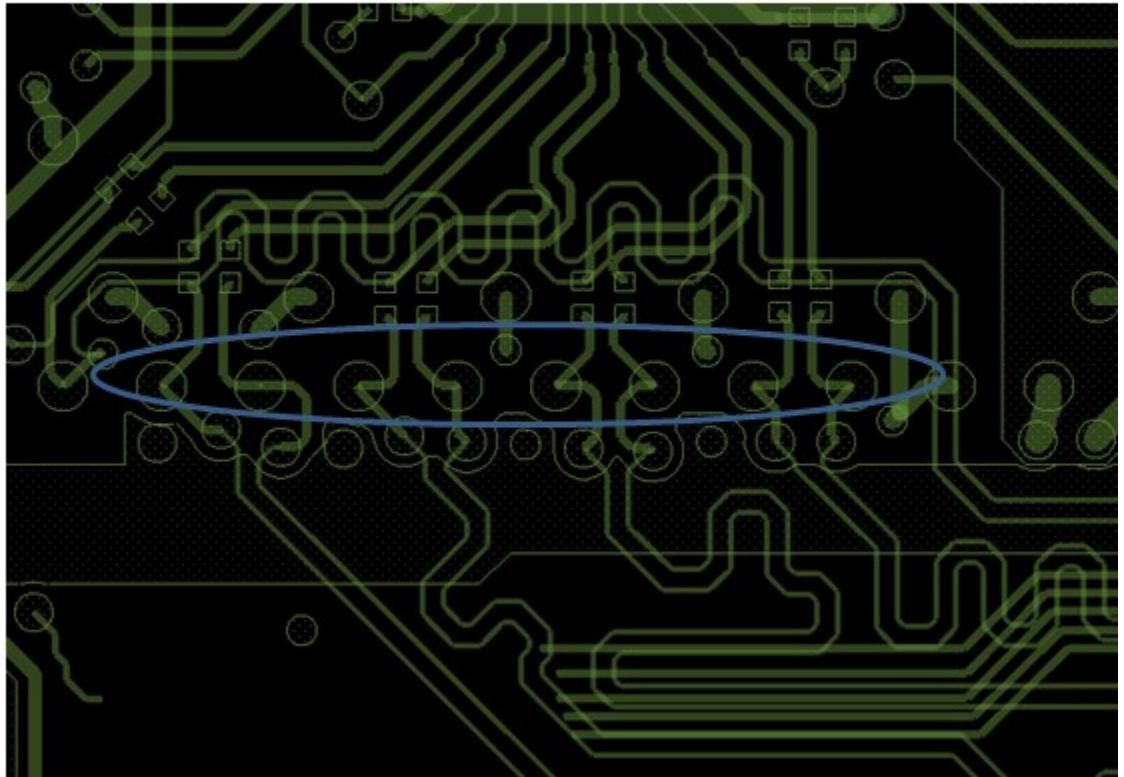
Two things I noticed when looking at their layout.

Why do they route the trace as circled below?

Please note our recommendation

The use of bends in differential traces should be kept to a minimum. When bends are used, the number of left and right bends should be as equal as possible and the angle of the bend should be $\geq 135^\circ$. This will minimize any length mismatch caused by the bends and therefore minimize the impact bends have on reflection and EMI.
