# MDIO interface Access Issue Debug

Version 0.1

18 Nov 2022

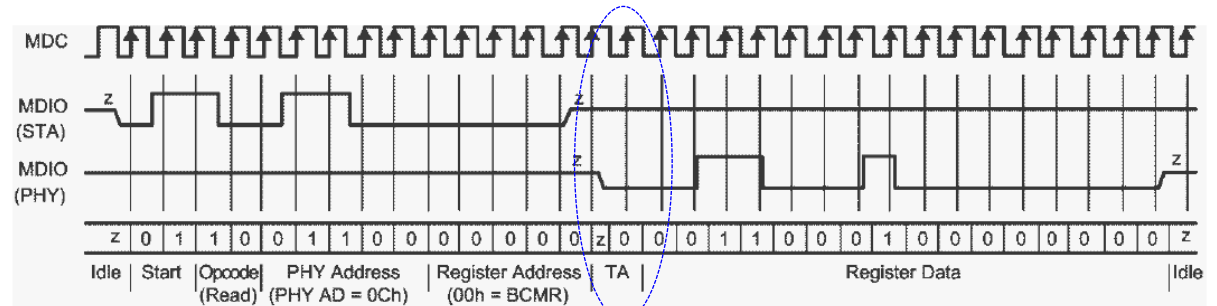
Figure 17. Typical MDC/MDIO Read Operation

The MDIO read access waveform from TI DP83867 Phy datasheet is shown to the right.

Note that there are two clock cycles for turn around time before the Phy starts driving the Read Register data on the MDIO line

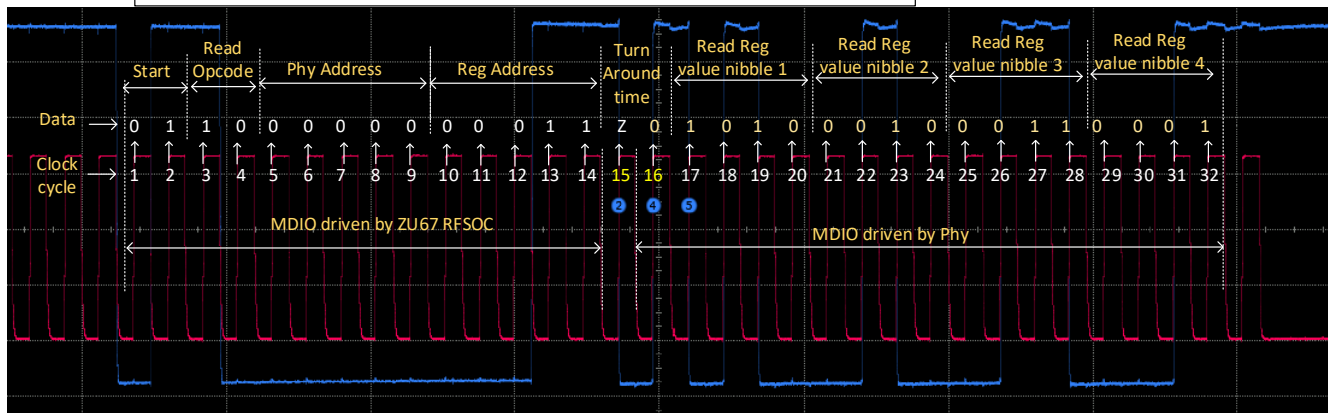
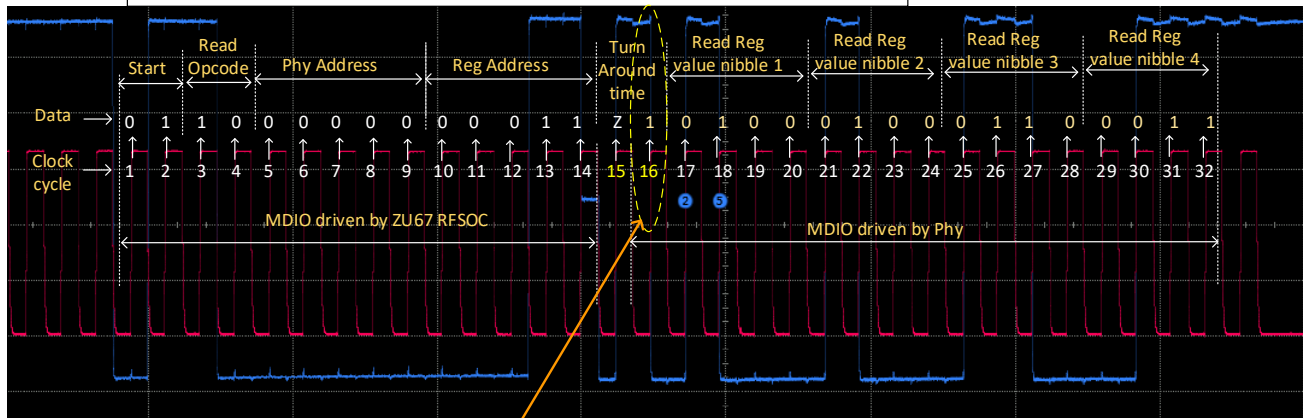
Fail Case: Phy ID2: 9Nov: MDIO\_PHYID2\_ZU67 READ FAIL\_JP178\_HDMI ADAPTER.pdf

## MDIO read access to PHYID2 register

Register address: 0x3

Register data: 0xA231

In fail case value read is  
0x4463  
(bits shifted to left by 1)

**Observation:** At the 16<sup>th</sup> Clock cycle, Phy device is expected to drive 0. However in the Fail case, the Phy device is driving 1 (seems to have started driving the Read register value 1 clock cycle early)

**Need to check on specification of ZU67 and Phy device during turn around time.**

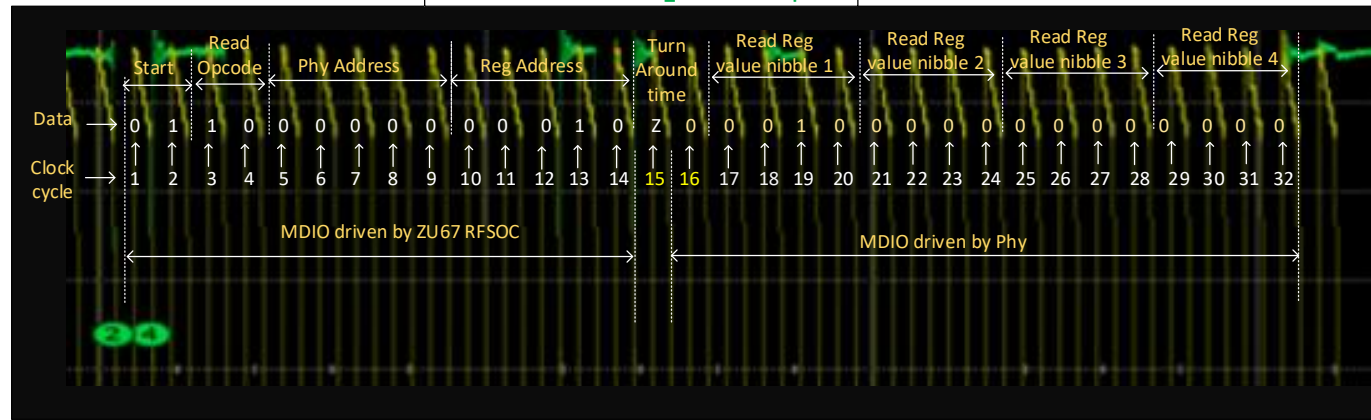
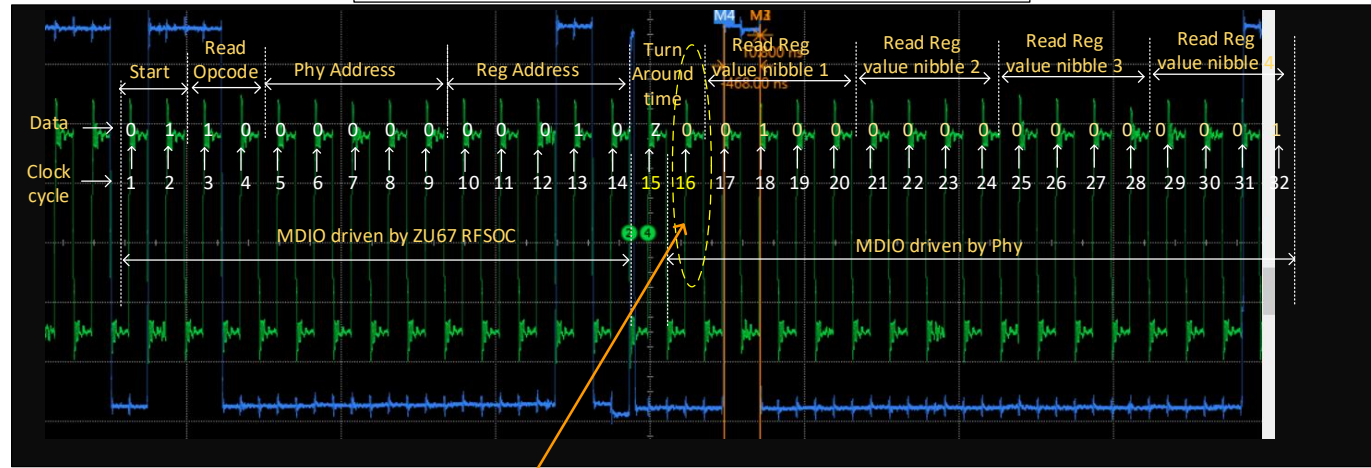
## MDIO read access to PHYID2 register

Register address: 0x2

Register data: 0x2000

In fail case value read is 0x4001 (bits shifted to left by 1)

**Observation:** At the 16<sup>th</sup> Clock cycle, Phy device seems to have started driving the Read register value 1 clock cycle early.  
**Need to check on specification of ZU67 and Phy device during turn around time.**
