FAILURE ANALYSIS REPORT

**FA QEM-CCR-1709-00009
ACTION-0074312**

Device: TUSB4041IPAPRQ1

Conclusion: The device failed due to an electrical overstress event.

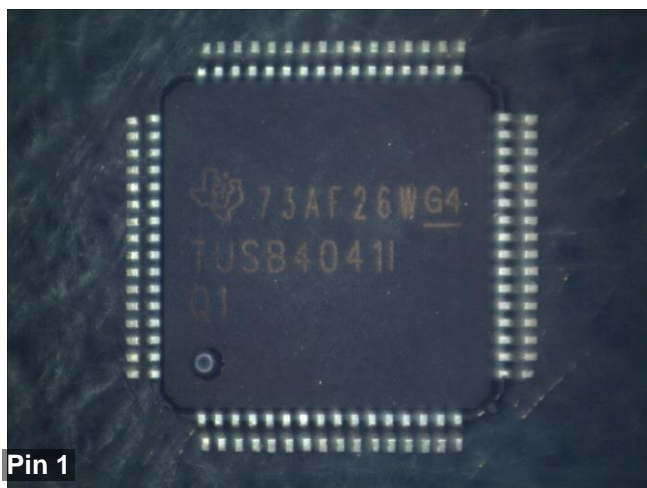
Figure Number: 1
Unit Number: 1

External visual inspection did not reveal any anomalies or defects.

Optical image of the top side external condition of the package.

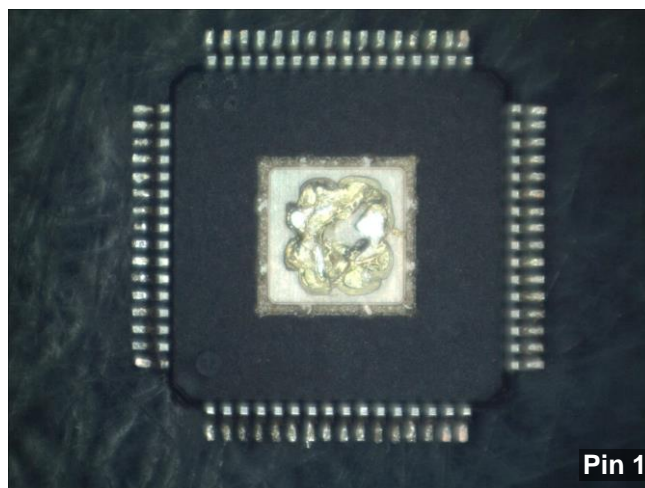
Figure Number: 2
Unit Number: 1

Optical image of the bottom side external condition of the package.

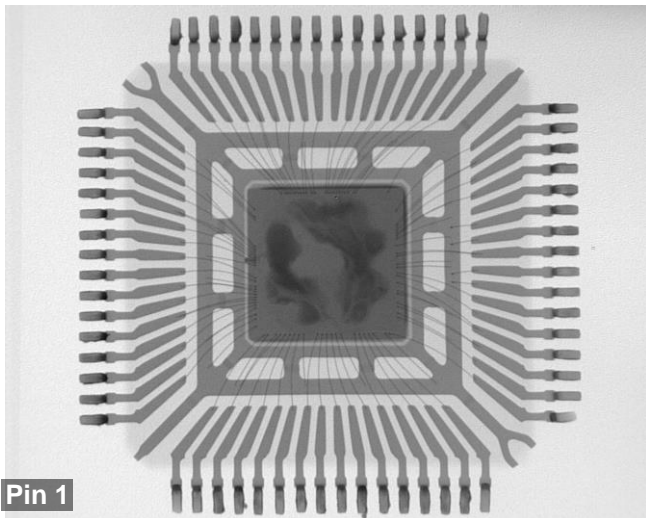
Figure Number: 3
Unit Number: 1

X-ray analysis did not reveal any anomalies or defects. The bond wires were in place and no anomalous bond wire sweep was observed.

X-ray analysis did not reveal any anomalies.

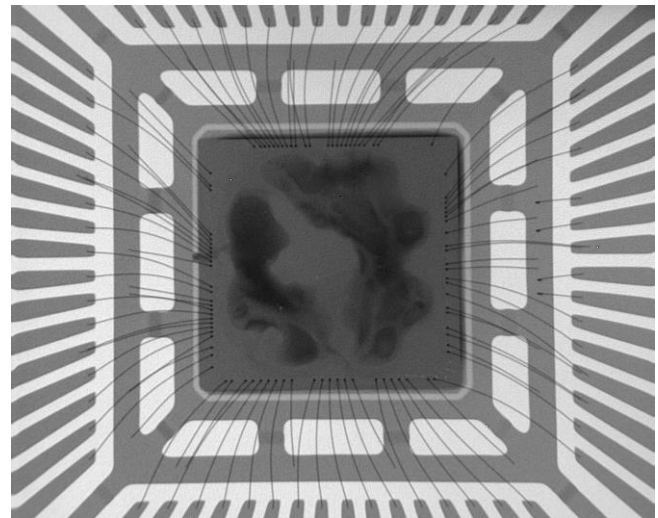
Figure Number: 4
Unit Number: 1

High magnification X-ray analysis did not reveal any anomalies.

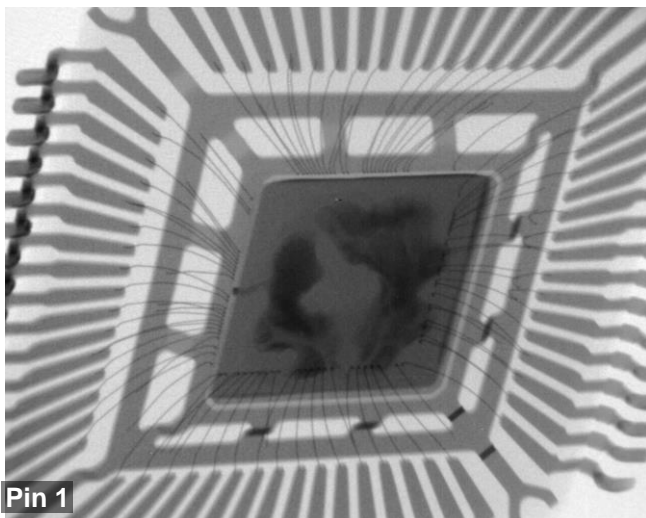
Figure Number: 5
Unit Number: 1

Angled X-ray analysis did not reveal any anomalies.

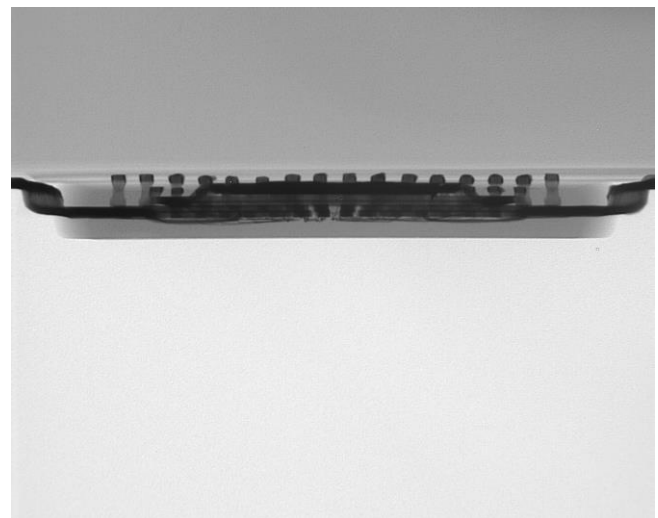
Figure Number: 6
Unit Number: 1

Side view X-ray analysis did not reveal any anomalies.

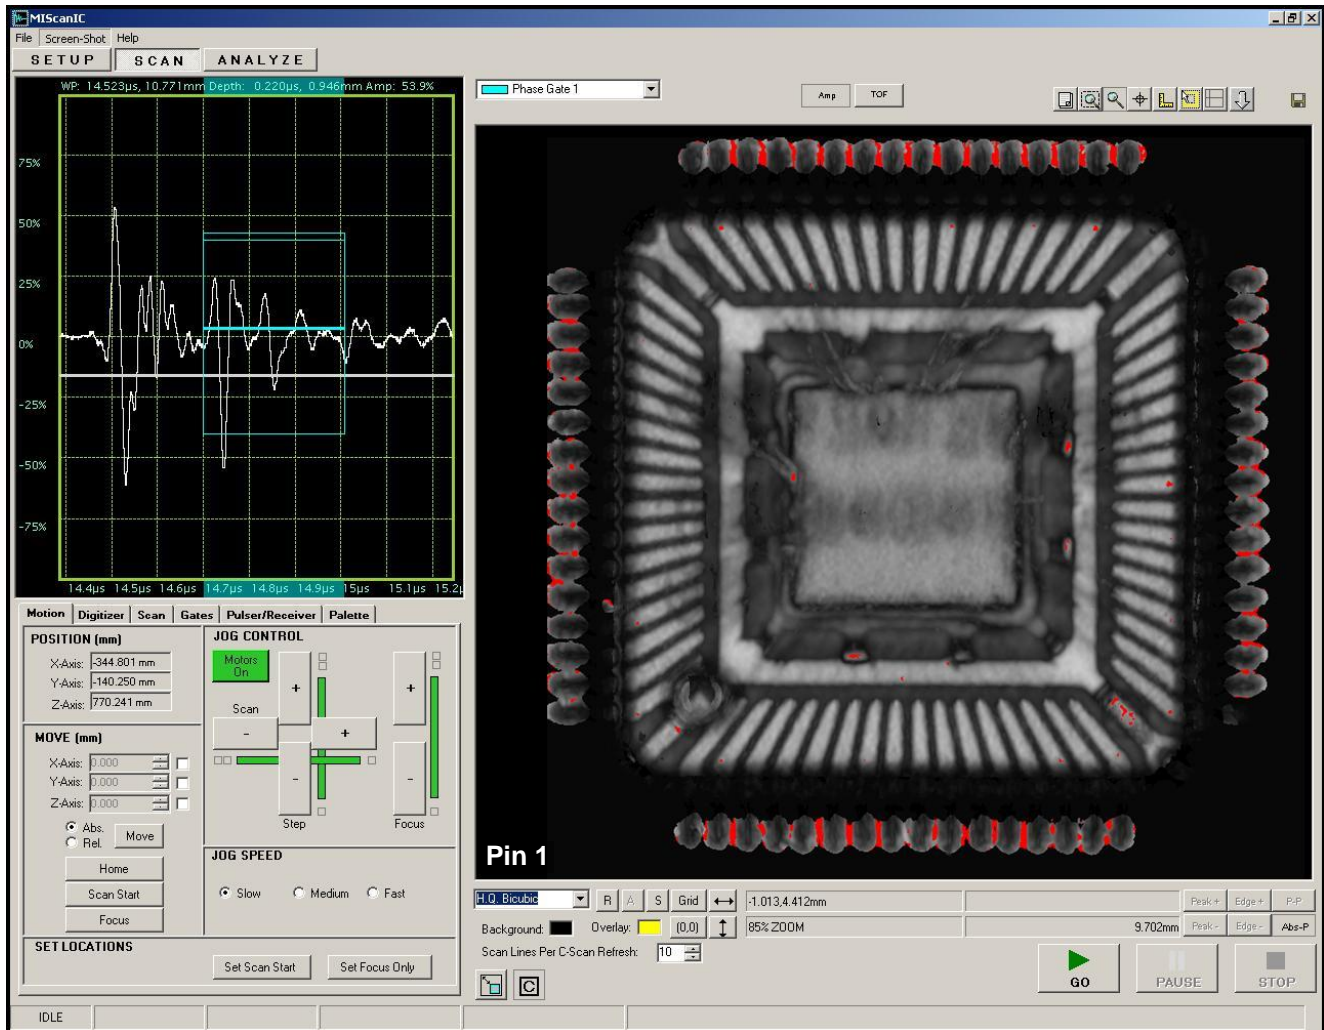
Figure Number: 7
Unit Number: 1

Scanning Acoustic Microscopy (SAM) did not reveal any delamination at the package/die interface.

SAM analysis did not reveal any delamination at the package/die interface.

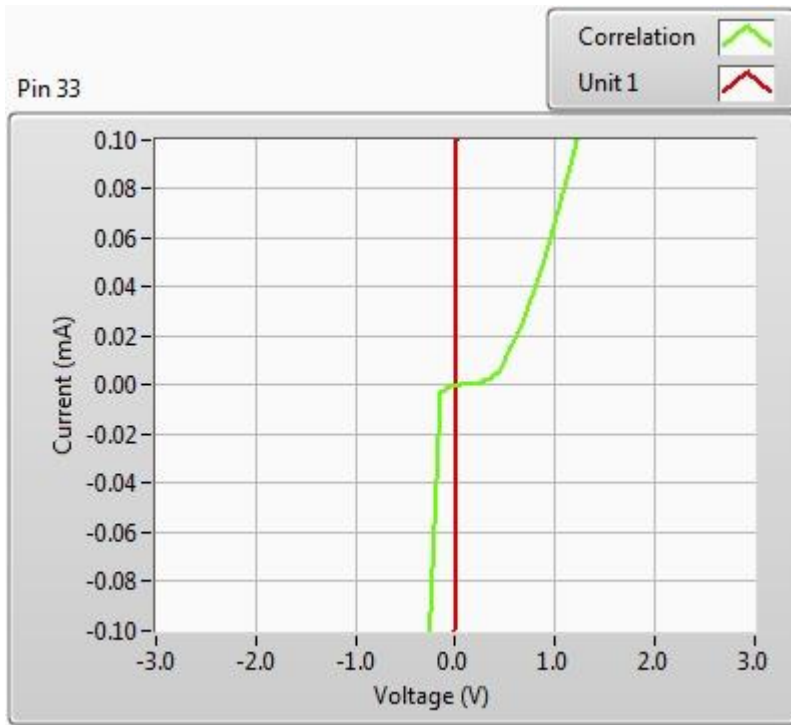
Figure Number: 8
Unit Number: 1

An all pins curve trace confirmed the reported short from pin 33 and pin 34 to GND, when compared to a correlation unit.

Curve trace image showing a short from pin 33 to GND.

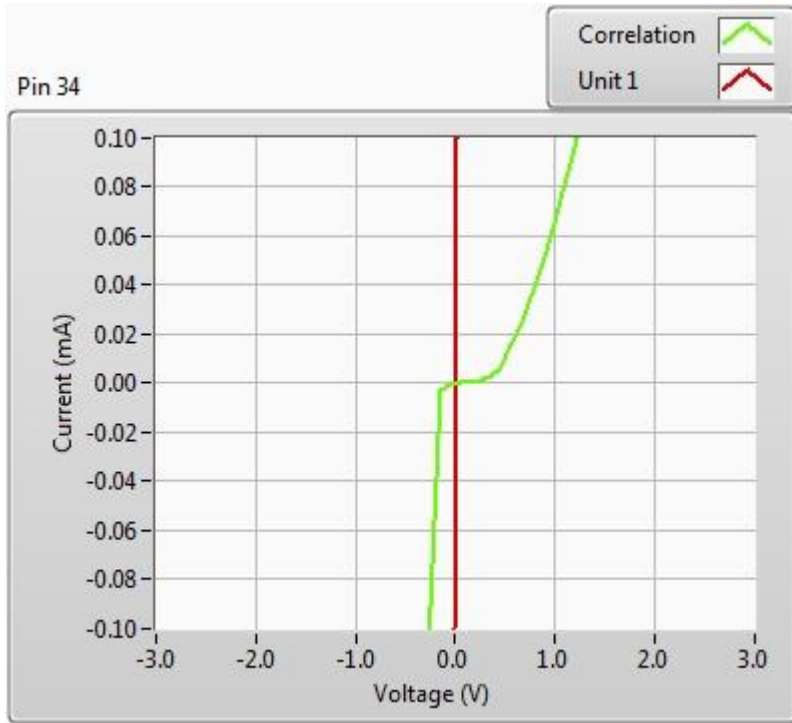
Figure Number: 9
Unit Number: 1

Curve trace image showing a short from pin 34 to GND.

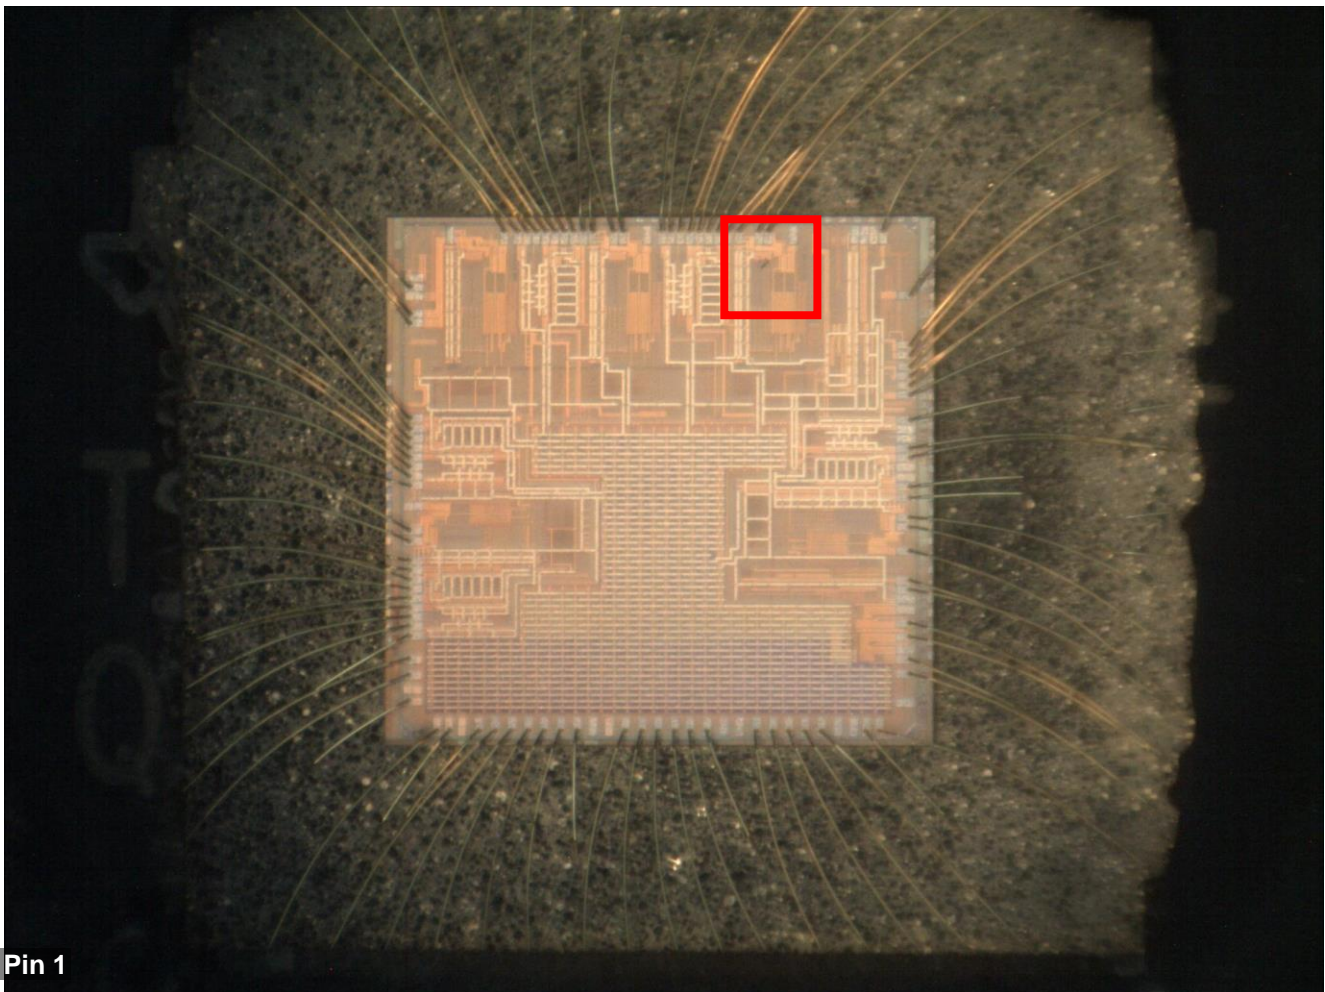
Figure Number: 10
Unit Number: 1
Layer: Protective Overcoat (PO)

The device was decapsulated using wet chemical etchants. Optical inspection of the die circuitry revealed EOS damage in the form of degraded mold compound, damaged, and reflowed metal.

Optical overview image showing the die area of the unit. EOS damage indicated by the red.

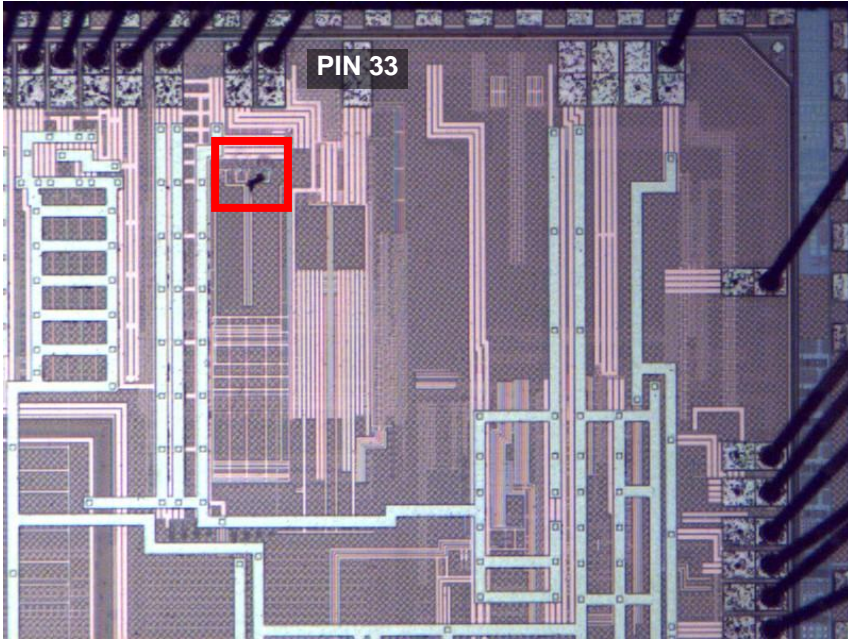
Figure Number: 11
Unit Number: 1
Layer: Protective Overcoat (PO)

High magnification optical image of the observed EOS damage, as indicated by the red.

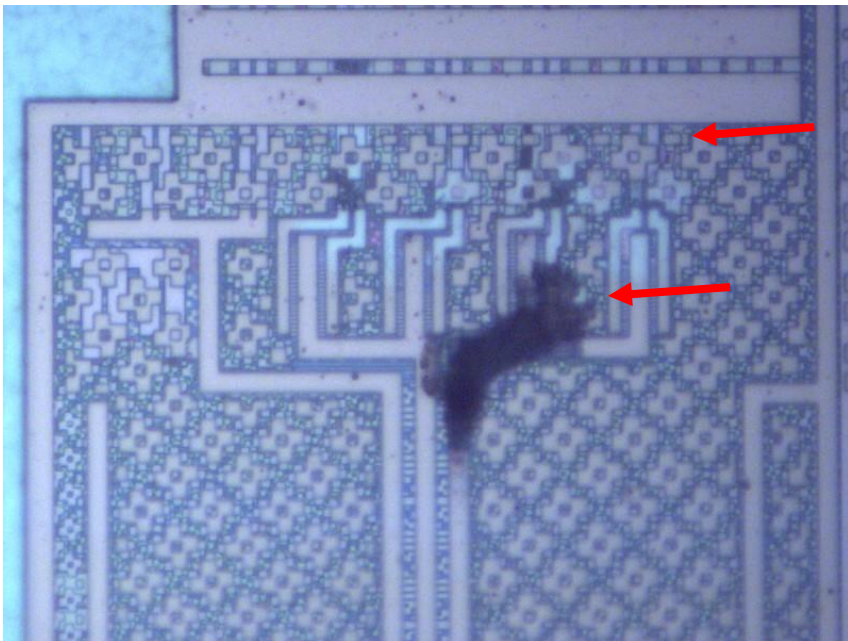
Figure Number: 12
Unit Number: 1
Layer: Protective Overcoat (PO)

High magnification optical image of the observed EOS damage, as indicated by the red.

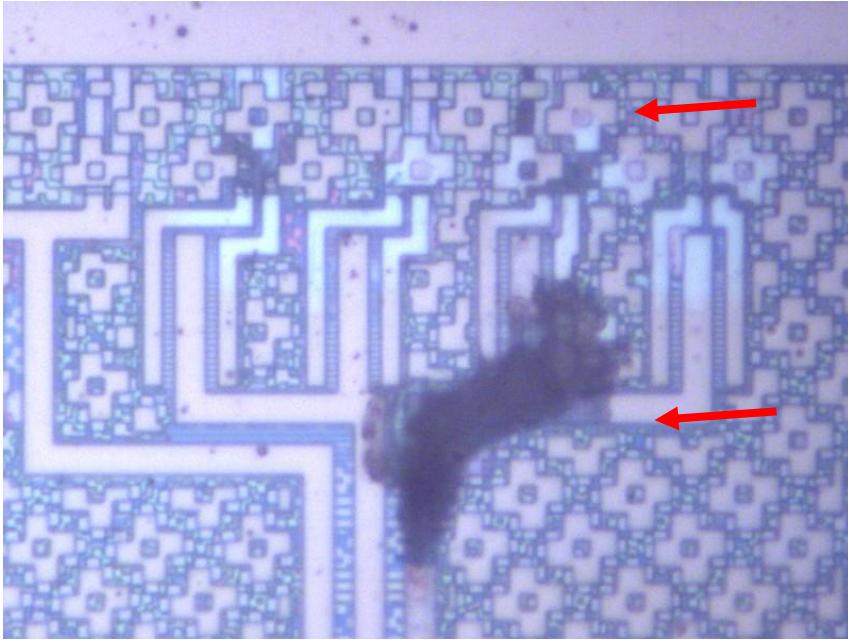
Figure Number: 13

**High magnification optical
image of the observed EOS
damage, as indicated by the
red.**
