Failure Analysis Report

FA QEM-CCR-1710-00243

Customer:	SERIAL SYSTEM (DSTR)	Assy Site:	
Customer Tracking ID:		Fab Site:	
Customer Part ID:		Technology:	C021
Customer Contact:	leizhigang	Analyst:	Asma Haddoud
Device Type:	TUSB4041IPAPRQ1	TI Contact:	Lisa Liu(CQE SZ)
		Qty Submitted:	1
Flow Type:	Customer Return	Date Submitted:	2017-10-13
Reviewer:		Approval:	Thym Legba.

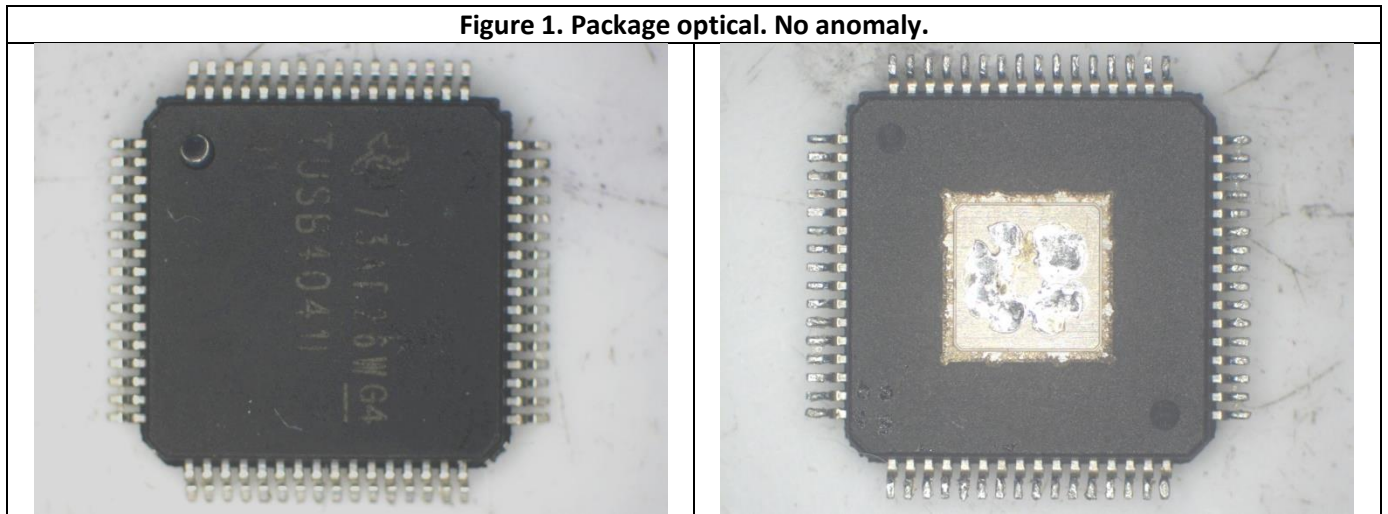
Figure 1. Package optical. No anomaly.

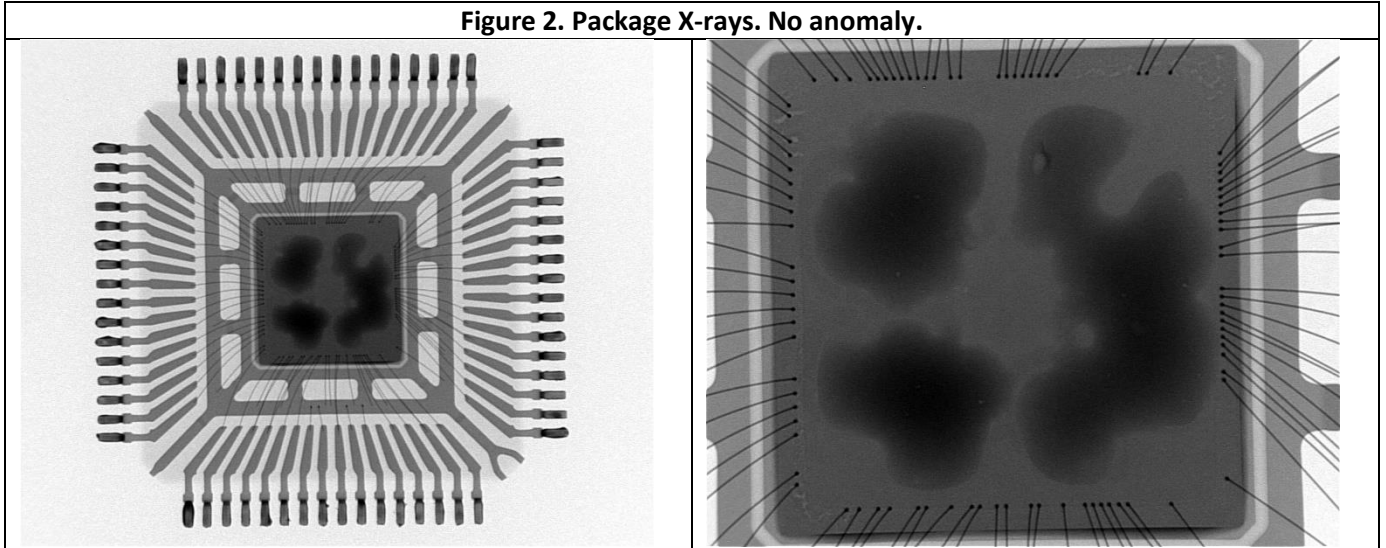
Figure 2. Package X-rays. No anomaly.

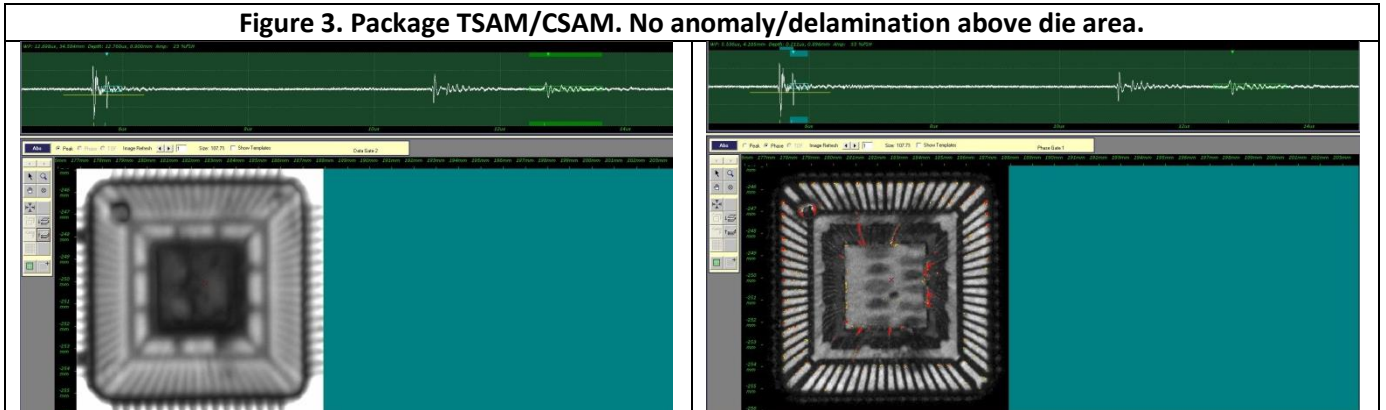
Figure 3. Package TSAM/CSAM. No anomaly/delamination above die area.

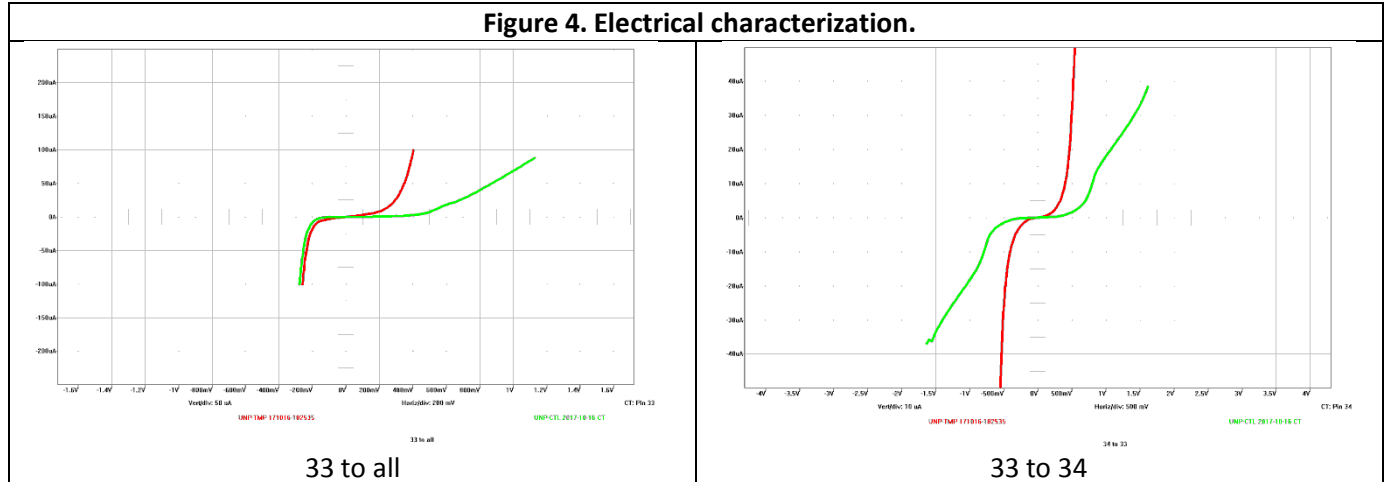
Figure 4. Electrical characterization.

A basic pin to pin curve trace was performed on the RMR unit and compared to a good unit. Anomalous path was observed on pin 33 when curve traced against other pins. The pin showed a leakage through the origin.

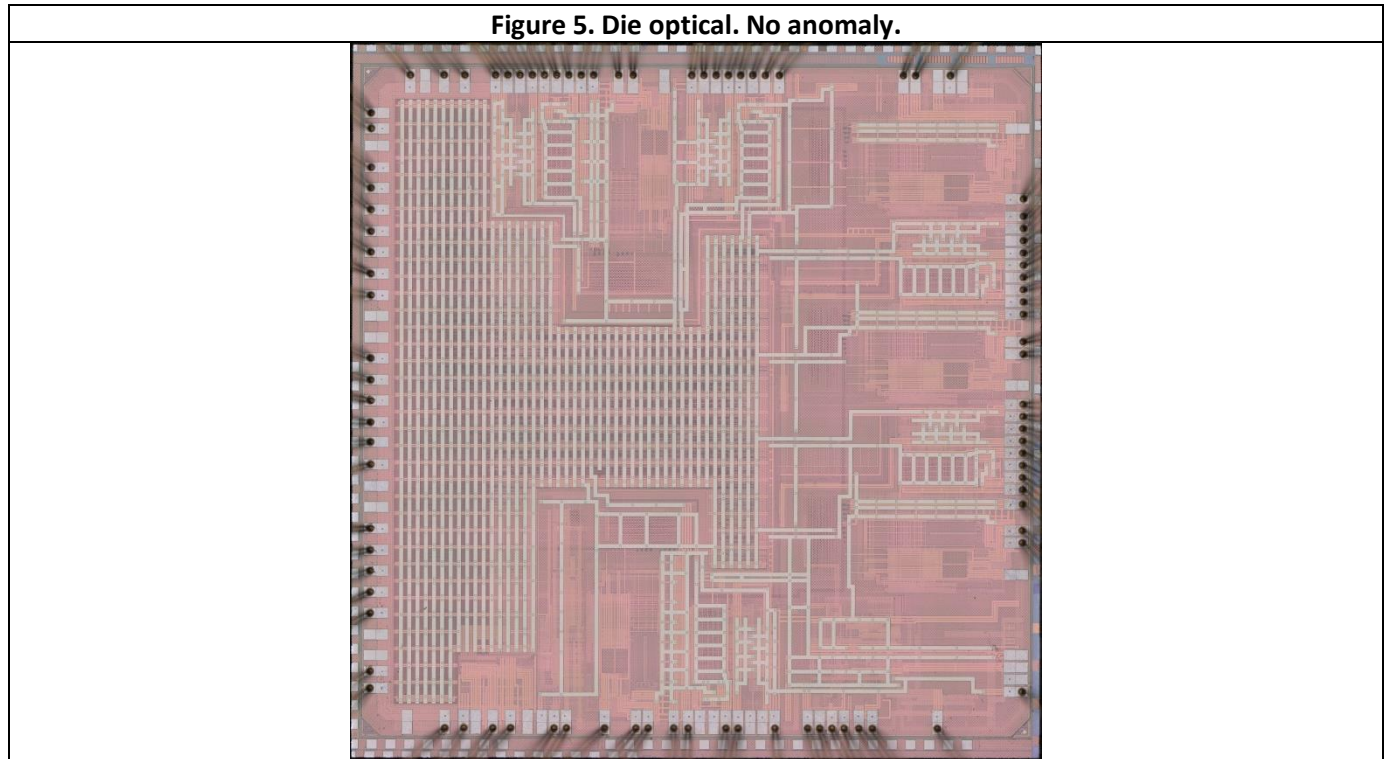
Figure 5. Die optical. No anomaly.

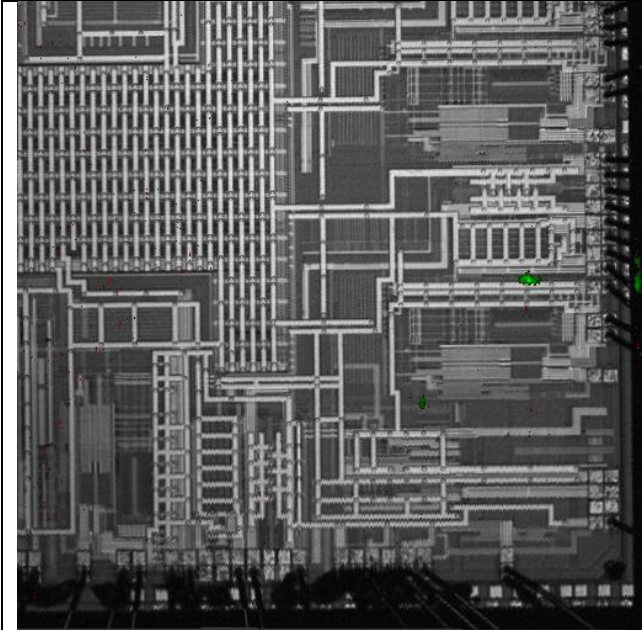
Figure 6. PEM. correlation

Optical Beam Induced Resistance Change (OBIRCH) was performed on the RMR unit and a good unit for comparison while exercising the leakage on pin 33. One additional/saturated site was observed.

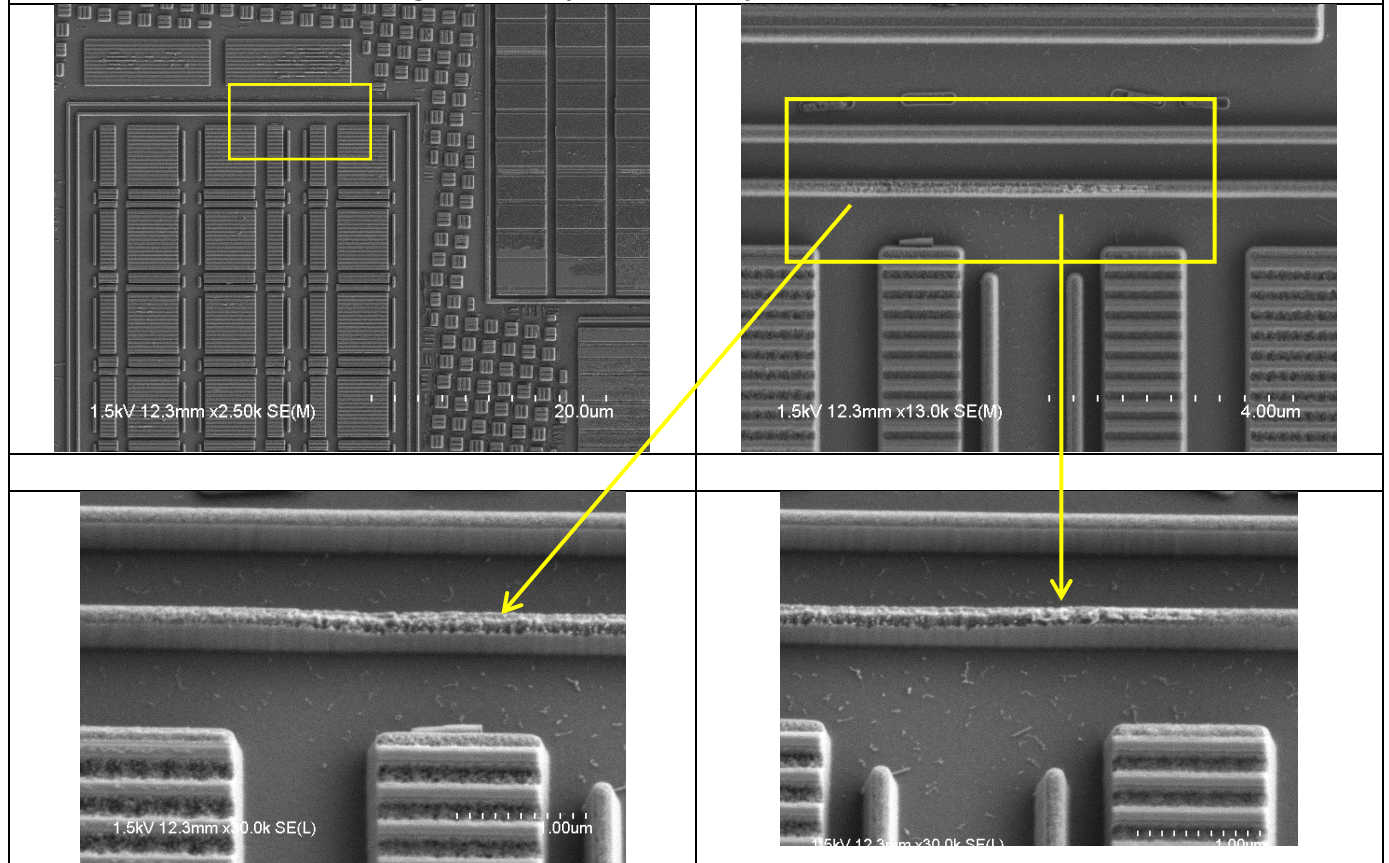
Unit was then deprocessed straight to silicon using HF acid. Optical inspection of the die using scanning electron microscope (SEM) showed an anomaly at Silicon around OBIRCH site's area. The anomaly looks like damage from thermal stress.

Figure 8. Die optical. Anomaly observed at Silicon.

Leakage on pin 33. Silicon damage at OBIRCH site.
