# RS485 Communication Problem

Application: Solar Inverter

Device: SN65HVD12DR

Customer: WW

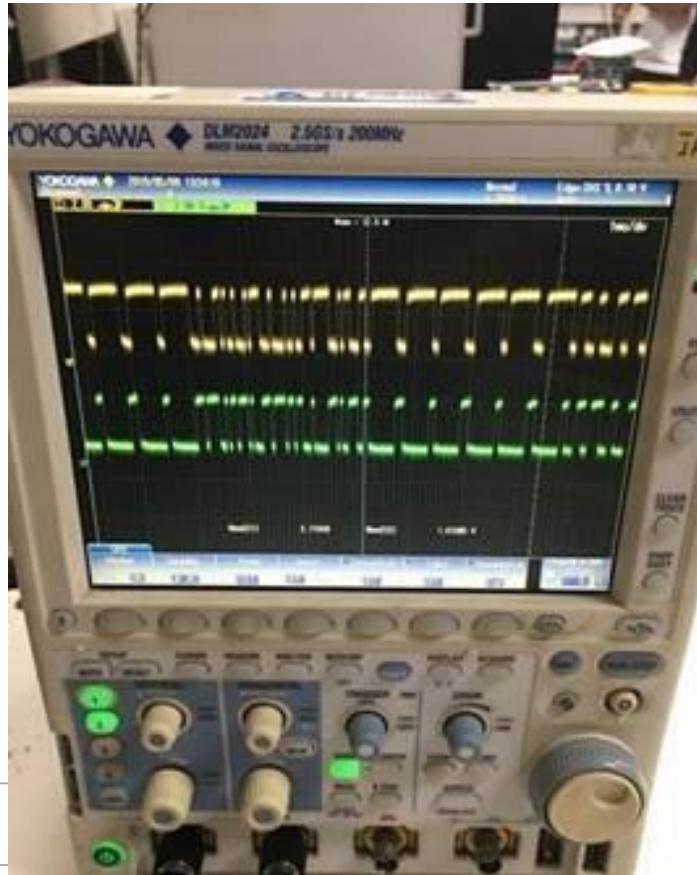
Good Waveform  
Which was measured  
Two months ago.  
:  
:

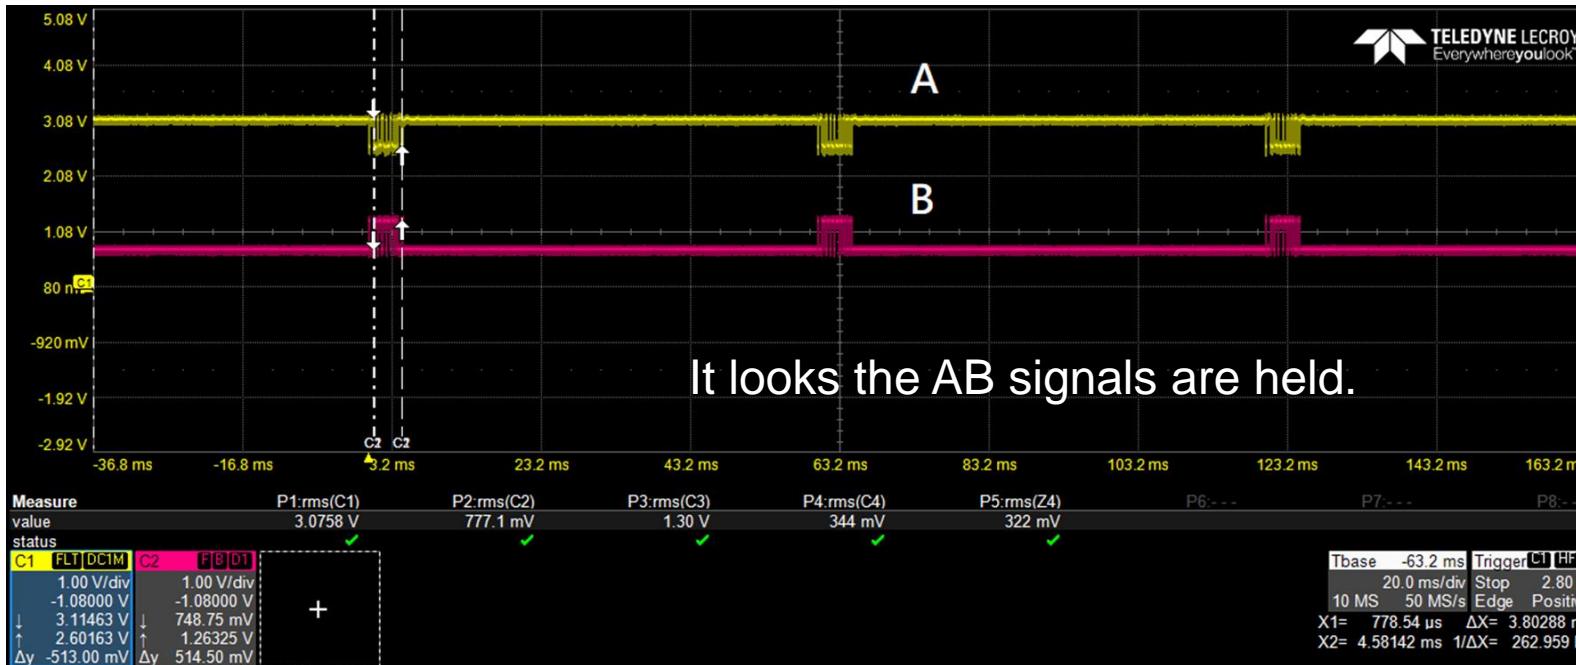
N.G Waveform:

PS: We checked the Slave side MCU UART is ok. Master side's UART is ok also.

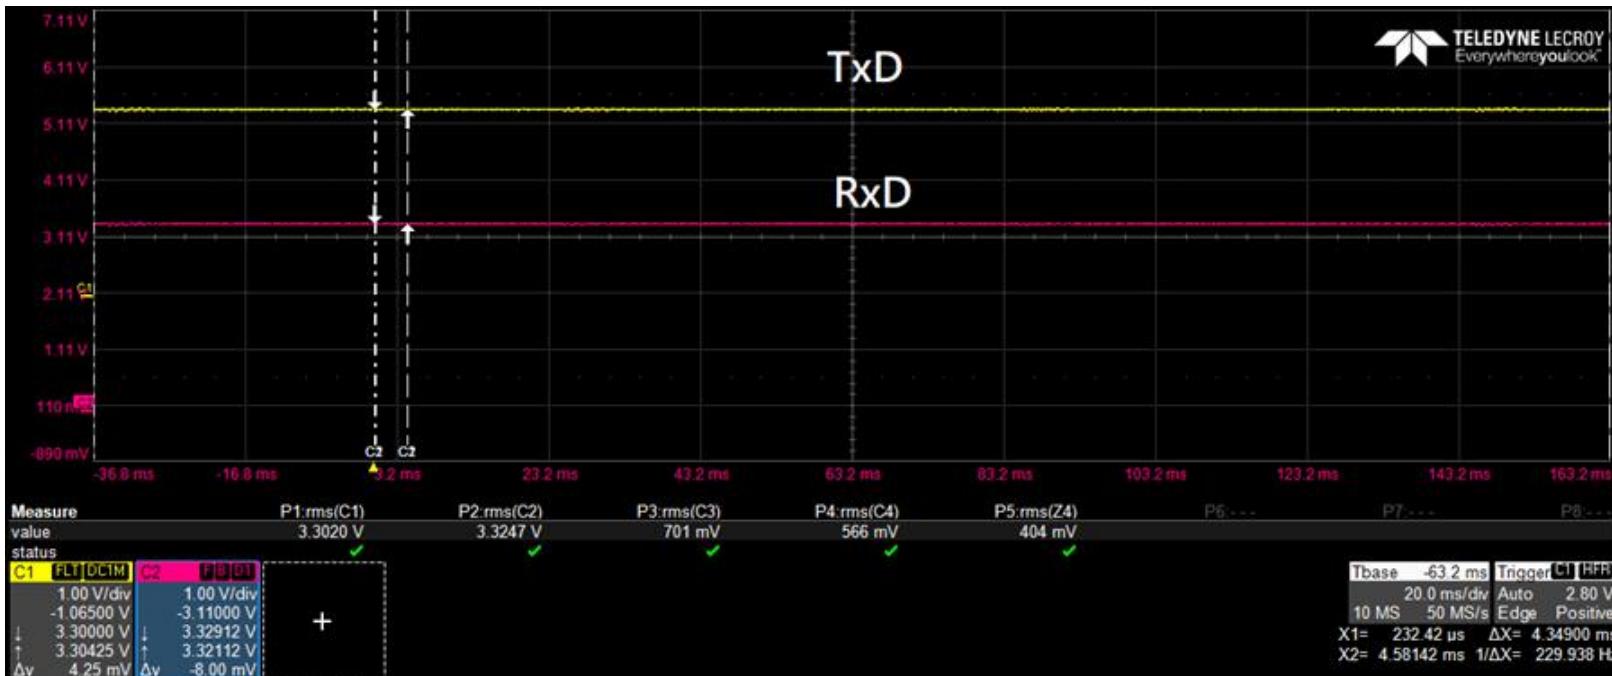
N.G Waveform:
