# ERRATA FOR IEEE 1394b THREE-PORT CABLE TRANSCEIVER/ ARBITER TSB81BA3, TSB81BA3I (SLLS559) AND TSB81BA3-EP (SGLS194)

SLLZ015C – DECEMBER 2002 – REVISED MARCH 2006

## TSB81BA3 Silicon Errata

This document contains corrections and additions to the following device data sheets: TSB81BA3 (TI Literature Number SLLS559) and TSB81BA3-EP (TI Literature Number SGLS194).

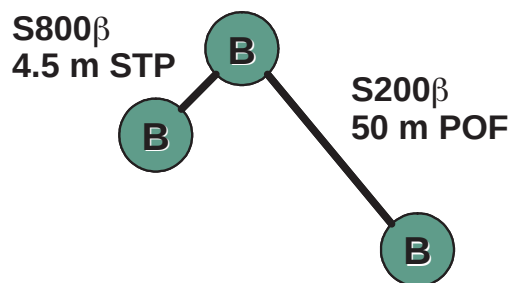
Figure 1. BOSS Arbitration Issue Caused By Mixed Cable Lengths

| SILICON<br>ERRATA ID | PROBLEM DESCRIPTION | RESOLUTION / WORK-AROUNDS |
|---|---|---|
| 2. BOSS arbitration issue | <p><u>Symptom</u><br/>A bus-reset may occur in certain topologies when 1394b BOSS arbitration is in use.</p> <p><u>Occurrences</u><br/>This issue is only possible if three or more BOSS-arbitration capable nodes are connected through a 1394b connection. To be BOSS-arbitration capable a node must have a 1394b PHY and a 1394b Link using the 1394b PHY-Link interface connection.</p> <p>If a narrow timing window is violated (dependent on cable lengths and/or mixed speed bus hops) a middle node may detect a packet collision, causing a PHY state timeout. The state timeout causes a bus reset. Repetitive occurrences result in repetitive bus resets.</p> <p><u>Example Topologies</u><br/>A. Mixing short and long cable lengths. A BOSS arbitration issue may occur in the middle node. Figure 1 shows an example topology that would exhibit the condition.</p> | <p>A. Use one or more 1394a link-layer controllers (LLCs). If the network only consists of nodes using 1394a link layers, then BOSS arbitration is not utilized; Gap_Count delays are maintained and therefore nodes are not affected by this errata.</p> <p>B. In nodes that do not have a link, disable BOSS arbitration (e.g., force the BMODE pin to the logic 0 state).</p> <p>C. Use a topology where all nodes use the same 1394a compatible bus speed (e.g., S400) and at least one IEEE Std 1394a-2000 node is present.</p> <p>D. Use a topology where all 1394B nodes are at the same 1394b bus speed, using matched cable lengths between 1M and 4.5M.</p> |

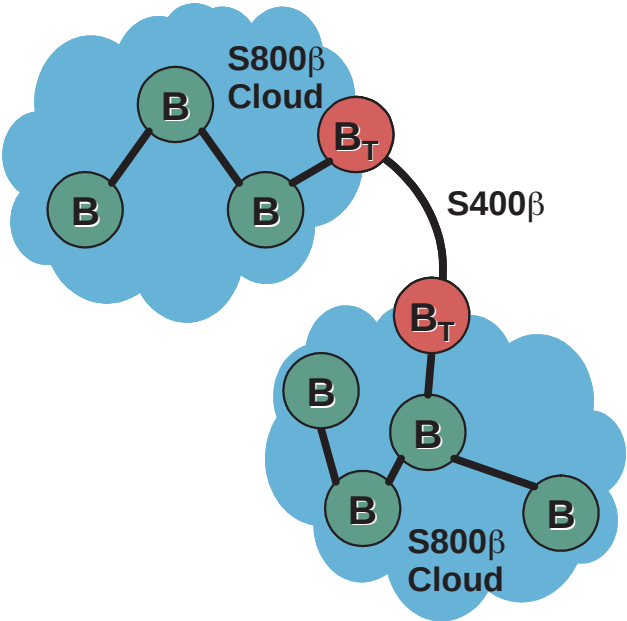
Figure 2. BOSS Arbitration Issue Caused By Mixed Bus Hop Speeds

| SILICON<br>ERRATA ID | PROBLEM DESCRIPTION | RESOLUTION / WORK-AROUNDS |
|---|---|---|
| 2. BOSS arbitration<br>issue (continued) | <u>Example Topologies</u> (continued)<br>B. Mixing bus hop speeds. Either transition node (B <sub>T</sub> ) may have a BOSS<br>arbitration issue. See Figure 2. | |

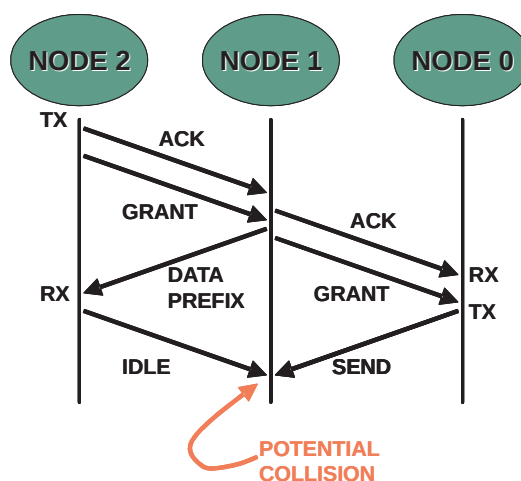
Figure 3. BOSS Arbitration Issue—Detailed Example Situation

| SILICON<br>ERRATA ID | PROBLEM DESCRIPTION | RESOLUTION / WORK-AROUNDS |
|---|---|---|
| 2. BOSS arbitration<br>issue (continued) | <p><u>Detailed Example Situation</u><br/>See Figure 3.</p> <ol style="list-style-type: none"> <li>Node #2 transmits a high-speed packet that ends an Async subaction or the Isoch period.</li> <li>Node #2 advances the Async phase (no requests pending for the current phase).</li> <li>Node #0 has a bus request pending for the new phase.</li> <li>Node #2 sends an Async grant.</li> <li>The Async grant is forwarded through a senior node (Node #1) and down through a junior connection to Node #0.</li> <li>If a narrow timing window is violated the middle node (Node #1) will detect a packet collision, causing a state-timeout while forwarding the grant to the next node. The state-timeout will cause a bus reset.</li> </ol> | |
