TL16C752DPFBRQ1 : the spike- like noise

The captured waveforms where the reception interrupt of TL16C752DPFBRQ1 cannot be cleared

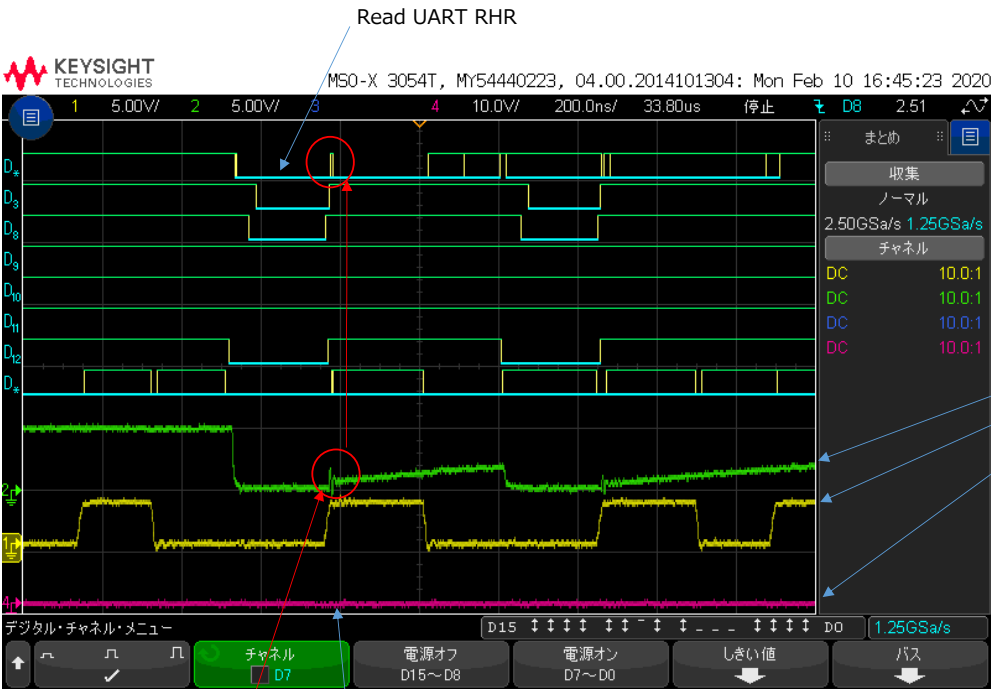
If normal, the interrupt should be cleared around here.

Immediately before the bus buffer was disabled, A1 on the CPU board changed from 0 to 1, so that it appears as spike-like noise on A1 on the backboard. This noise is recognized as "1" by the bus buffer on the communication board, and A1 of UART changes from 0 to 1 at almost the same timing as the deassertion of / CS signal of UART.

The UART-LSI has been accessed twice.
The address signal on the backboard is in high impedance (pull-up) each time access is completed.
The address bus on the CPU board is continuously output.

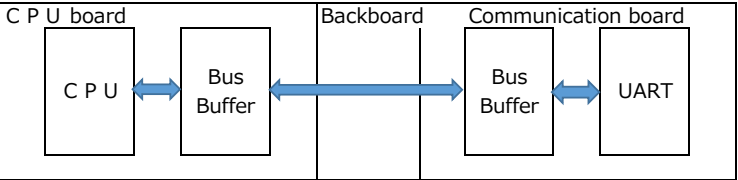
Configuration overview:

Enable the bus buffer and drive the signals on the backboard only when accessing the unit (ex. Communication board) outside the CPU board from the CPU.
When the bus buffer is disabled, the signal on the backboard is pulled up
