# TUSB2036 Troubleshooting

## Symptoms

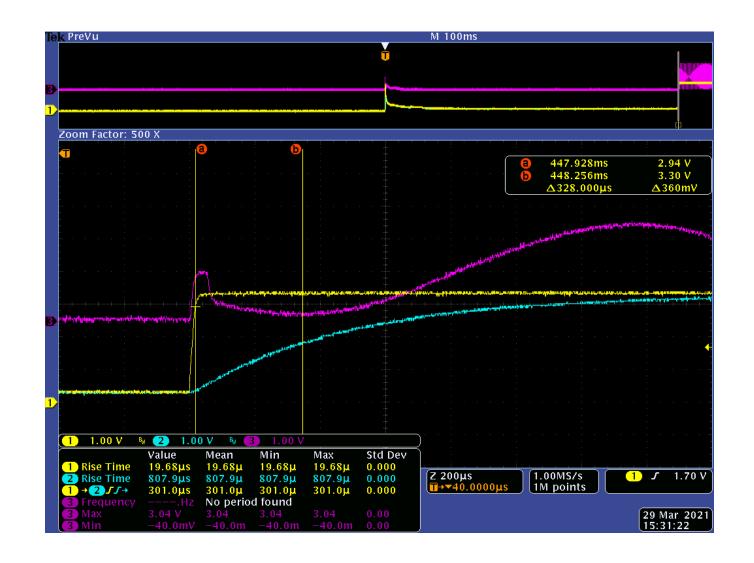
#### Power-on Reset

- CH1 3.3V\_USB
- CH2 Reset
- CH3 XTAL1 pin
  - Due to 1MS/s rate the 6MHz oscillation is not shown properly. I have confirmed that it is working fine.
- Timing from 90% VCC (2.97V) on VCC to V(IT)+ (1.8V) on reset

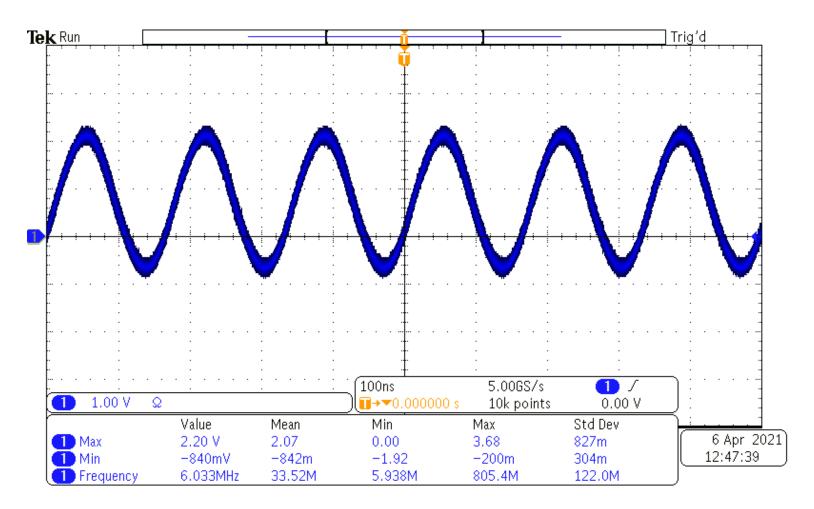
## XTAL1 Input Pin

- Overdriven
- Within max operating range

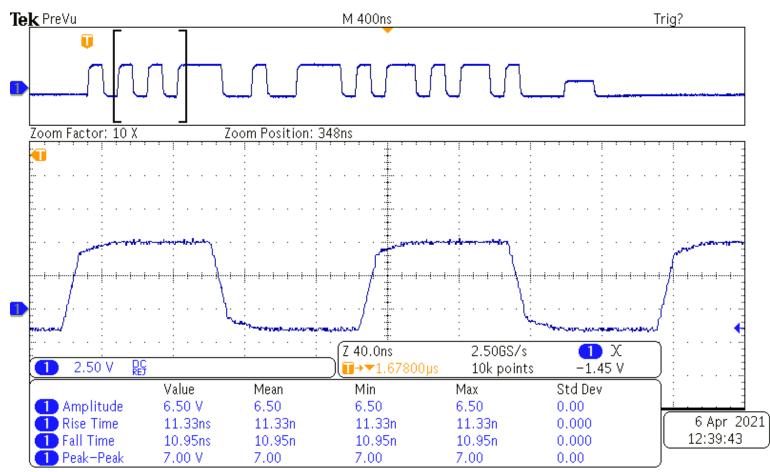
### Upstream Port 0

R33 and R34 on TUSB2036 side (PD0 and PM0)

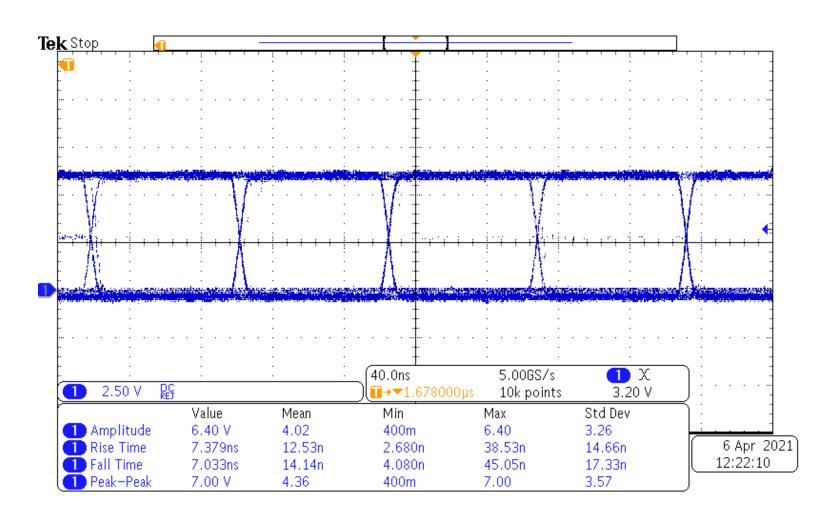
#### Downstream Port 1

R35 and R36 on flash drive side

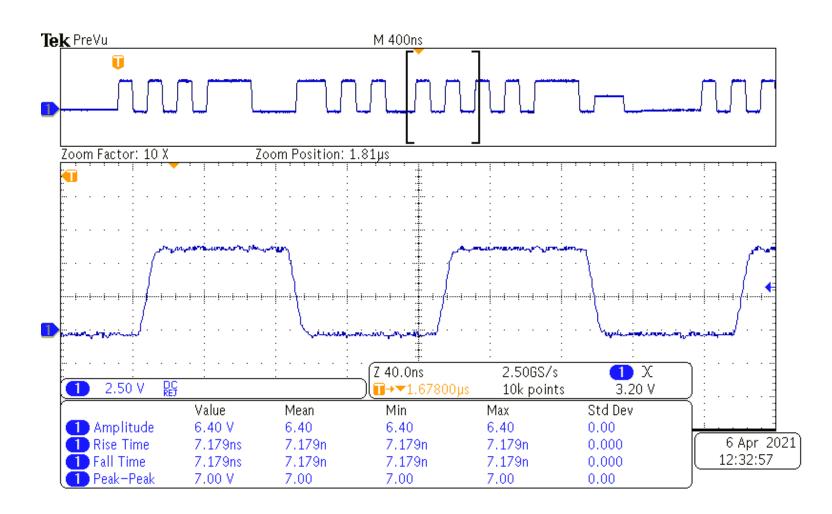
### Downstream Port 1

R35 and R36 on flash drive side

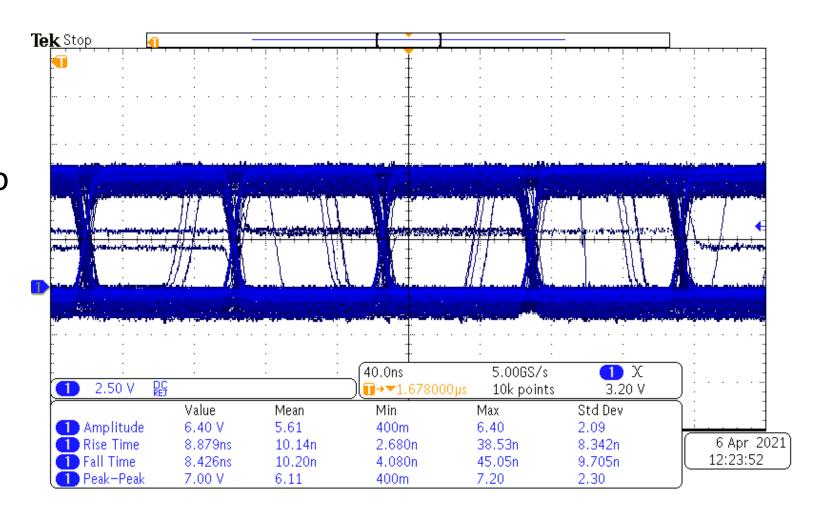
#### Downstream Port 2

- R2 and R4 on ADuM3160 side
- I did not attempt to capture a single transaction like for port 1 (previous slide)

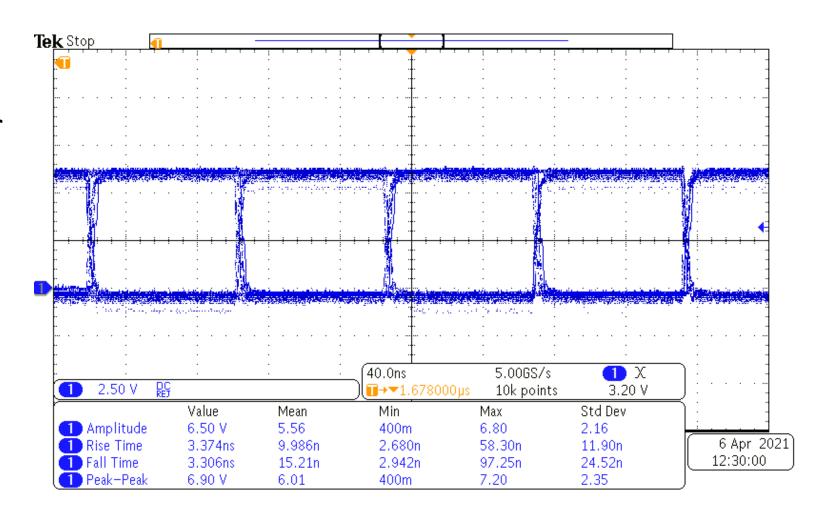
### Downstream Port 2 After Isolator

R3 and R5 on FTDI IC side (on another schematic sheet)
