Problem Statement:

The USB 3 Hub inside the USB3 DMD occasionally drops from Windows as shown below:

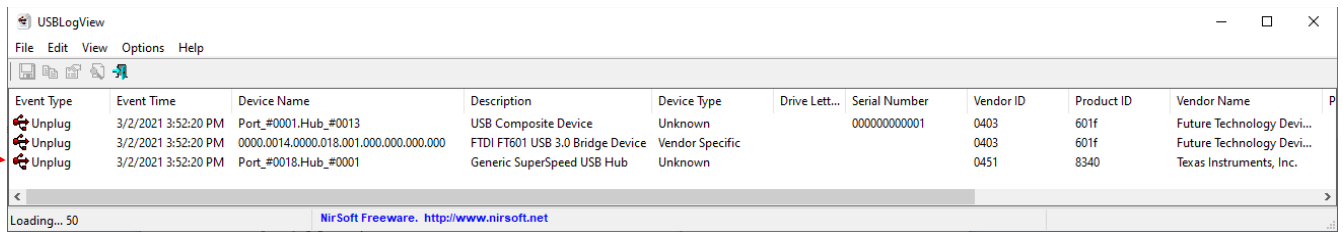
Event Type	Event Time	Device Name	Description	Device Type	Drive Lett...	Serial Number	Vendor ID	Product ID	Vendor Name
Unplug	3/2/2021 3:52:20 PM	Port_#0001.Hub_#0013	USB Composite Device	Unknown		000000000001	0403	601f	Future Technology Devi...
Unplug	3/2/2021 3:52:20 PM	0000.0014.0000.018.001.000.000.000.000	FTDI FT601 USB 3.0 Bridge Device	Vendor Specific			0403	601f	Future Technology Devi...
Unplug	3/2/2021 3:52:20 PM	Port_#0018.Hub_#0001	Generic SuperSpeed USB Hub	Unknown			0451	8340	Texas Instruments, Inc.

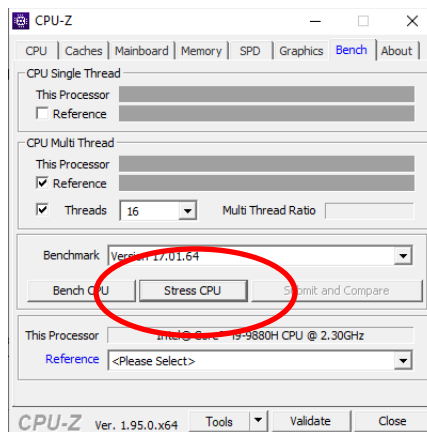
1. This can be replicated on the test bench by running a free program called CPU-Z in "Stress CPU" mode.

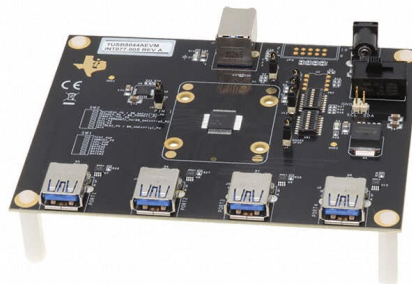
2. When tested this way, the problem happens within a few minutes with the BSN0011 Berkcom PC with a K1200 or P1000 GPU card. It also happens without a GPU card with the USB connected to the motherboard but seems less frequent. The USB dropout also occurs with the Dell 3430 with a GPU card, but seems to fail less frequently.
3. The signal VBUS going low usually is what causes an USB Unplug event when the USB cable is disconnected. However, on the test bench, the critical VBUS signal does not go low or have any noise.
4. This also happens when using the TI reference design (PN: TUSB8044AEM) so this indicates a problem with the hub chip.
