Often while operating in our instrument, the USB 3 HUB (PN: TUSB8043AIRGCR) drops out of Windows as shown:

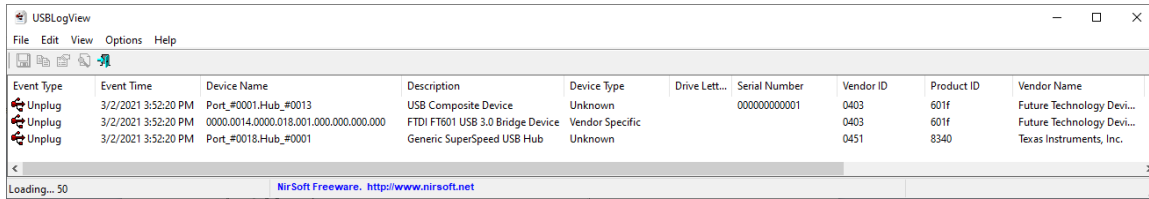
Event Type	Event Time	Device Name	Description	Device Type	Drive Lett...	Serial Number	Vendor ID	Product ID	Vendor Name
Unplug	3/2/2021 3:52:20 PM	Port_#0001.Hub_#0013	USB Composite Device	Unknown		000000000001	0403	601f	Future Technology Devi...
Unplug	3/2/2021 3:52:20 PM	0000.0014.0000.018.001.000.000.000.000	FTDI FT601 USB 3.0 Bridge Device	Vendor Specific			0403	601f	Future Technology Devi...
Unplug	3/2/2021 3:52:20 PM	Port_#0018.Hub_#0001	Generic SuperSpeed USB Hub	Unknown			0451	8340	Texas Instruments, Inc.

The USB 2.0 section of the HUB is working fine.

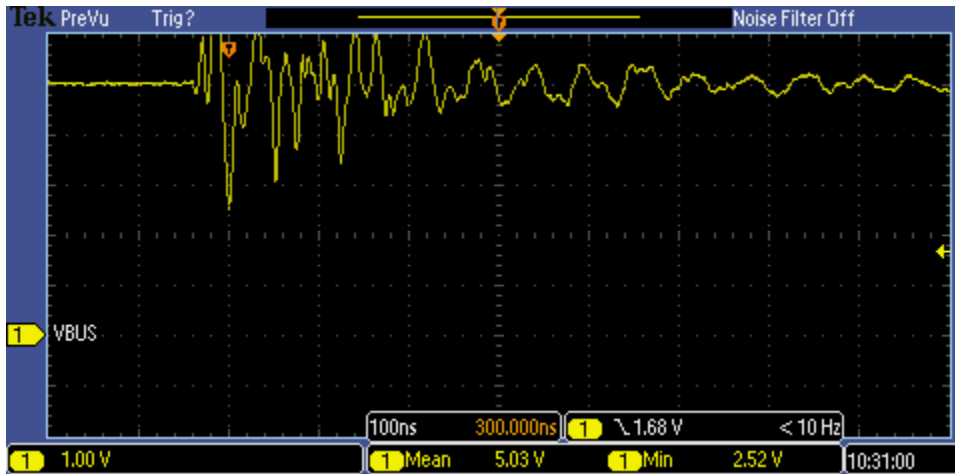
We do have some noise on VBUS as shown:

However, the USB 3 HUB as I understand it, has debouncing logic on the VBUS. Can this noise explain why only the USB 3 section of the hub unplugs?

Does TI have any suggestions to improve the robustness of the design?
