- **CRU Description:**

VIN=5V, VOUT should be 3.3V, but return unit is only 0.4V

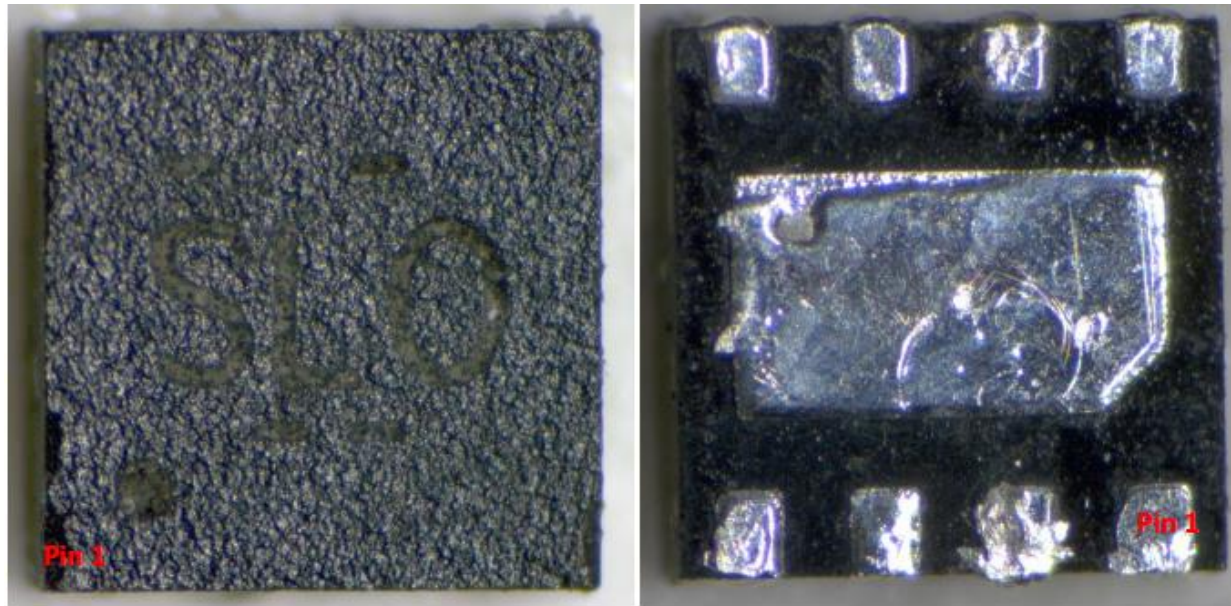
**Figure 1:** Optical pictures of the return unit.

Returned units#1 was inspected with optical microscope. No anomaly was observed at external package.

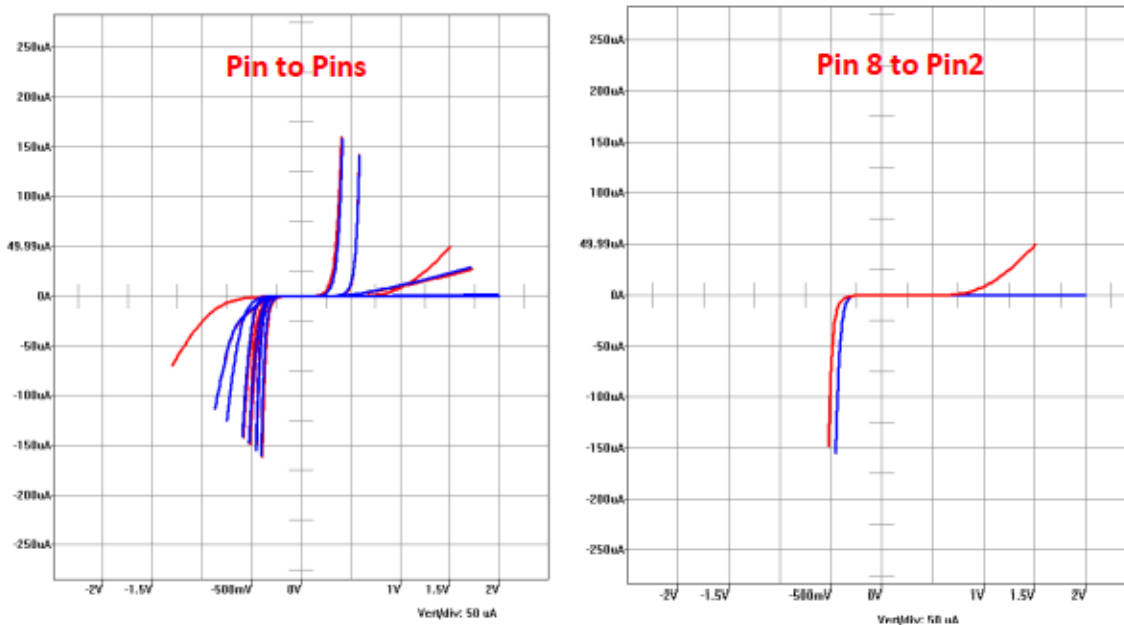
**Figure 4:** I/V curves of the return unit.

Curve trace analysis performed on the return unit showed that pin 8 (VIN) to pin 2 (GND) had early turn on issue. See in Figure4.

(Blue line represents the good unit; Red line represents the CRU)

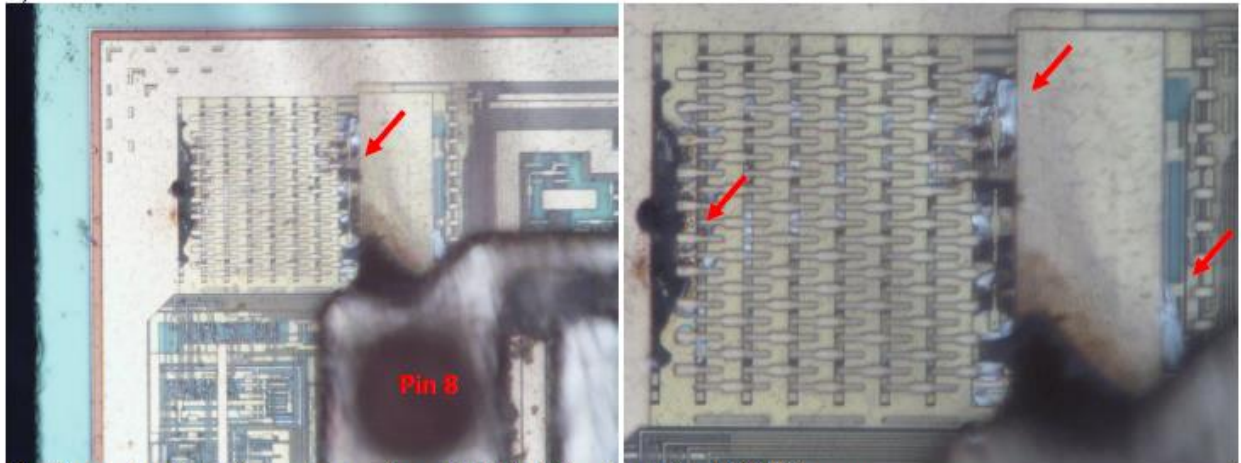
**Figure 5:** Optical pictures of the return unit after de-capsulation

Damage in the form of flashed metal was observed near pin 8 (VIN). See in Figure 5.

b) Zoom in of the damage area found EIPD at the short pins BOAC traces

PFA found EIPD as flashed metal near VIN pin.
