Failure Analysis Report

OPA333AMDBVREP Amplifier Output Instability During Temperature Variation

Document Number: AER007FR020
Project Title: AS6042

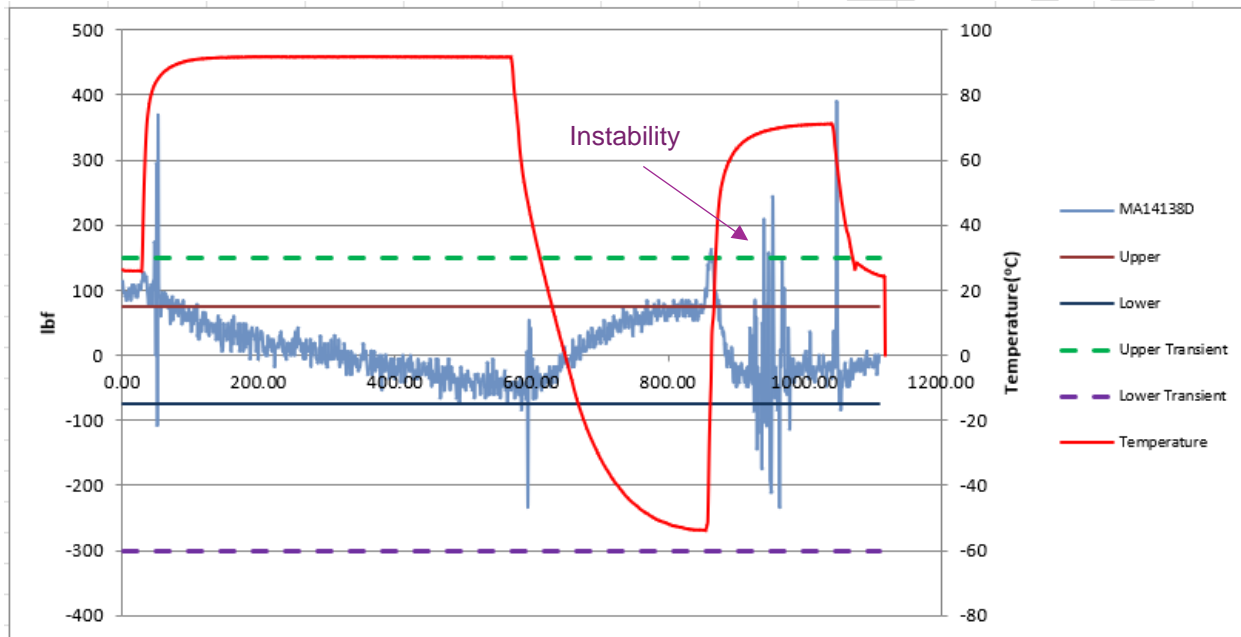
During the temperature cycling of the sensor with PCB assembly, some units started to show instability at certain temperature points which were random. Refer Figure 1. This is occurring at a 3% rate and needing a resolution for a smooth production process.

Figure 1: Output becomes unstable during temperature cycling

Containment Action: Screening the defective devices with in-process temperature cycling

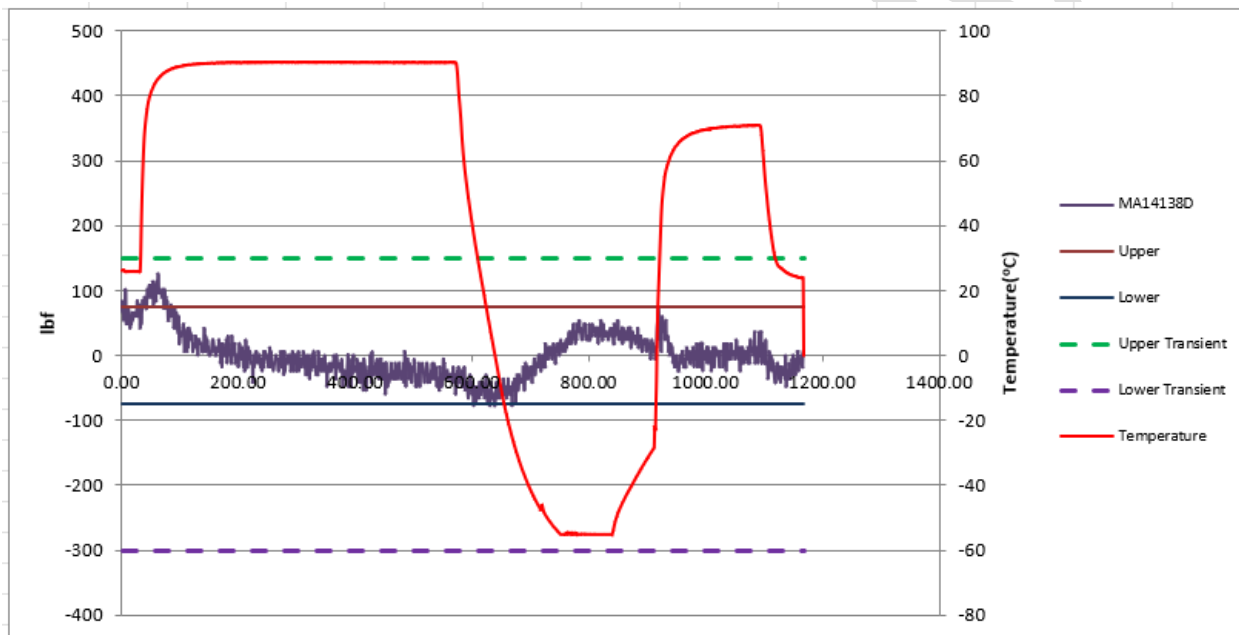
Next PCB level investigation was initiated. There it was observed either U2 and/or U8 replacement could cure the issue. Refer Figure 2

Figure 2: Instability disappeared after U2/U8 replacement

A lot of OPA333AMDBVREP is being used so far in the production PCBs and some devices from the lot showed the unstable behaviour during temperature cycling. The issue could be cleared by replacing the devices from an in-house batch. Corresponding lot/batch details are mentioned in the [Appendix](#).

Therefore, this failure mode is considered to have a higher probability of occurrence.

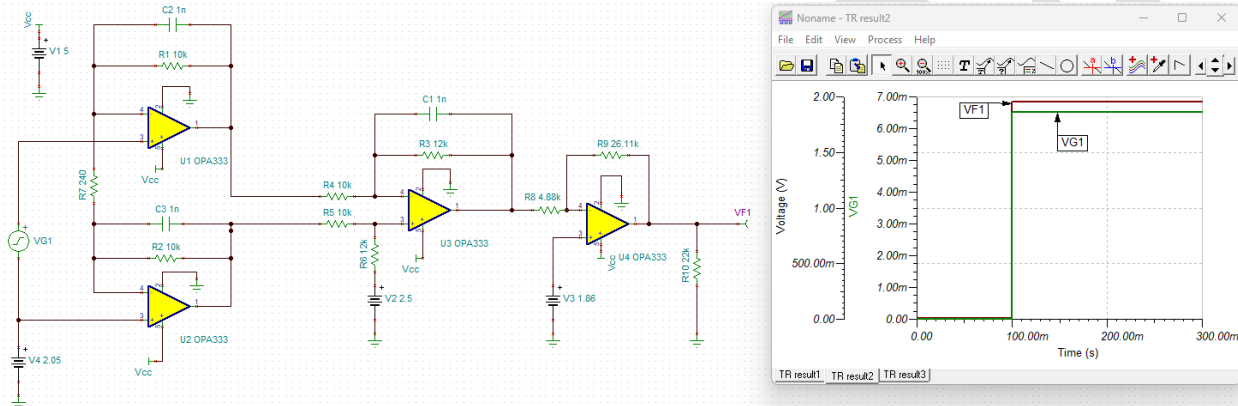
During the design phase the stability was checked at nominal conditions with spice simulation. Refer Figure 3

Figure 3: Spice Simulation

This was further verified in the TI E2E Amplifiers forum under the ticket "[OPA333A-EP: Stability check of OPA333](#)"

Therefore, this failure mode is considered to have a lower probability of occurrence.
