# Problem Description

- Fresh units decap observed cratering (ILD crack) issue on all bonding pads.
- Visual inspection, X-ray, CSAM don't observe any anomaly on units
- IV test pass, no anomaly was observed.
- Fully decap on unit#1 found bonding layer crack at all pads.
- FIB cross section on unit#2 didn't observe damage at inner bonding layers.

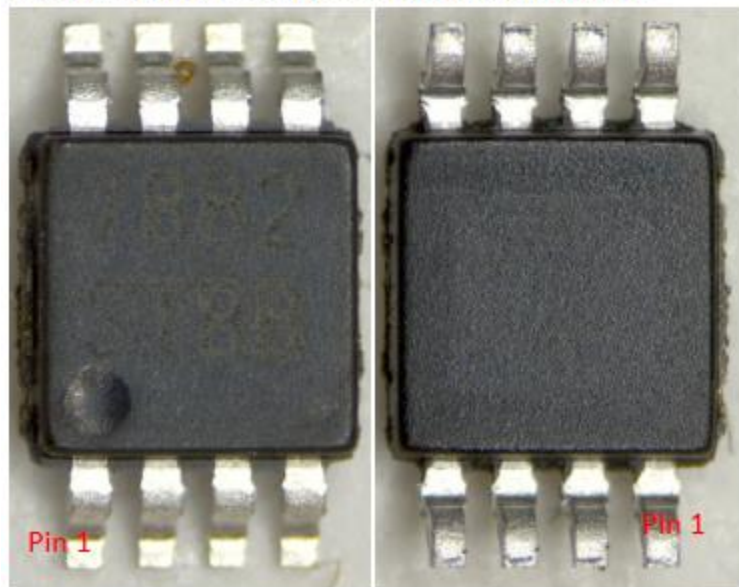
External package inspection found no anomaly on return units,

a. Top and bottom view of unit #1,

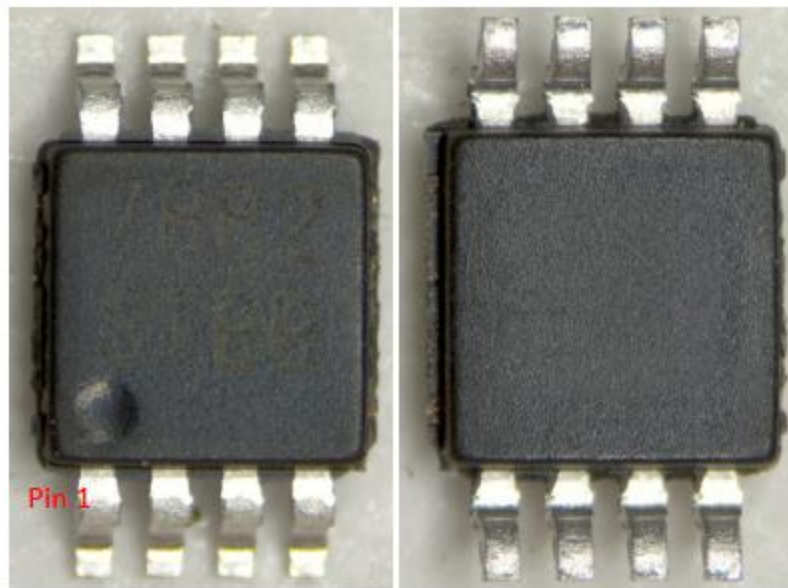
b. Top and bottom view of unit #2,

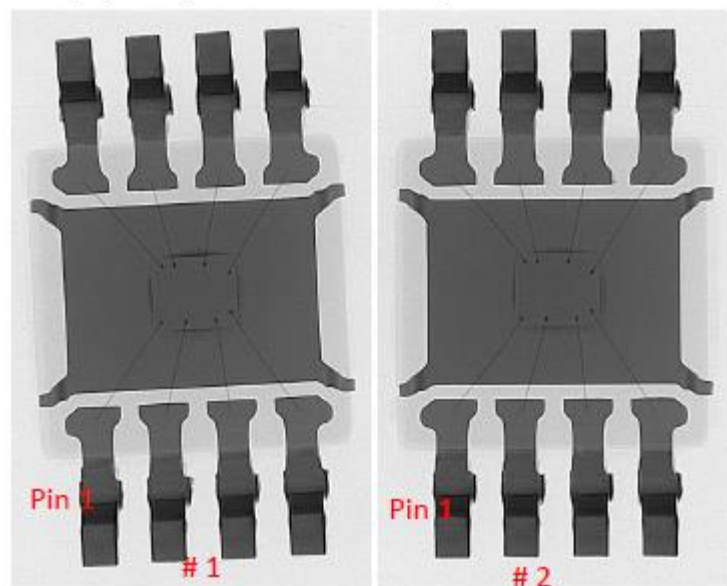
Radiographic inspection found no anomaly on return units.

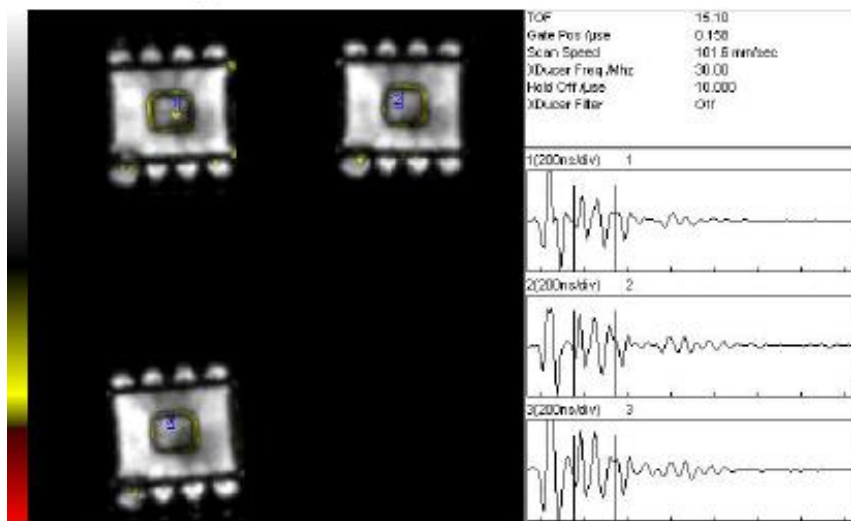
Acoustic microscopy found no delamination on return units die surface.

Fig. 3: No anomaly was observed on return units die surface.

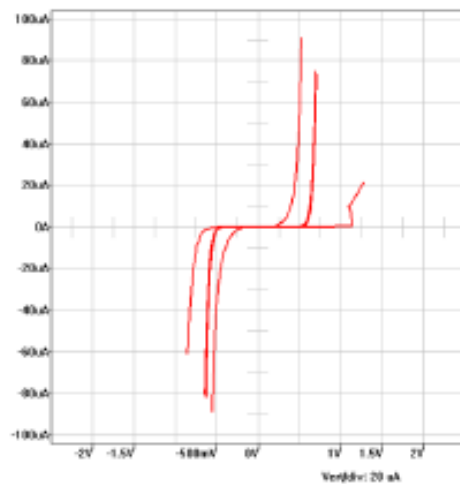
a. Pins to pins I/V of unit #1,

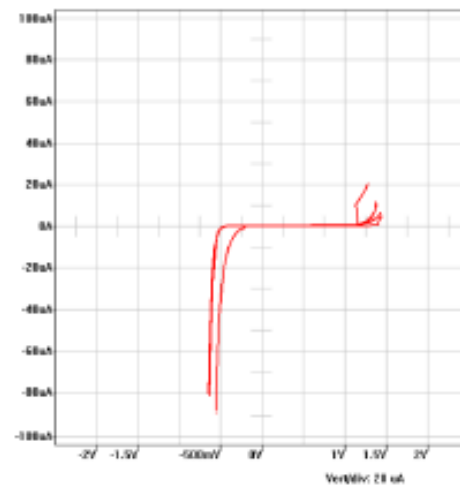
b. Pins to GND I/V of unit #1.

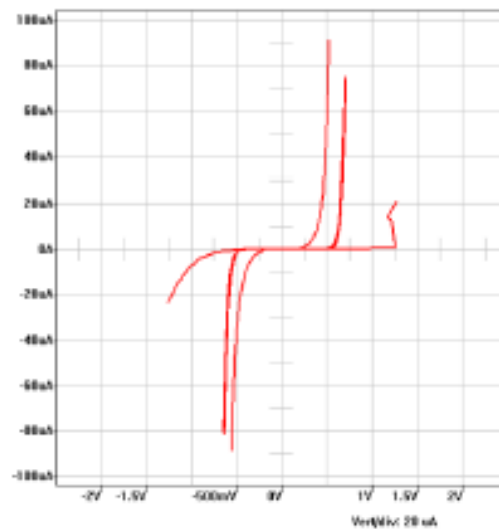
c. Pins to pins I/V of unit #2,

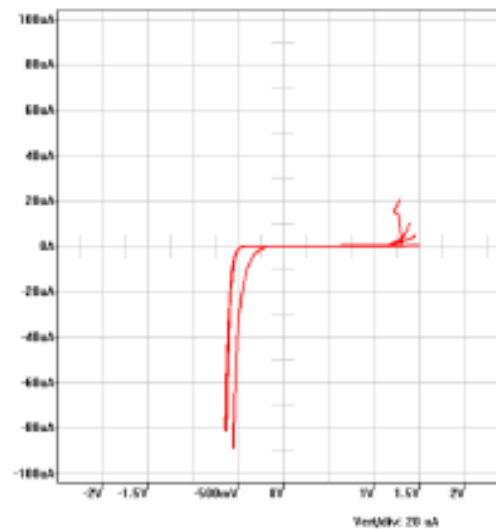
d. Pins to GND I/V of unit #2.

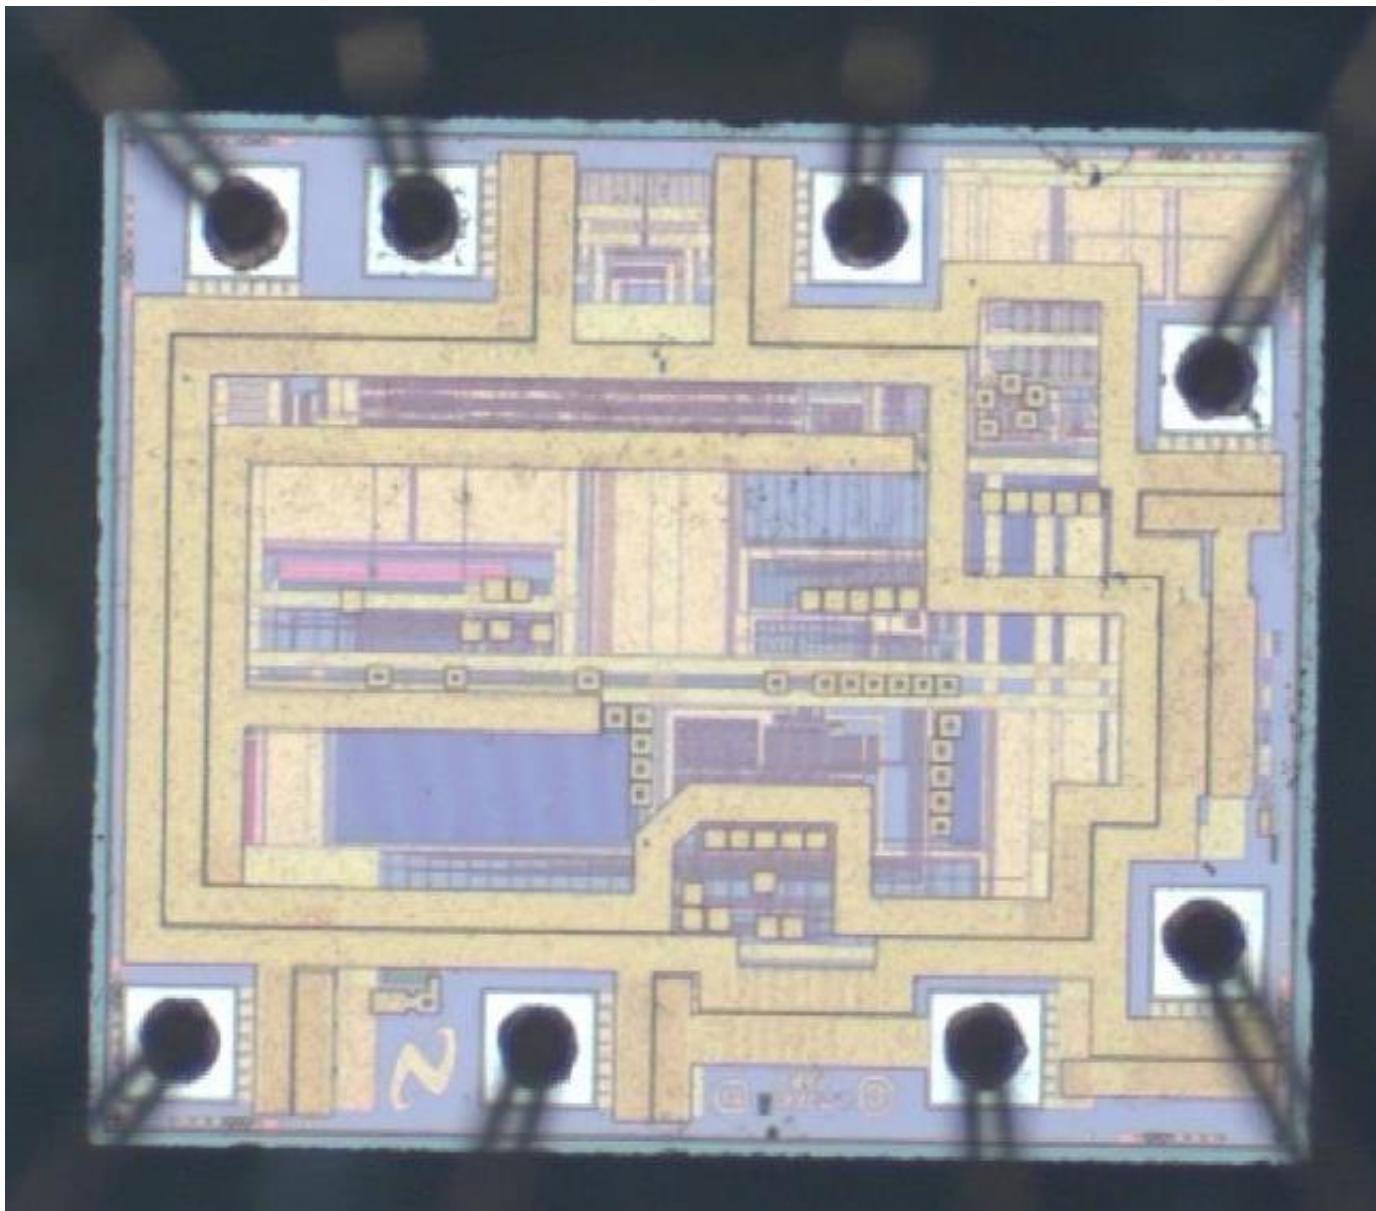
Return unit#1 was decapped and visual inspection didn't observe anomaly

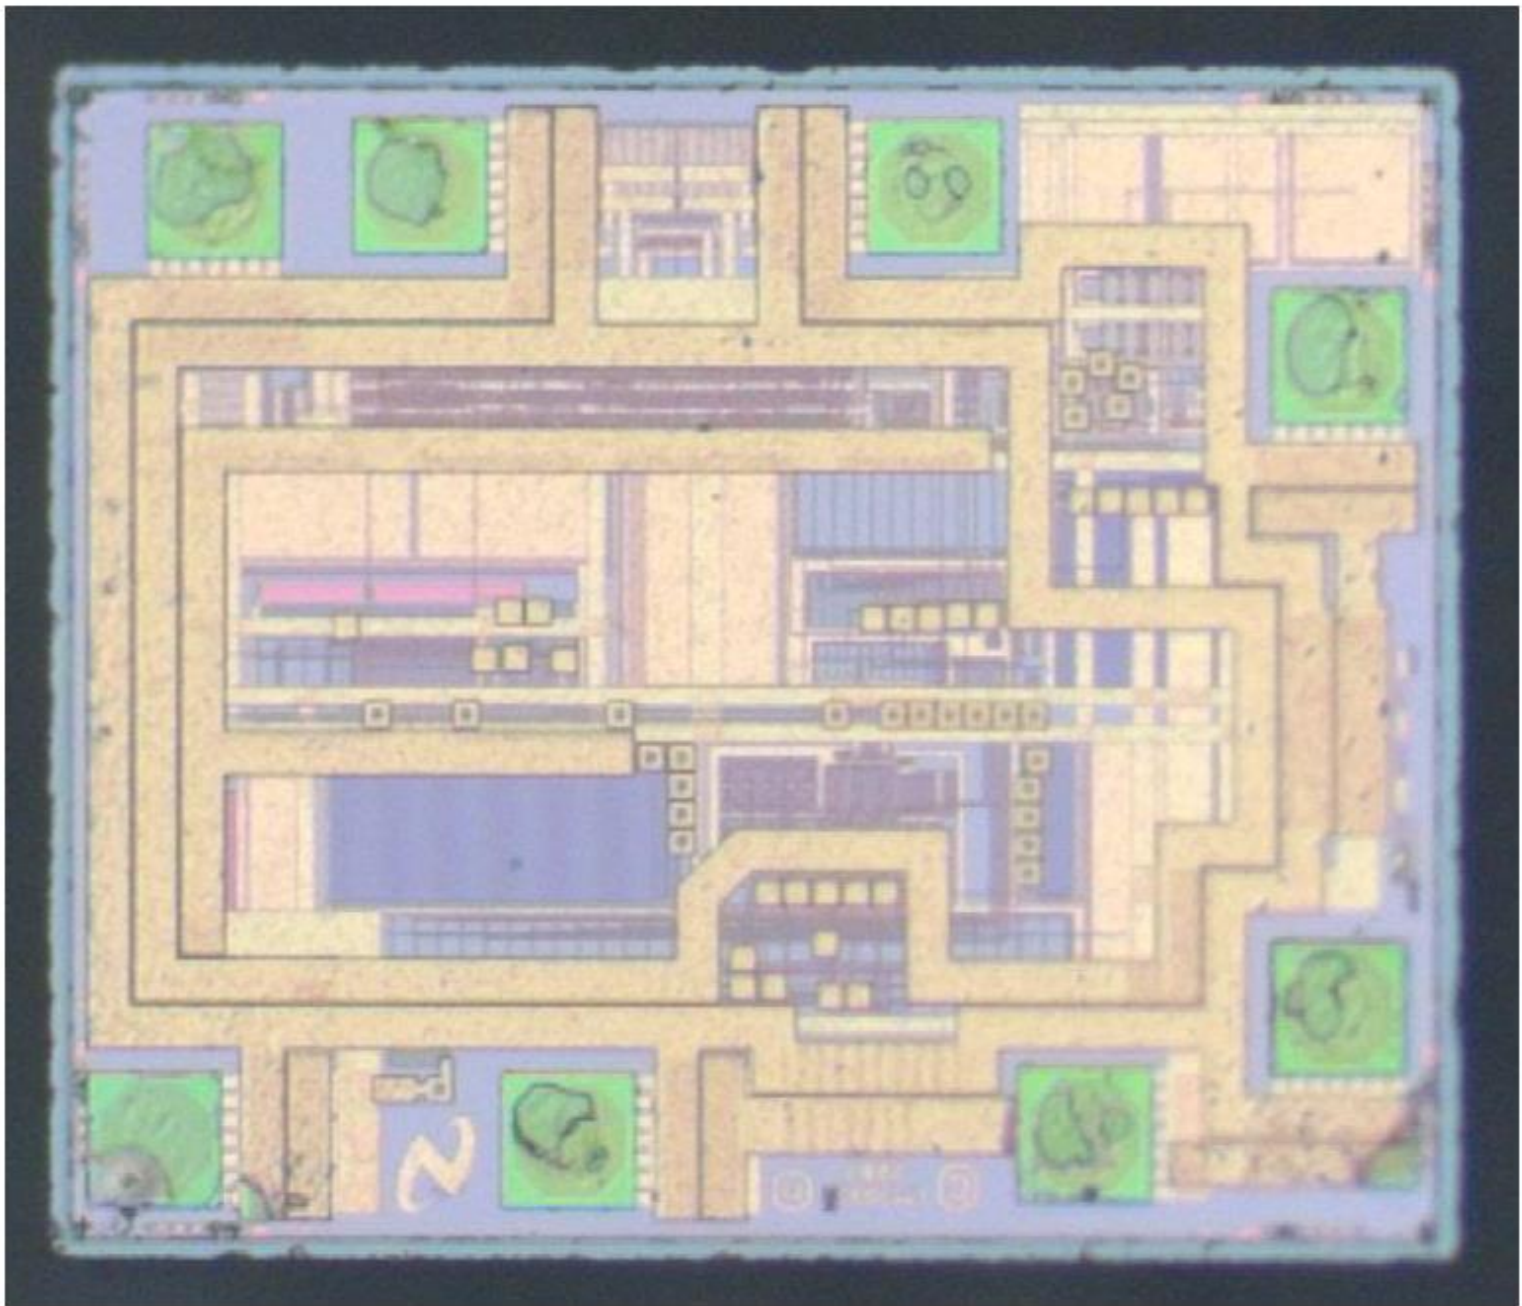
Bonding wire of unit#1 was removed and observed bonding layer crack at all pads.

4. The crack between the ball and aluminum pad are common to this technology as TIEM controls the bond process tightly to minimize damage to the pad structure without causing non-stick on pad (NSOP) fails during bonding.

- TI Reliability tests all passed.
- TI have shipped 6M+ units, so far no verified electrical/function failure related to bond pad crack.
- **In conclusion, the minor crack at bond pad top metal is acceptable, no impact to device electrical performance and reliability risk.**

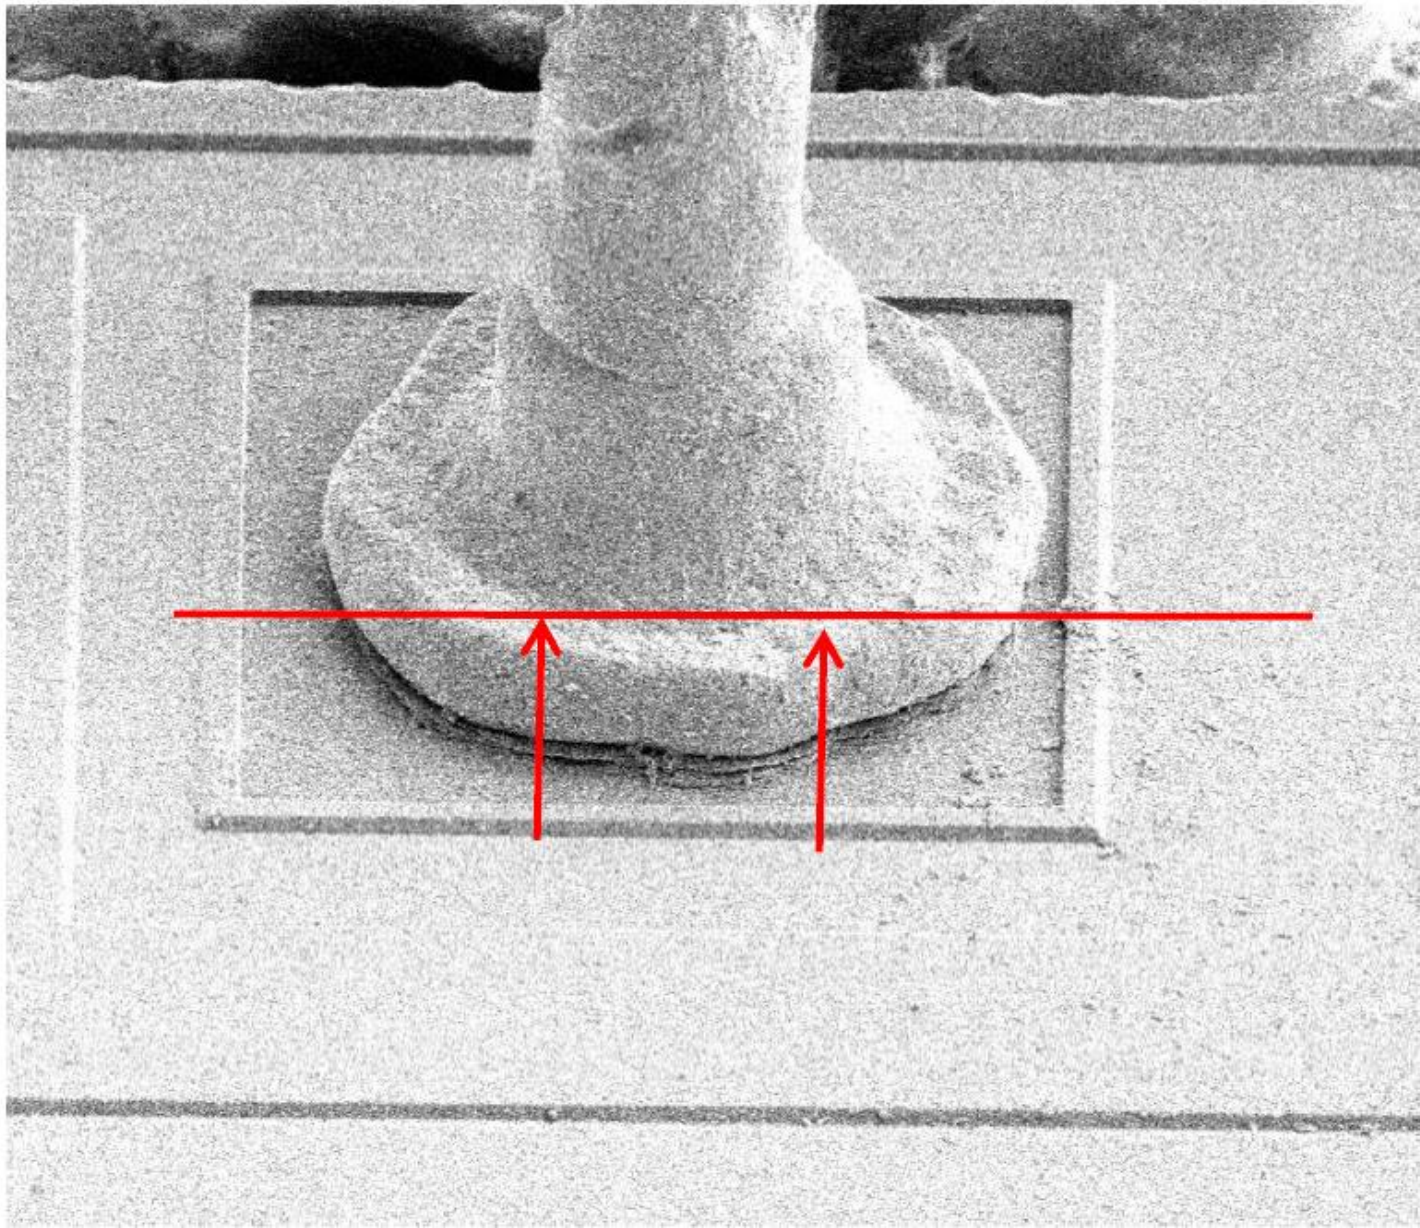
Return unit #2 was submitted to do FIB cross-section,  
no anomaly was observed under the bond pad.

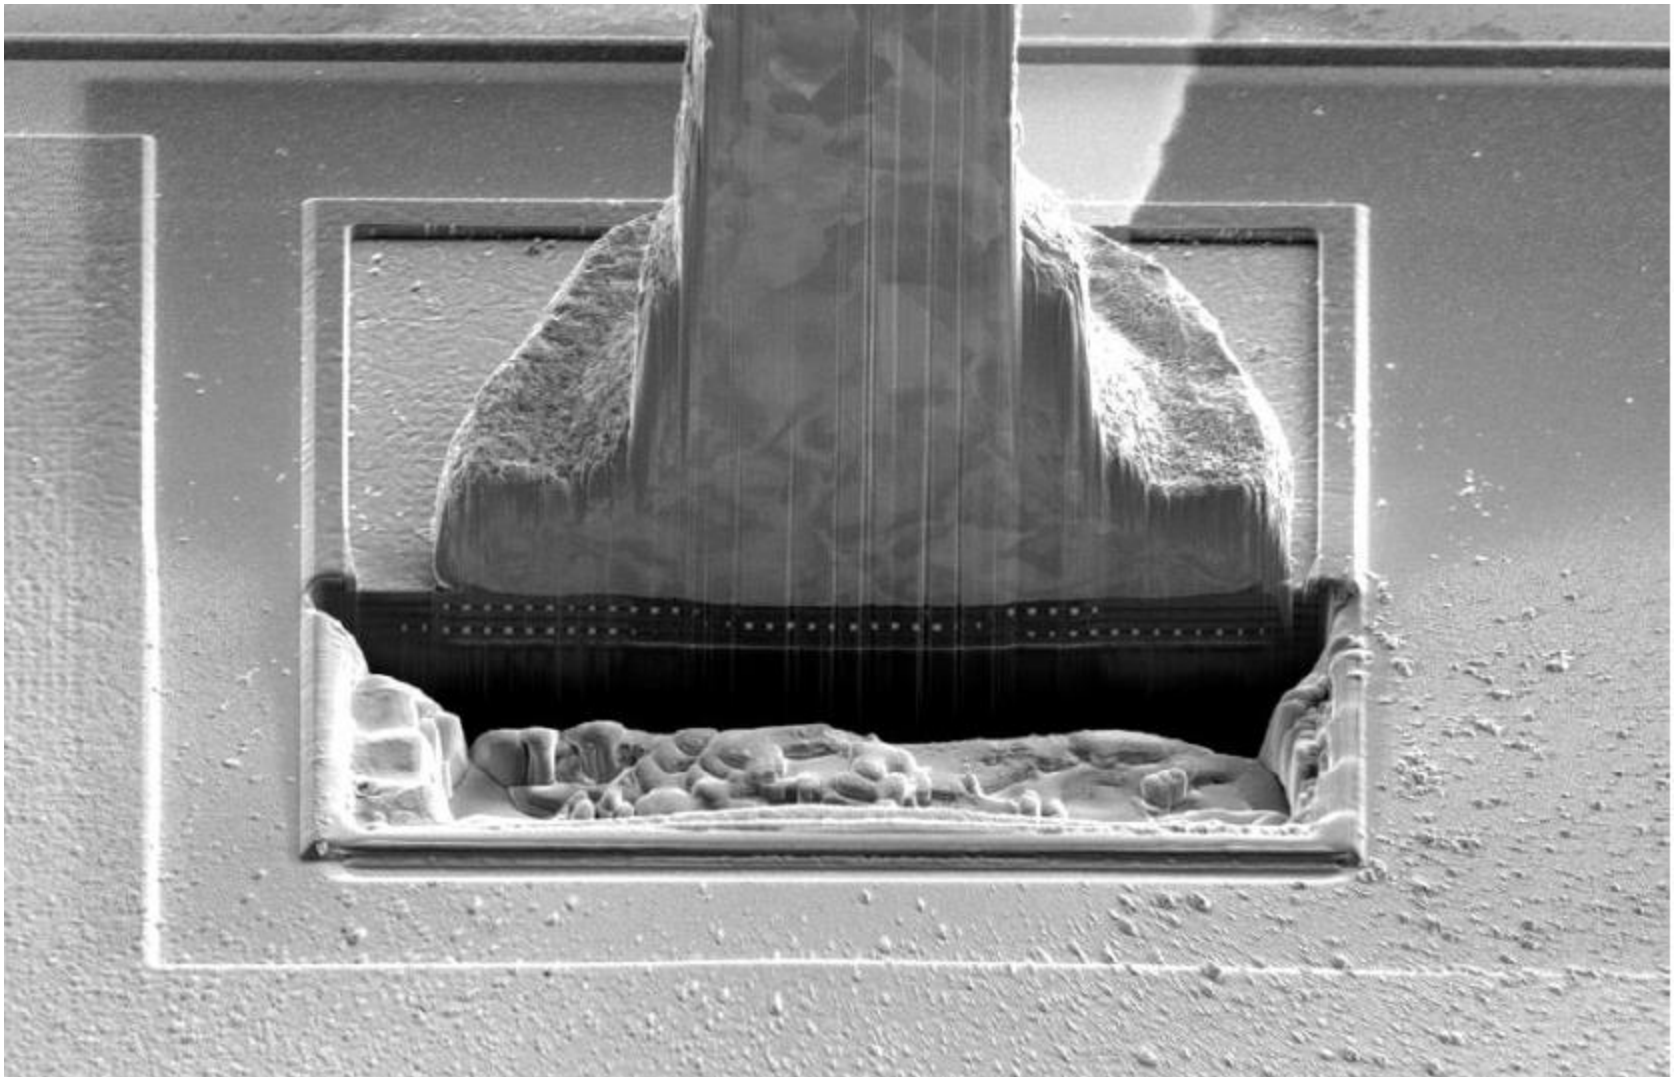
Unit#2: Overview of the cross-section

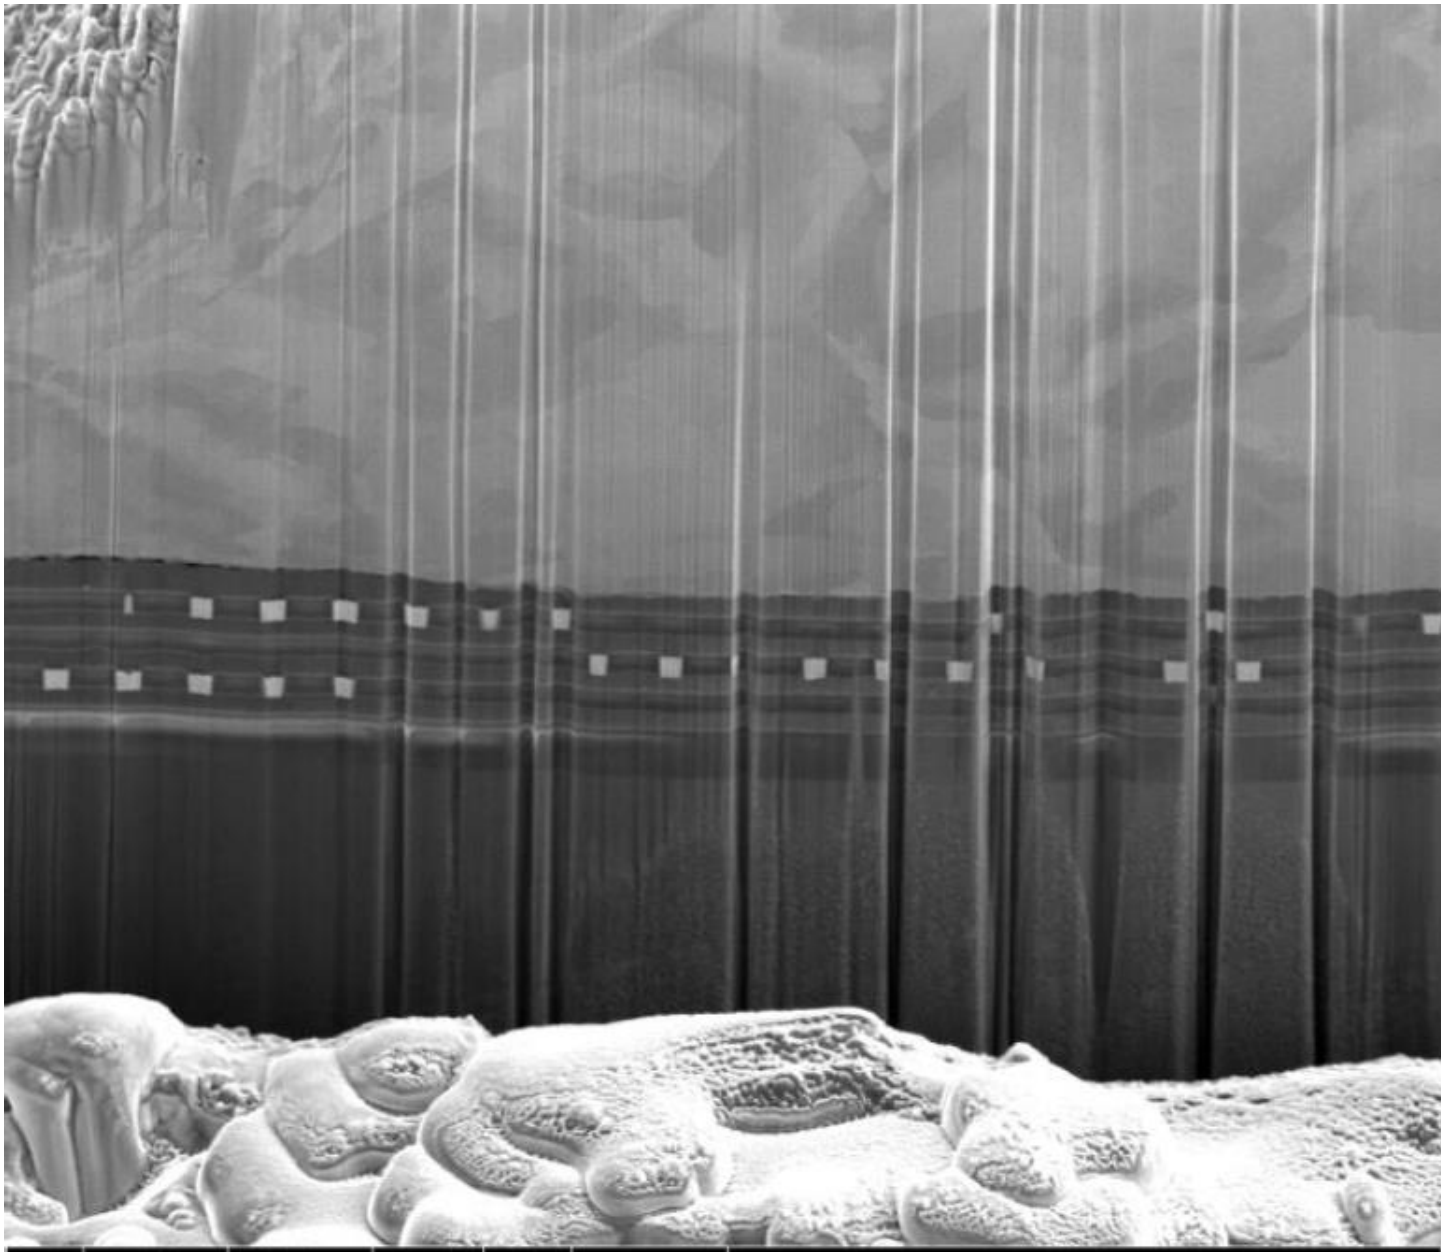
Zoom in the cross-section of unit #2. Inner bonding layers are not damaged.

2. this is a 4 level metal product and the bond pad (Metal 4) is connected to Metal 3 by vias beneath the pad. Similarly, Metal 2 and Metal 1 are connected by vias. The zoom in cross section in slide 8, the four layers of metal and three separate via layers are visible. The above drawing does not show the Via1 structures between Metal 1 and Metal 2 but they are there on the product. **The vias are a very low resistance ohmic contact between the metal layers.** So minor crack above metal 4 won't impact electrical performance.

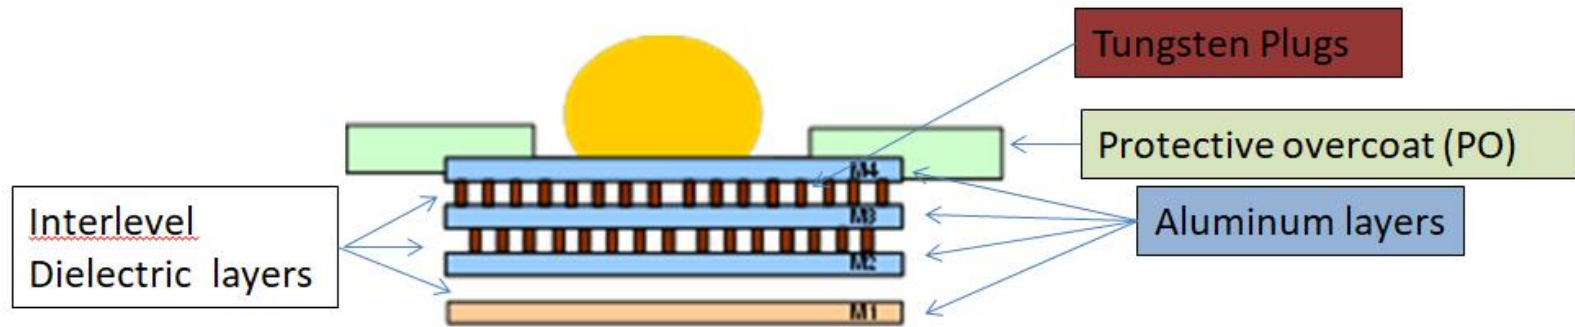
1. TI examined this bond pad structure many years ago and noted that it was susceptible to cracks in the top metal layer and the dielectric beneath the ball bond but it did not fail electrically because the metal layers beneath the bond pads are not “active”. The diagram above illustrates the bond pad layout.

3. And, the pad is electrically immune to this defect, because **signal and power leads are not allowed to run under the pad. In addition, the silicon under the pad does not have any components.**
