# LP8556TMX-E02/NOPB – FA Update

# Executive Summary:

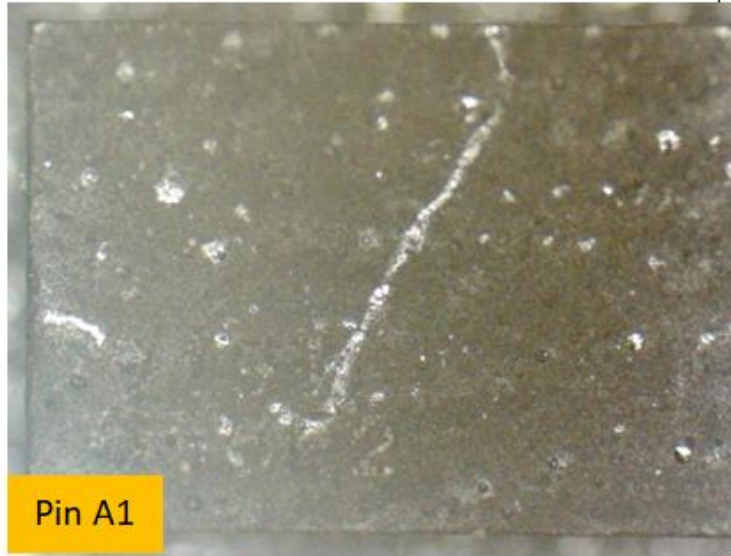
1. Visual inspection: No anomaly observed

a. Top view of returned unit

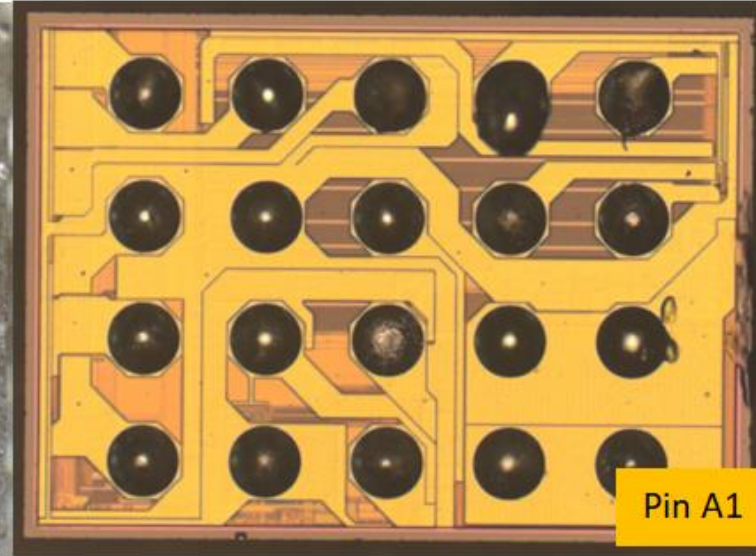
b. Bottom view of returned unit

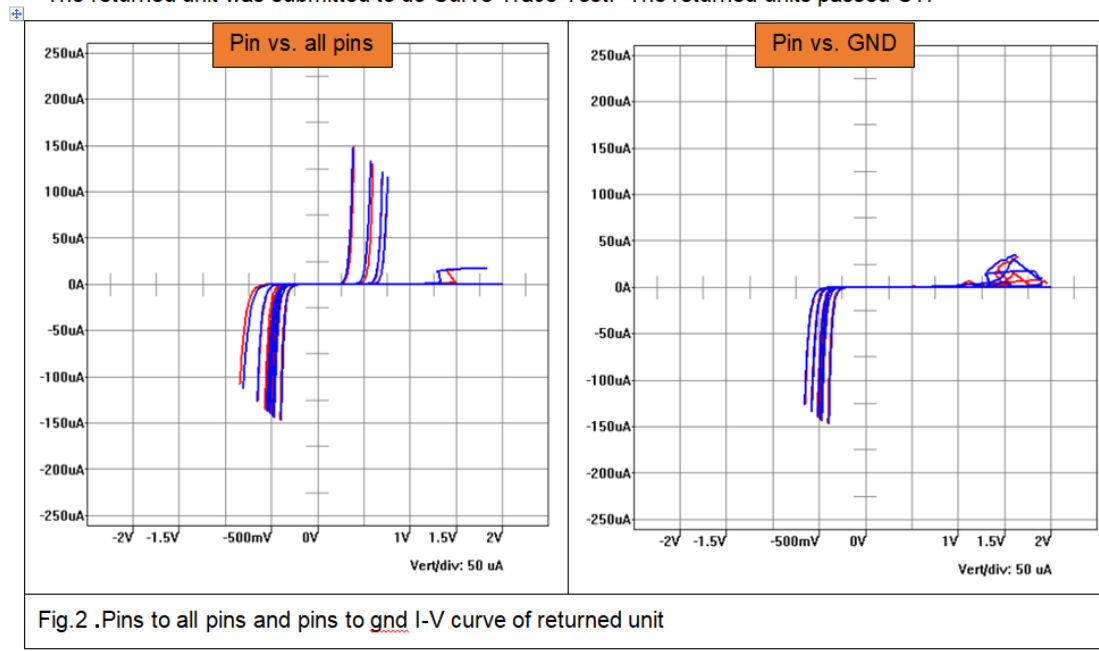
The returned unit was submitted to do Curve Trace Test. The returned units passed CT.
