OPA365 test waveforms

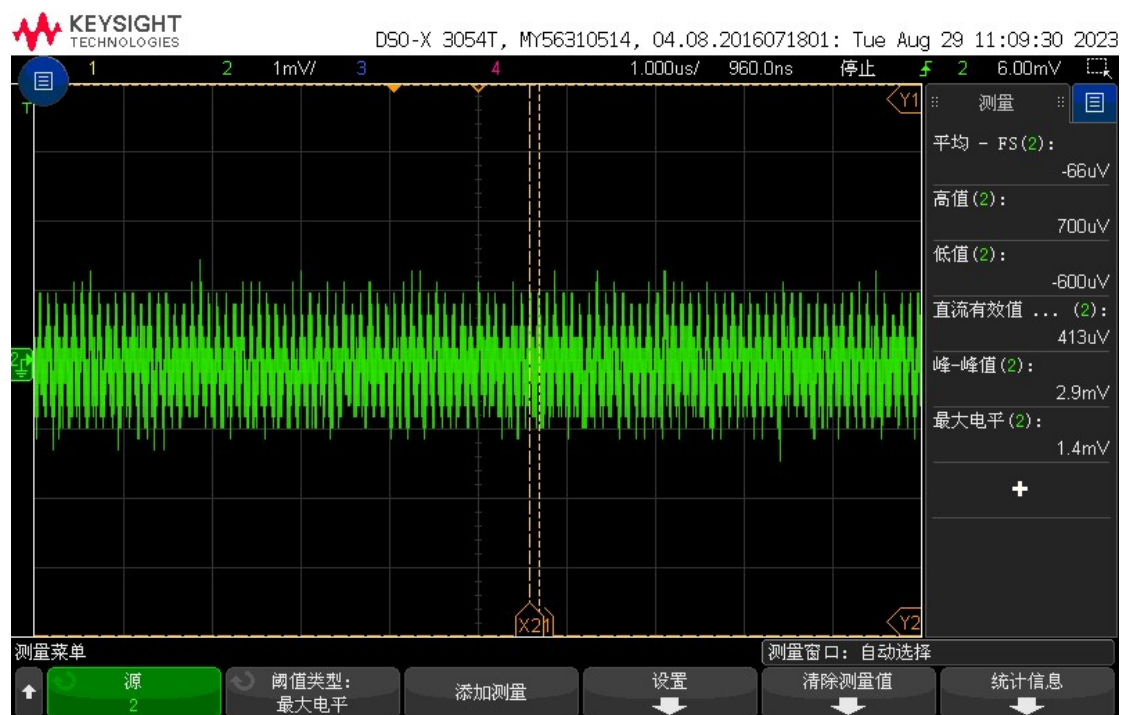
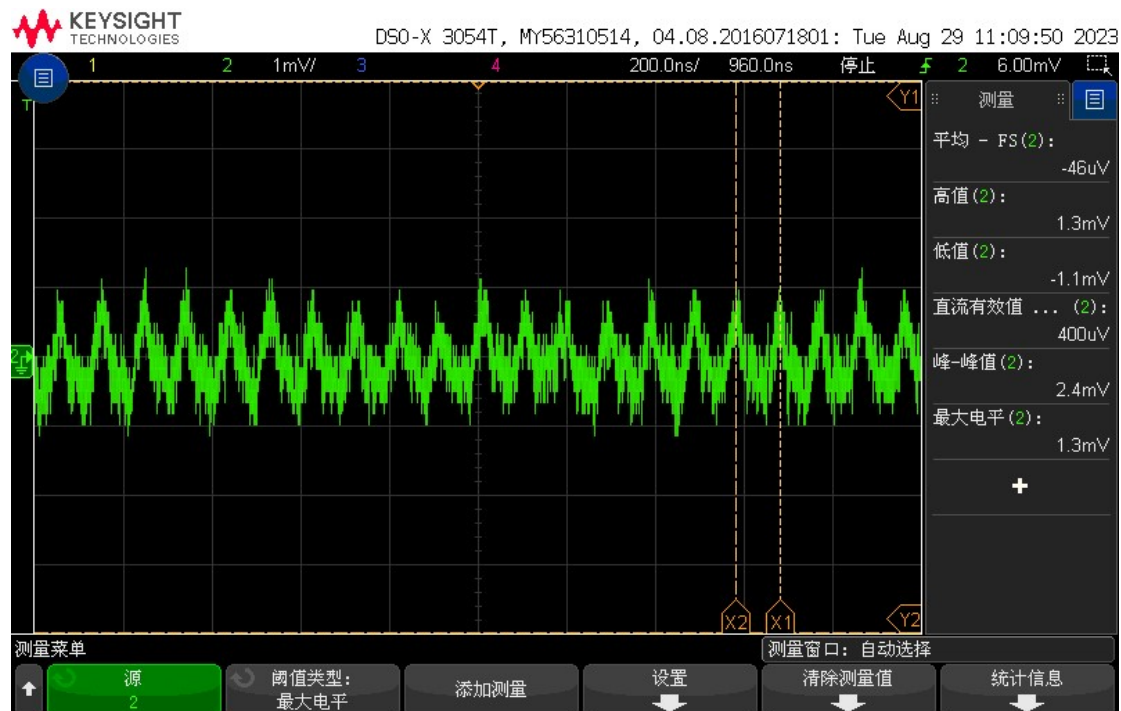
- Output waveform referenced to GND at output GND pad

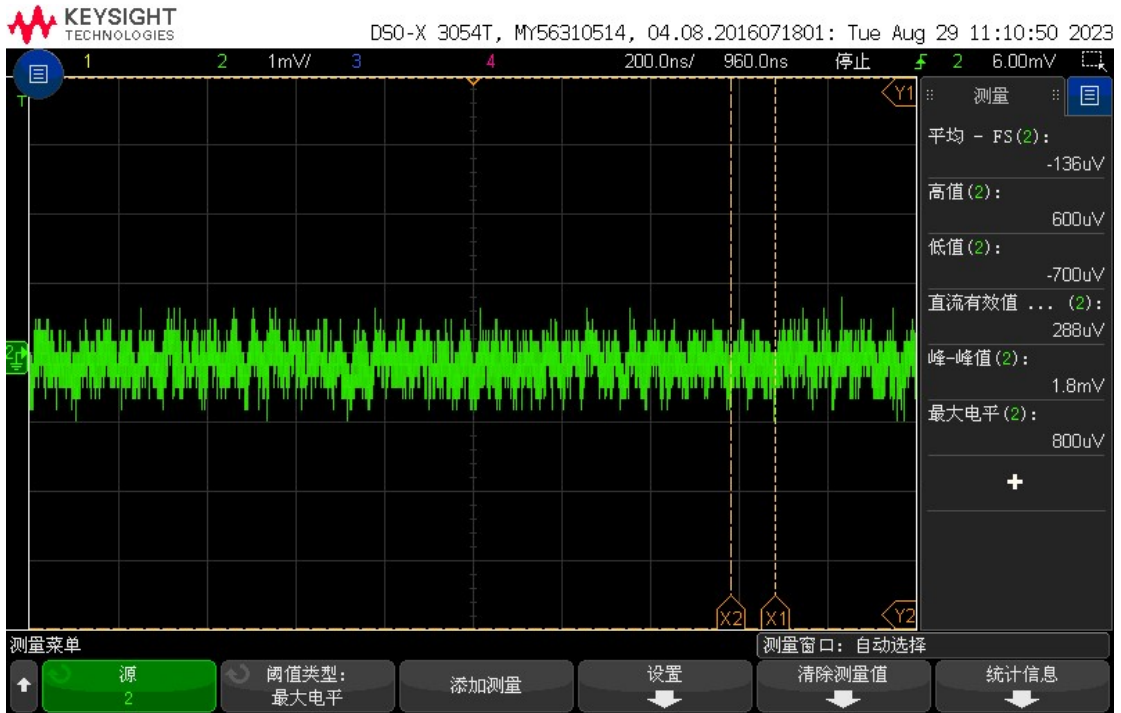
- C12 GND terminal waveform (reference to the same GND pad as output waveform)

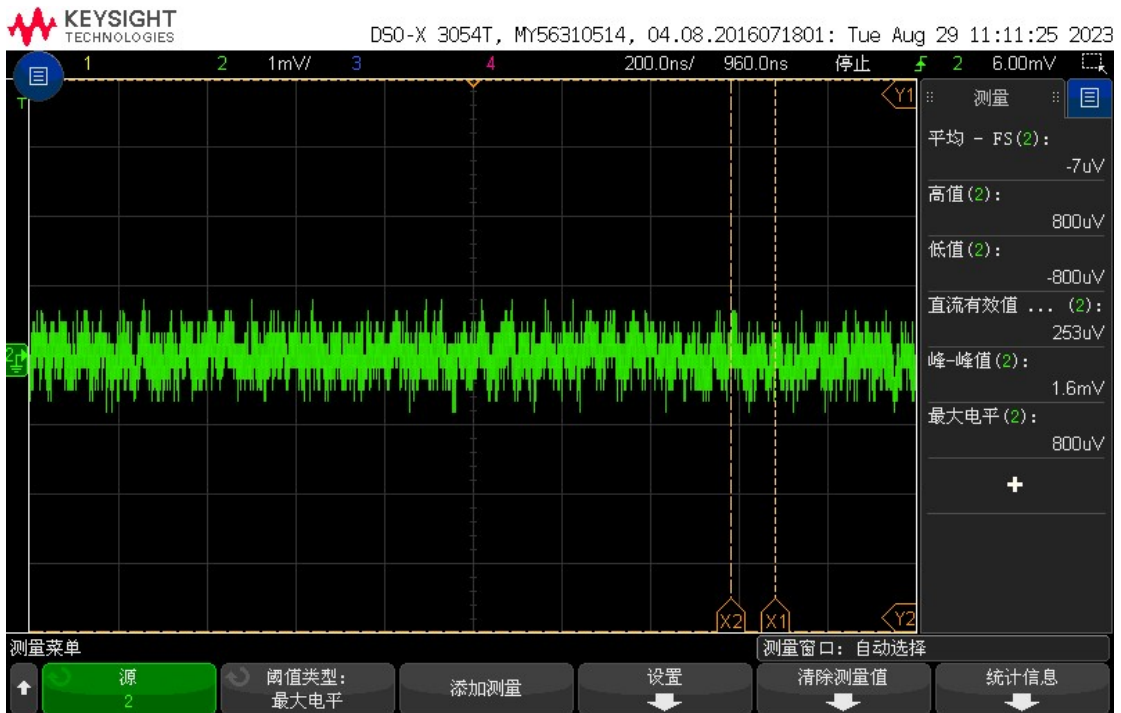
- C12 3V terminal waveform (reference to the same GND pad as output waveform)

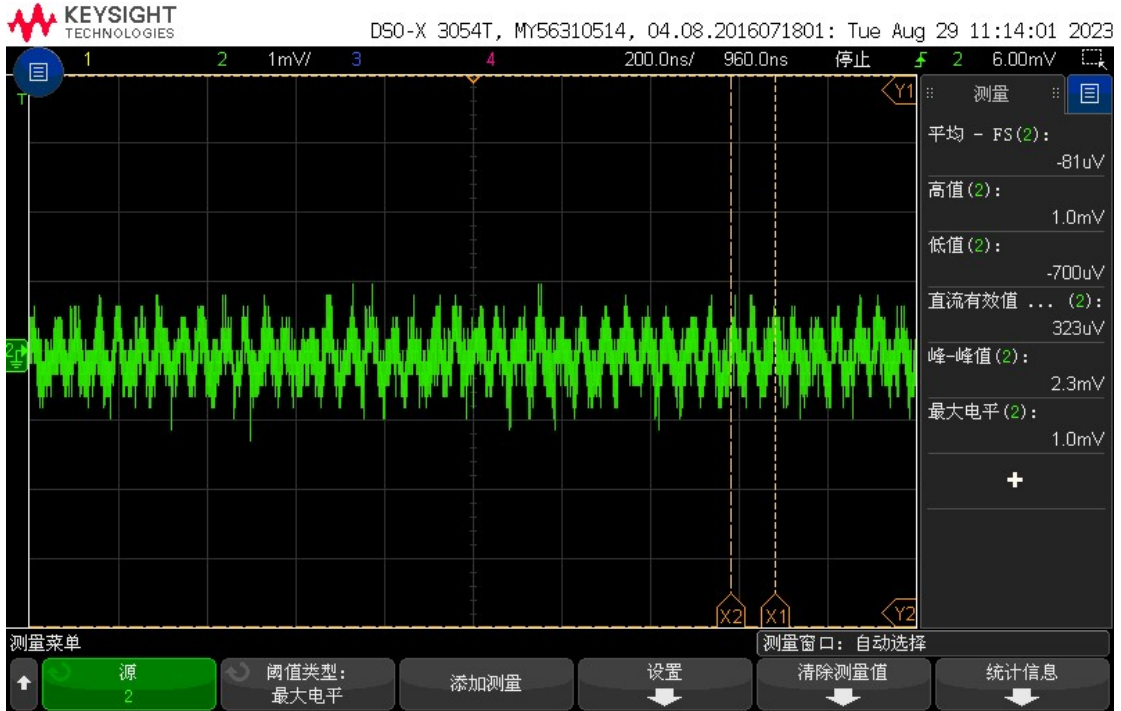
- Opamp VCC terminal waveform (reference to the same GND pad as output waveform)

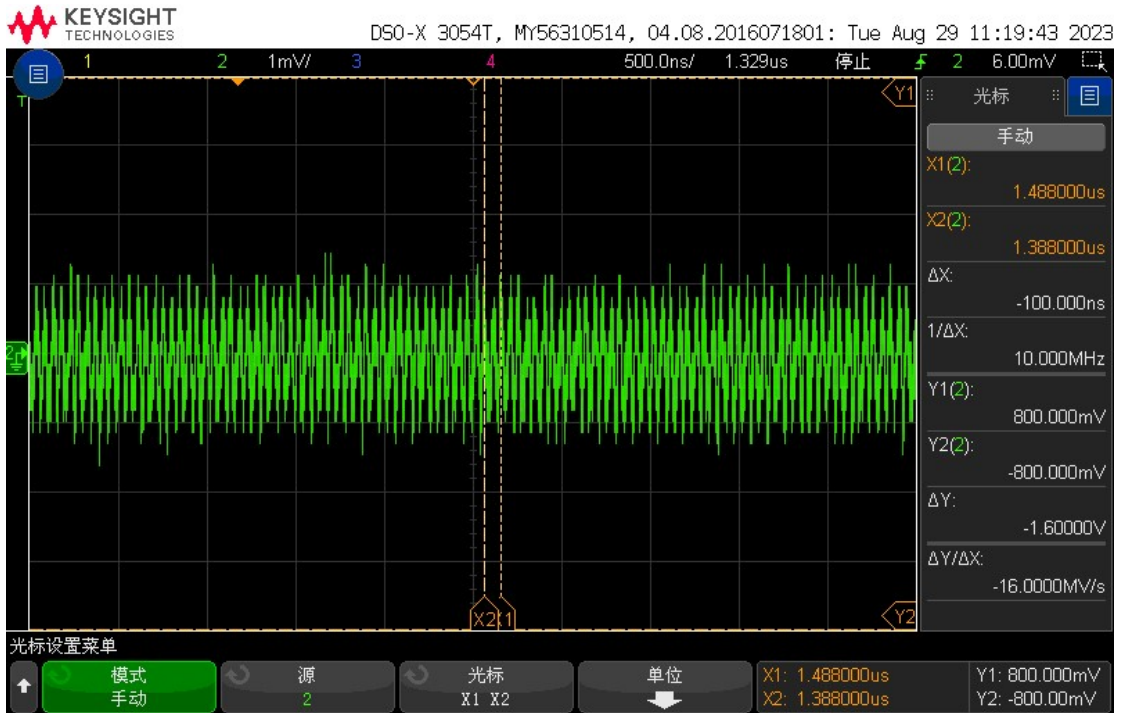
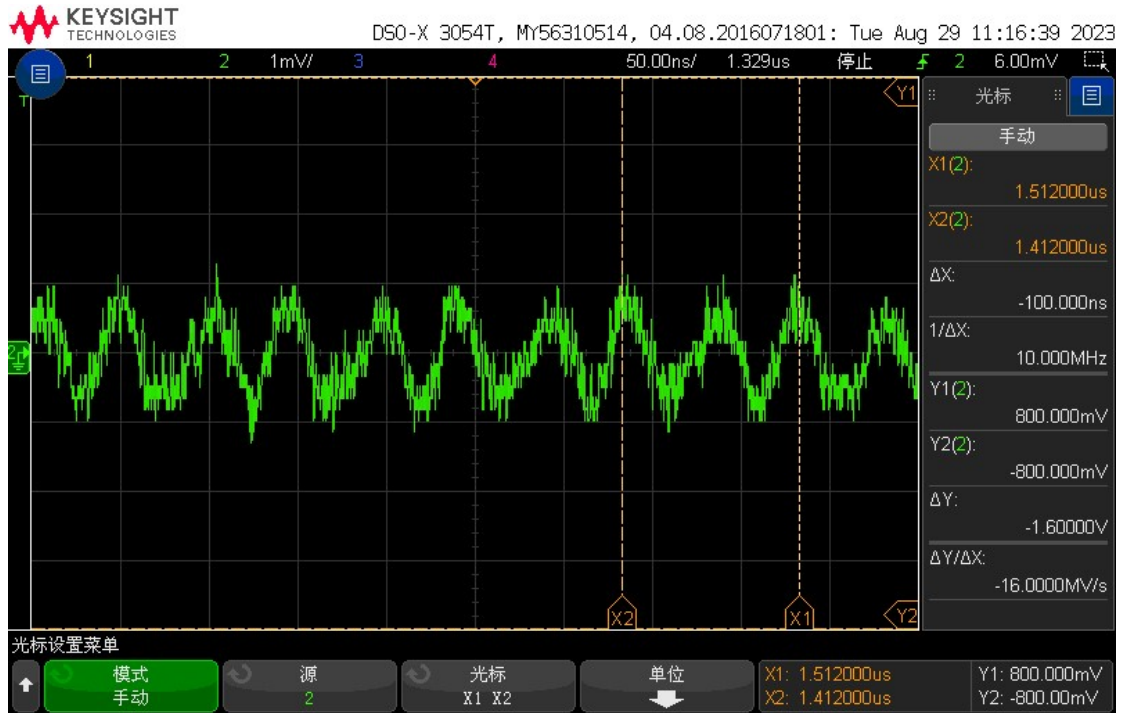
- Voltage across 1nF chip MLCC on top of Opamp

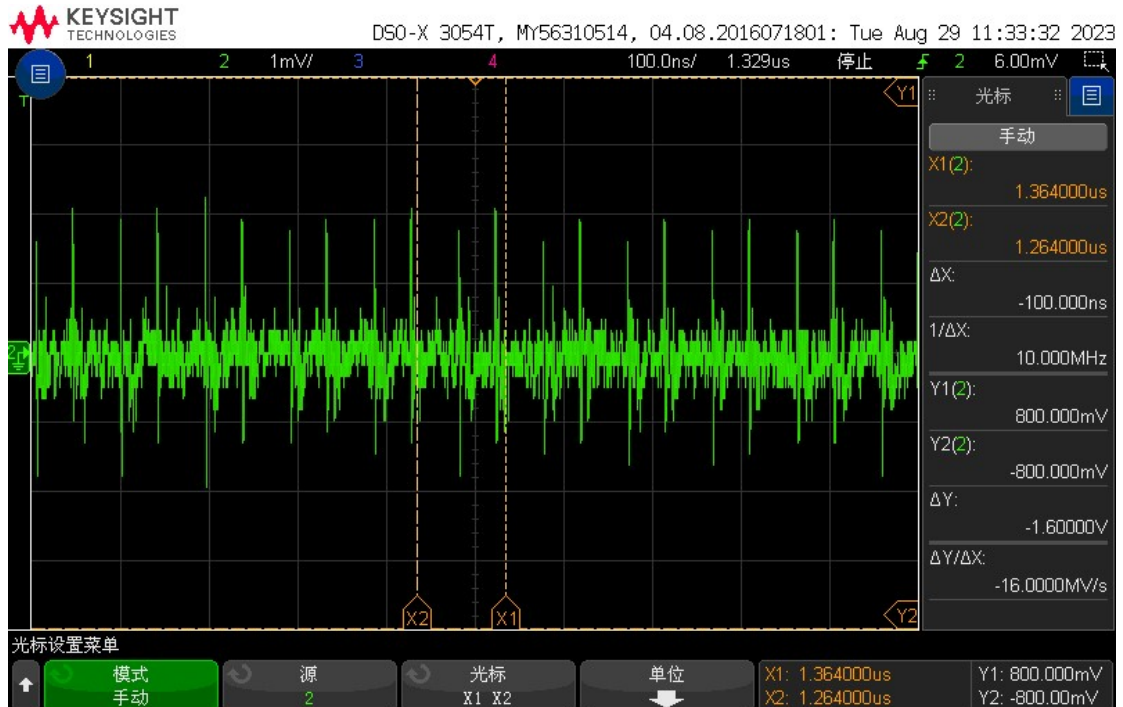
After removing this 1nF chip MLCC on top of Opamp.

- Opamp VCC terminal waveform (reference to the same GND pad as output waveform)

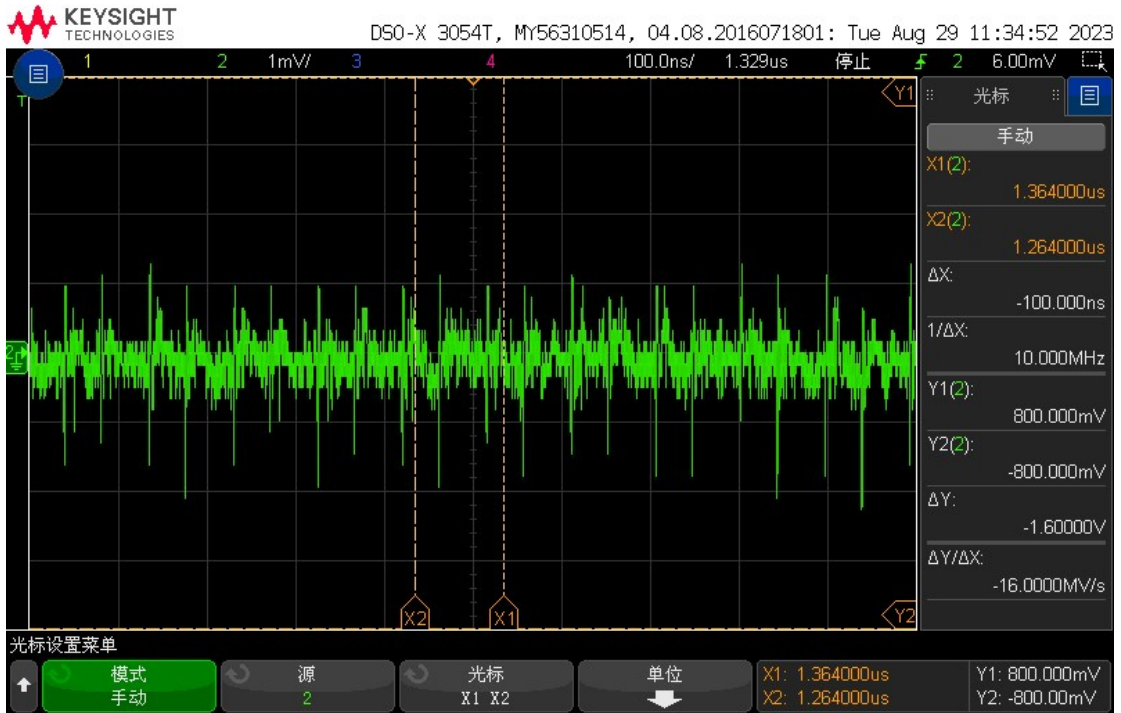
- Opamp VEE terminal waveform (reference to the same GND pas as output waveform)

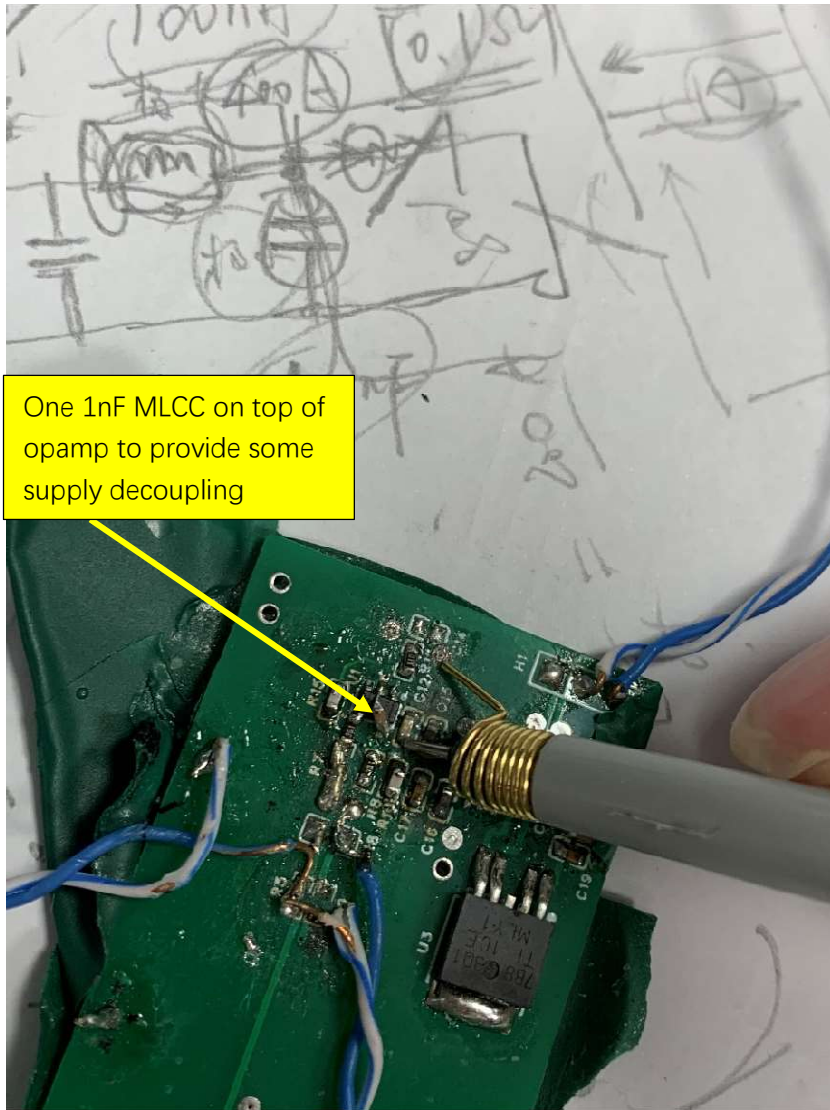
Note: The 1nF chip MLCC on top of Opamp was added when I first saw the spike like noise on the supply pin. I knew the power decoupling is not well laid out. After the 1nF capacitor is added, the spike like noise is gone from the voltage at VCC pin. But I had not measured the voltage across the 1nF capacitor. I just noticed this time that the voltage across 1nF capacitor is still not good enough. See below figure for information of this extra decoupling capacitor.

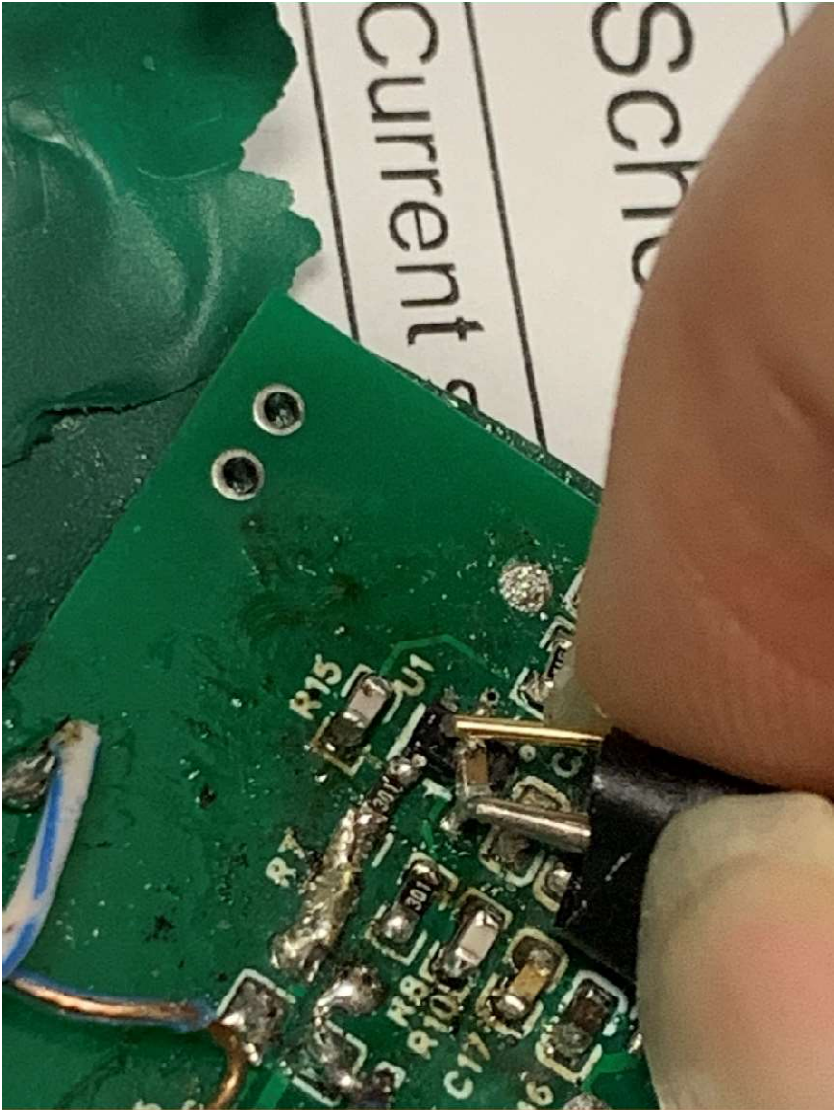
Below picture shows how I measured the voltage across this extra decoupling capacitor.
