# Optical inspection for #1

# X-ray inspection for units (#1-#2)

# Decapsulation

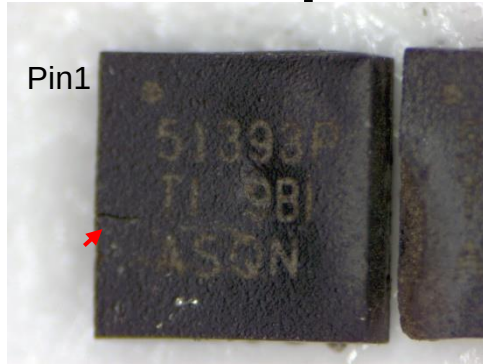
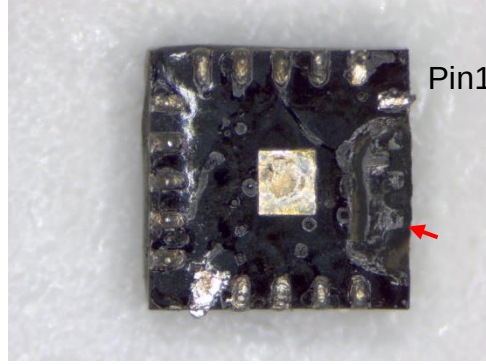
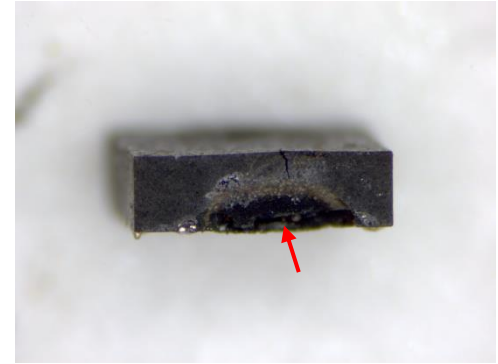
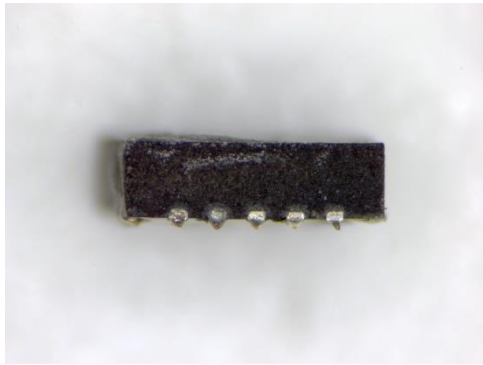
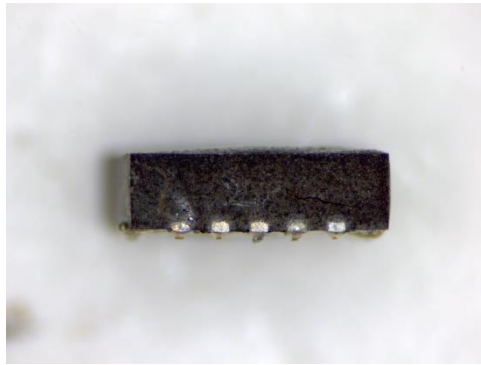
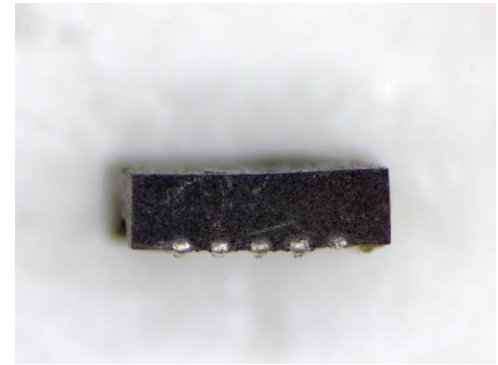
Unit#1: burnt mark was observed at pin1-pin5 area

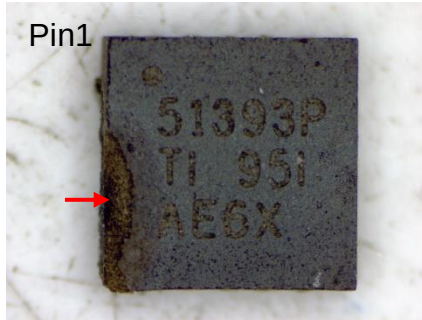
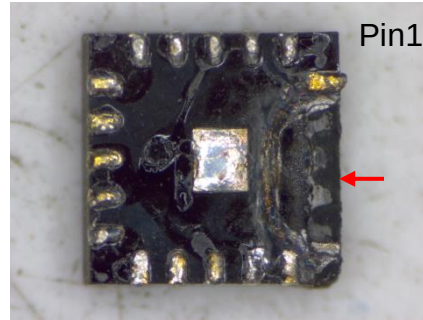
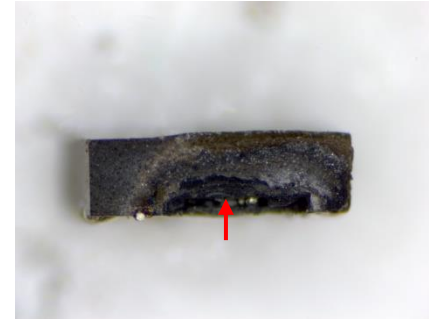
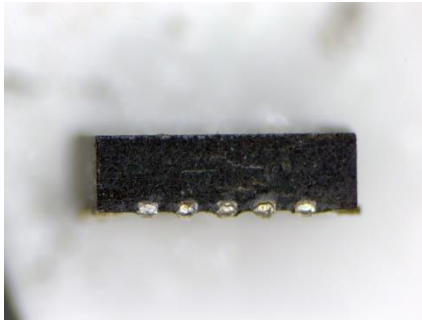
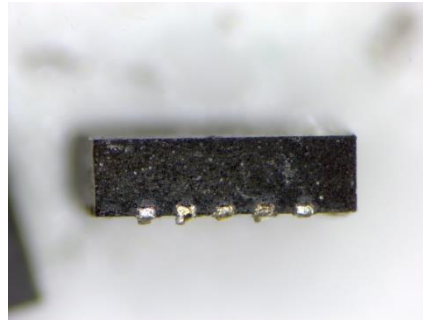
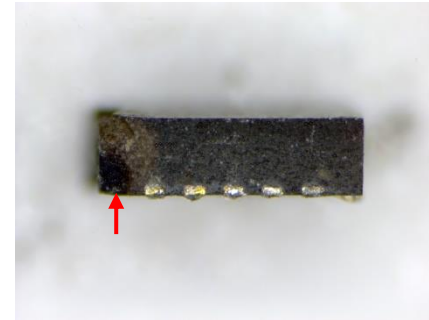
Unit#2: burnt mark was observed at pin1-pin5 area

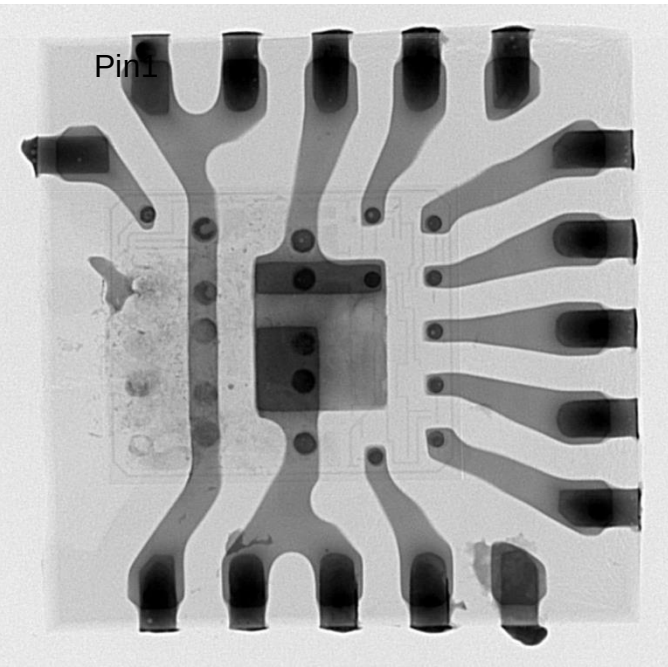
Unit#1

Fused solder joints was observed at pin1-pin6, pin19-pin20 area on both units

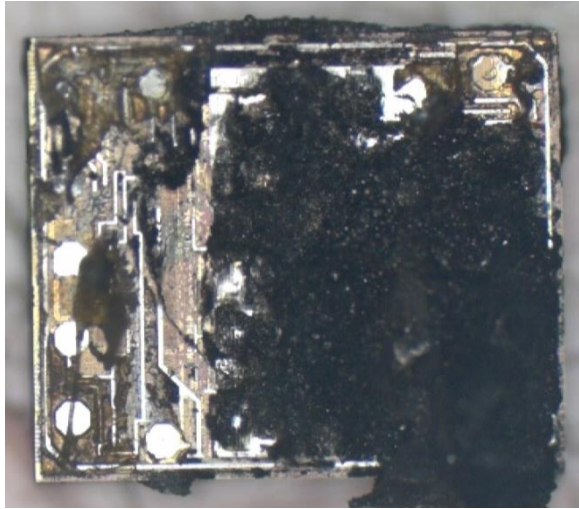
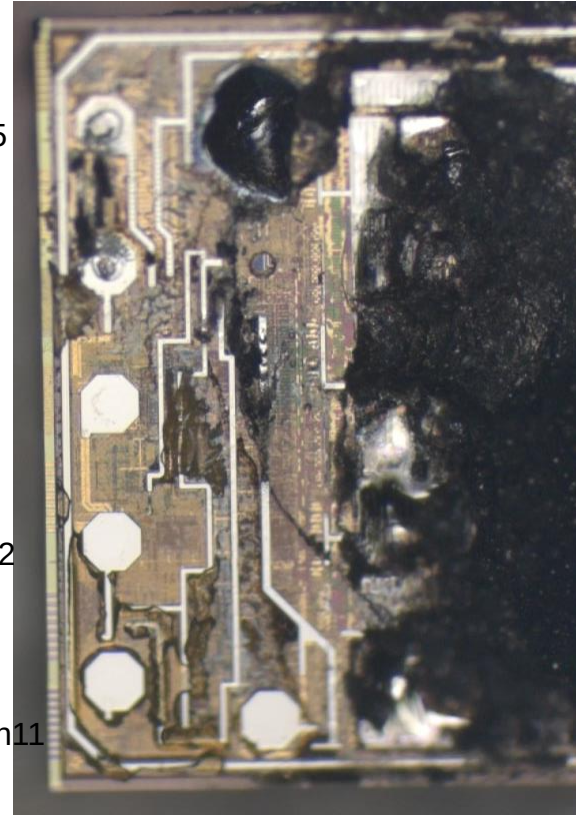
Unit#1: Sever EOS damage over die  
no damage was observed at pin11-pin13.
