Day 2 Pictures

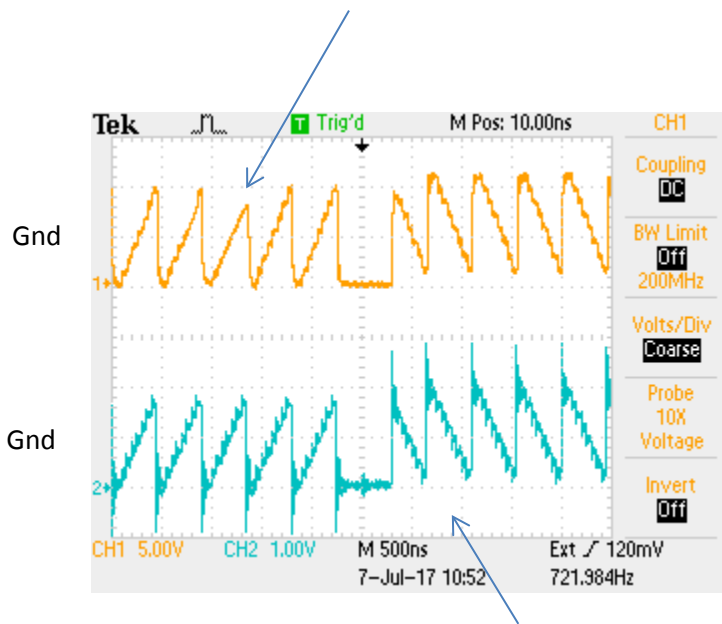
Less frequent THS6002 difficulties and they don't persist as long.

Sorry, trashy ribbon cable input side probed.

- Today's channel selection and setup was behaving better, reflecting inconsistency day-to-day.
- Amp behavior degraded slightly after running system for a while and warming up.

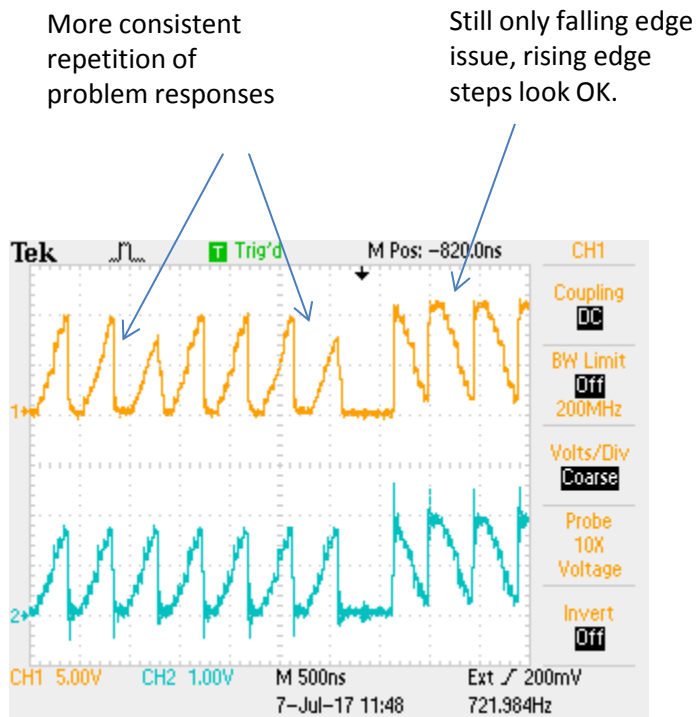
Increase to +/- 15V Supply Rails

- Re-wired to run THS6002 directly on +/- 15V supply rails.
- Behavior improved slightly in that output was bit more stable with less randomness.
- Not the magic solution, supply headroom saturation not the problem?

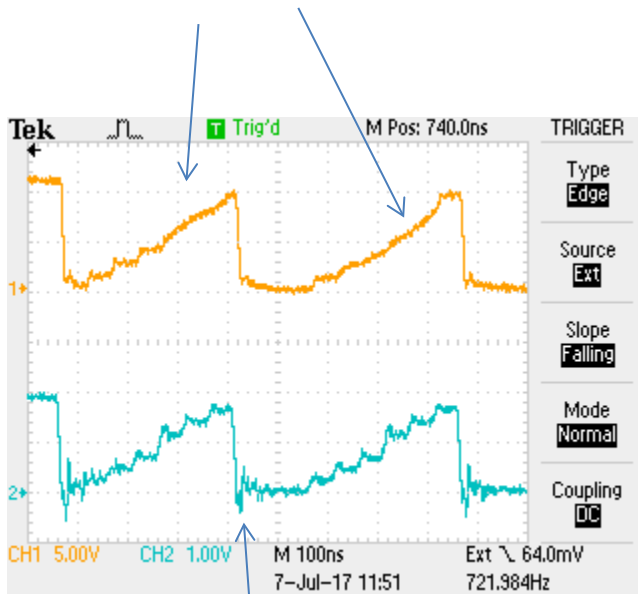
Close-Up, Filtering of Small Steps

BW issue? – Can't quite respond to input steps fast enough.

More of same, attenuated peak.

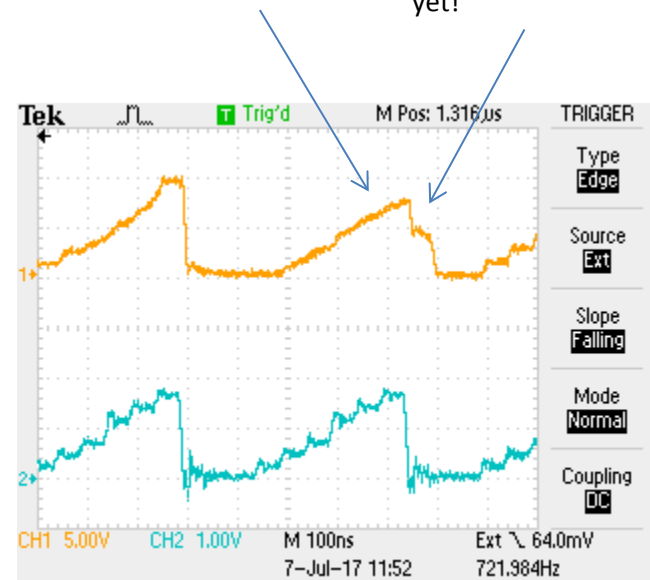
Wait a minute, not ready for that step yet!

Is it possible this HF input ringing is exceeding 6002 BW capabilities and causing a saturation/recovery period?

But wait, the ringing is there every falling step, not just occasionally.

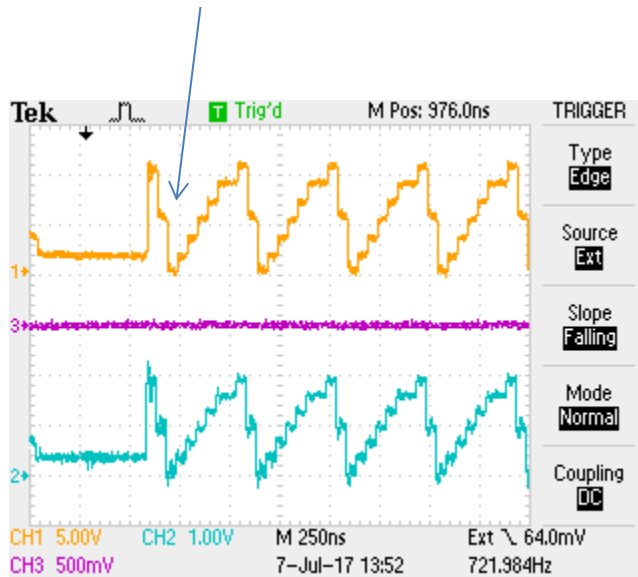
This one avoids full-scale falling step, two steps of half scale. No problem!

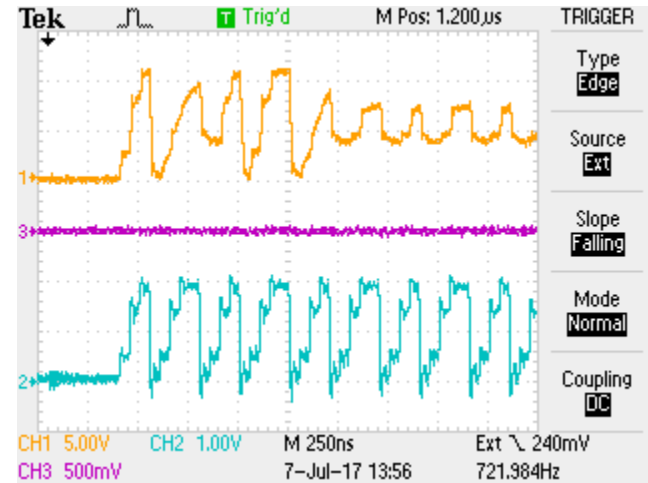
Much faster cycle rate, full-scale falling edge, 3-sample rising edge. Now we have a problem!

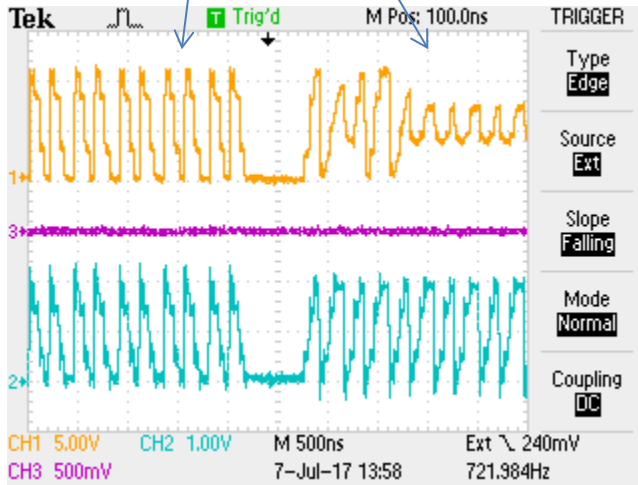
Again no problem with large rising edge steps. Fast falling edges – Wooha!

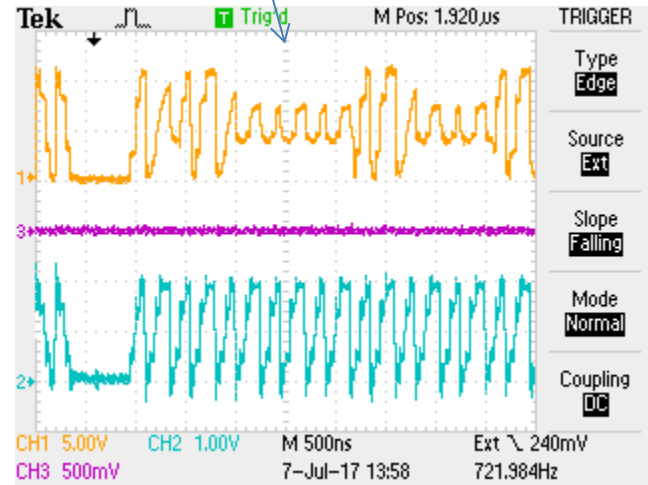
Again, long recovery periods.

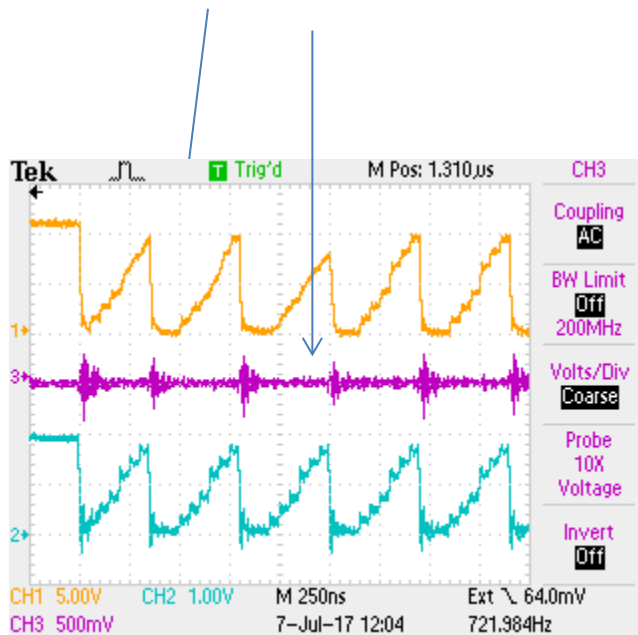
+15V supply at pcb input.

0.5V p-p ripple not too surprising since there are 32 op-amps all switching simultaneously in this case.

Could stand to add more/larger decoupling caps - -
