- **CRU Description:**

Field return  
cannot start up

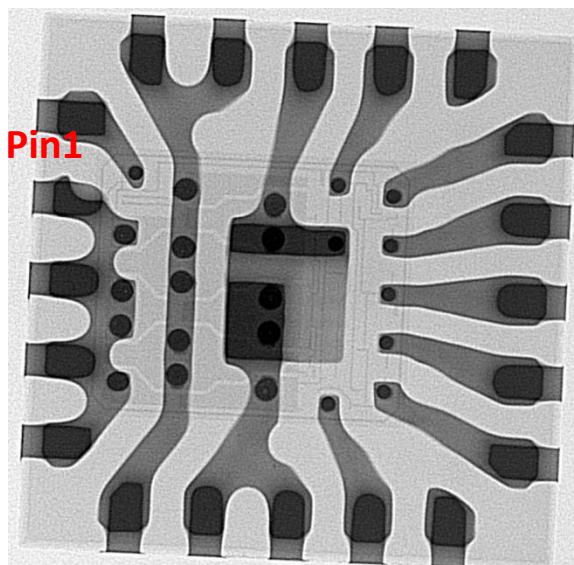
Fig.2: X-ray image of returned unit. No internal package issue was observed.

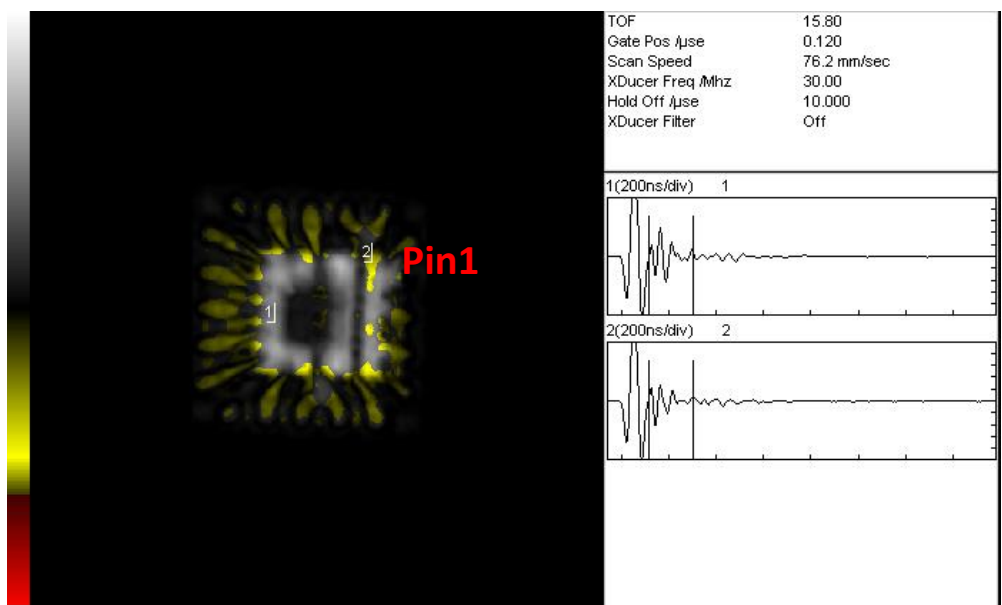
Fig.3: C-SAM image of returned unit. No delamination was observed over die surface.

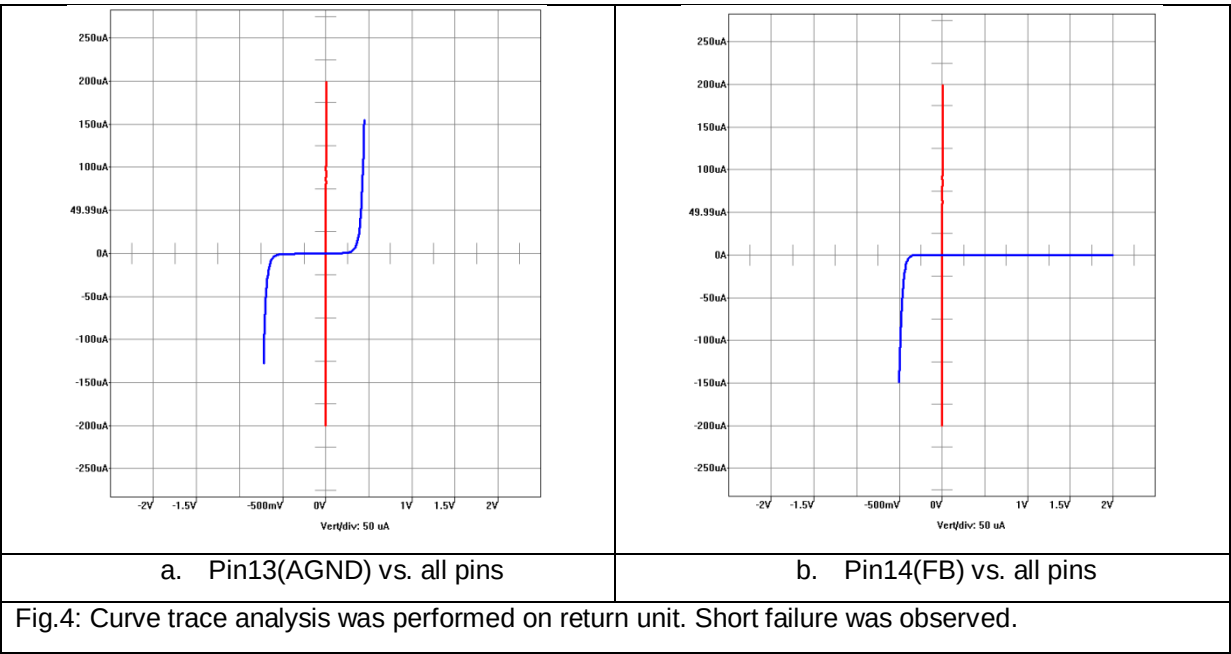
Blue curve represents correlation unit. Red curve represents returned unit.

Short failure was observed at Pin14(FB) vs. Pin13(AGND) on returned unit.

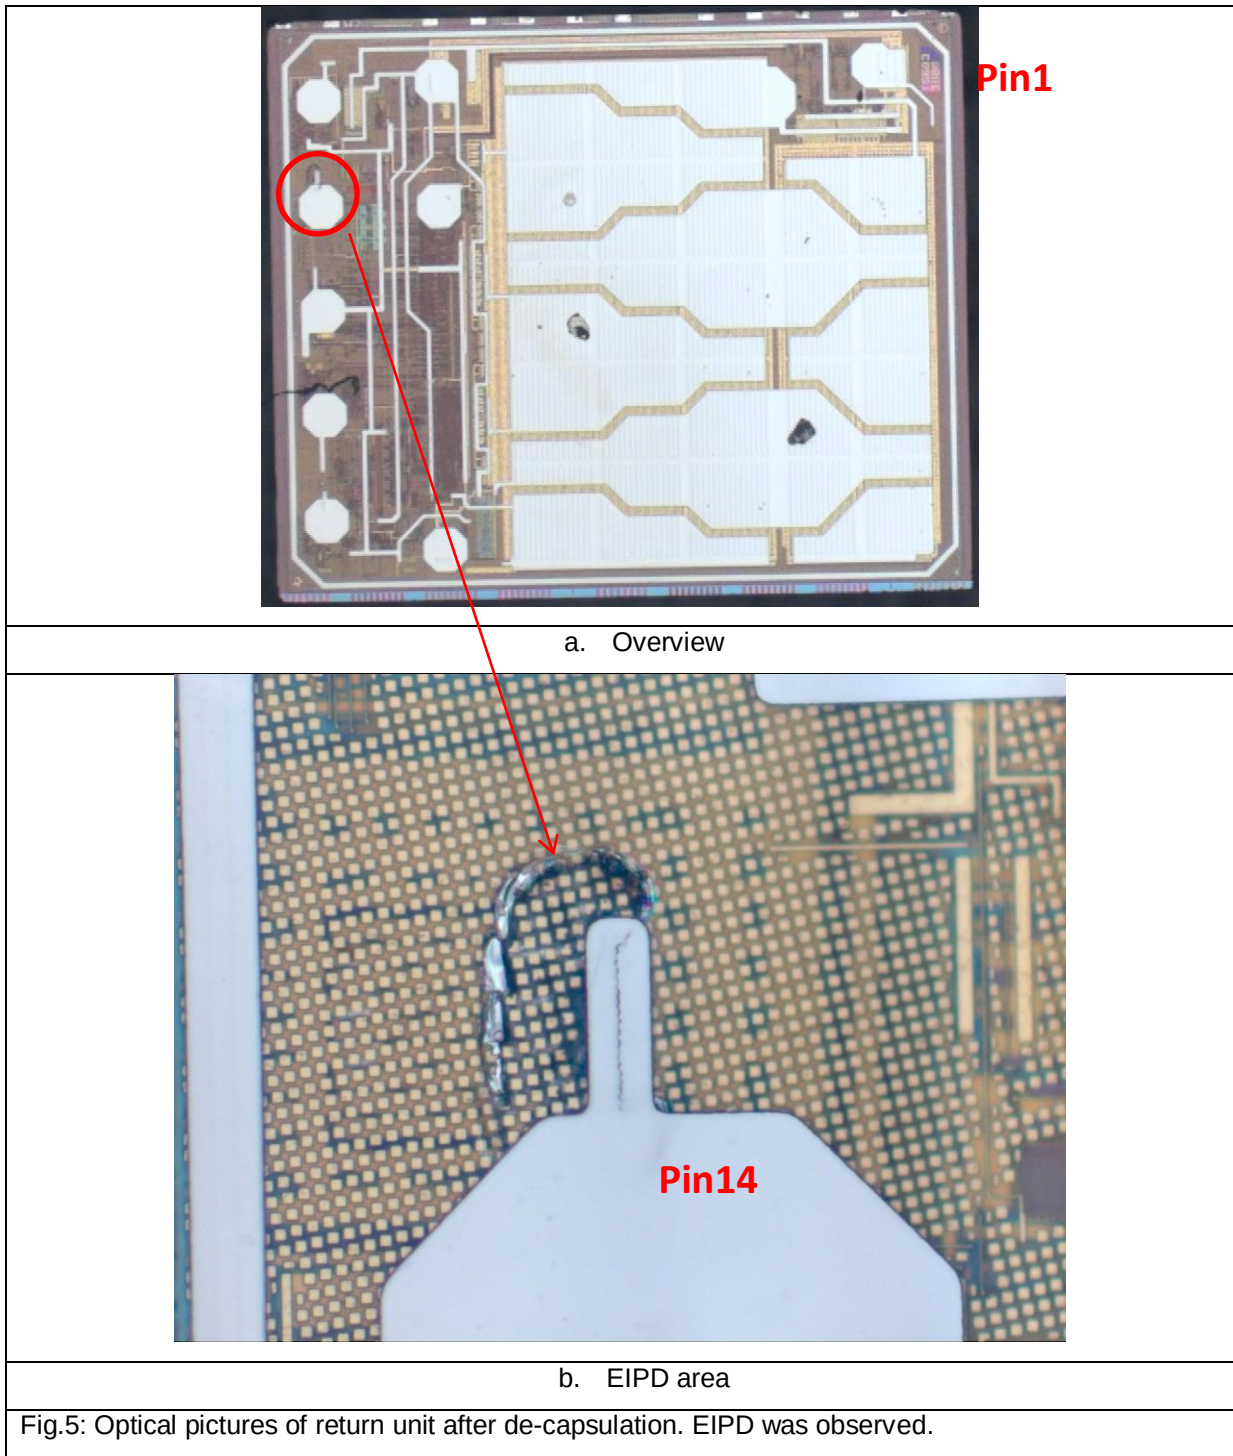
EIPD was observed on the die surface.
