- **CRU Description:**

#1: field return, VIN/SW/VCC short, package damaged, request decap to review all damage area  
 #2: simulation test with high VIN, old marking as TPS568330, 7BC66JI, need IV test and decap result  
 #3 & #4: simulation test with resistor start, #4 with longer power up time and damaged package, need IV test and decap result to see if similar EIPD as #1

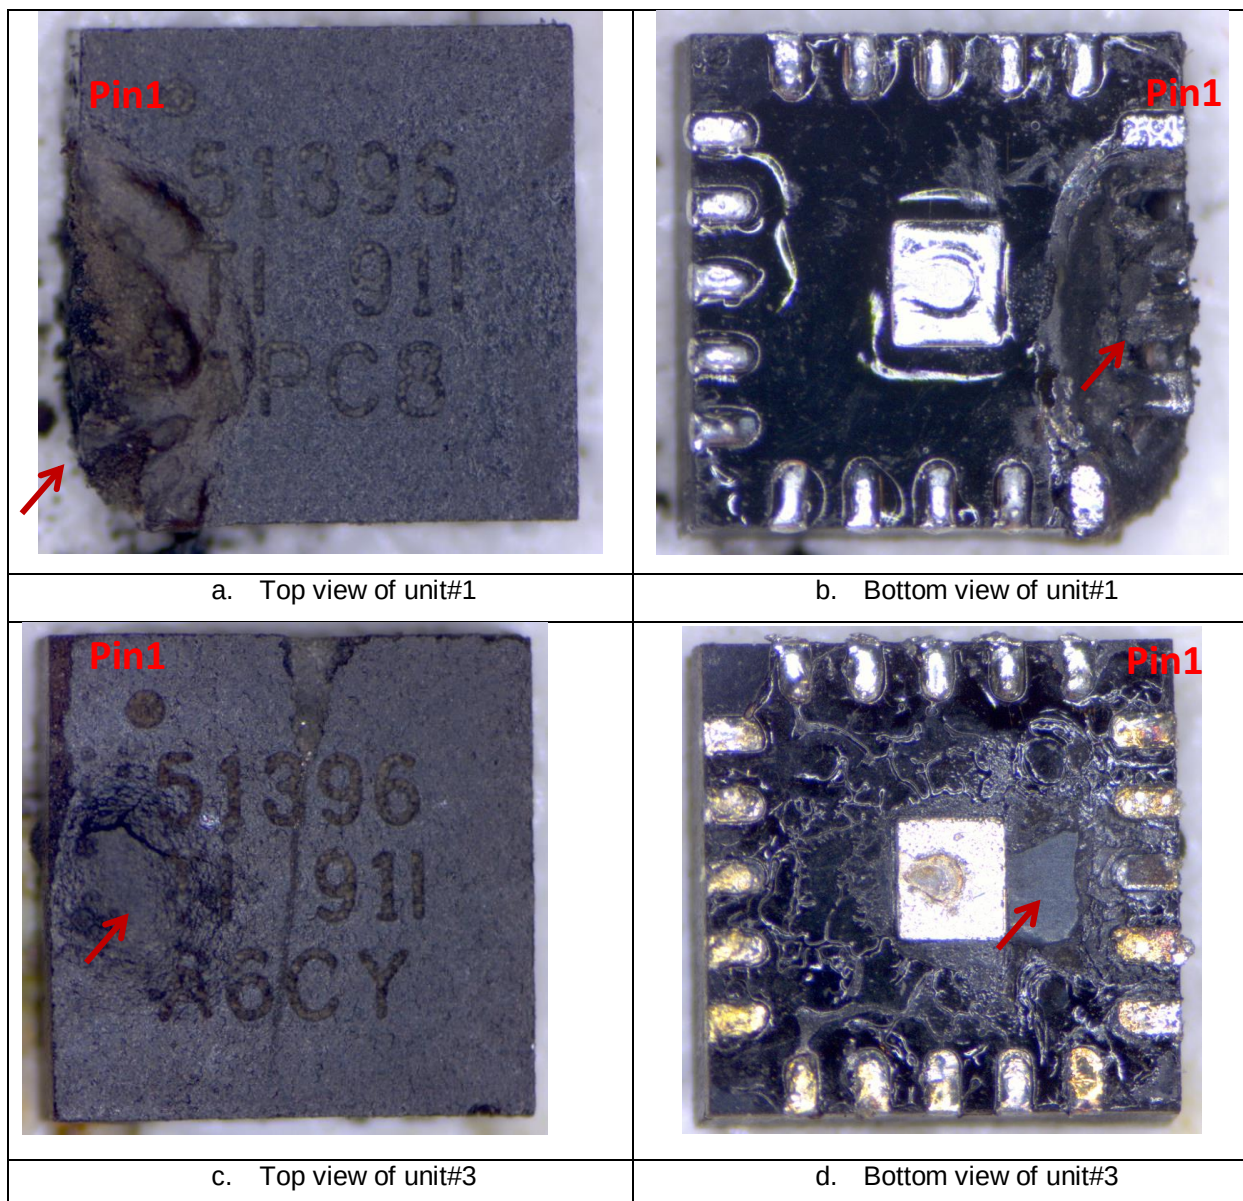
**Unit#1 & 3** is damaged too bad to decap, both units are damaged at VIN (pin2-5).

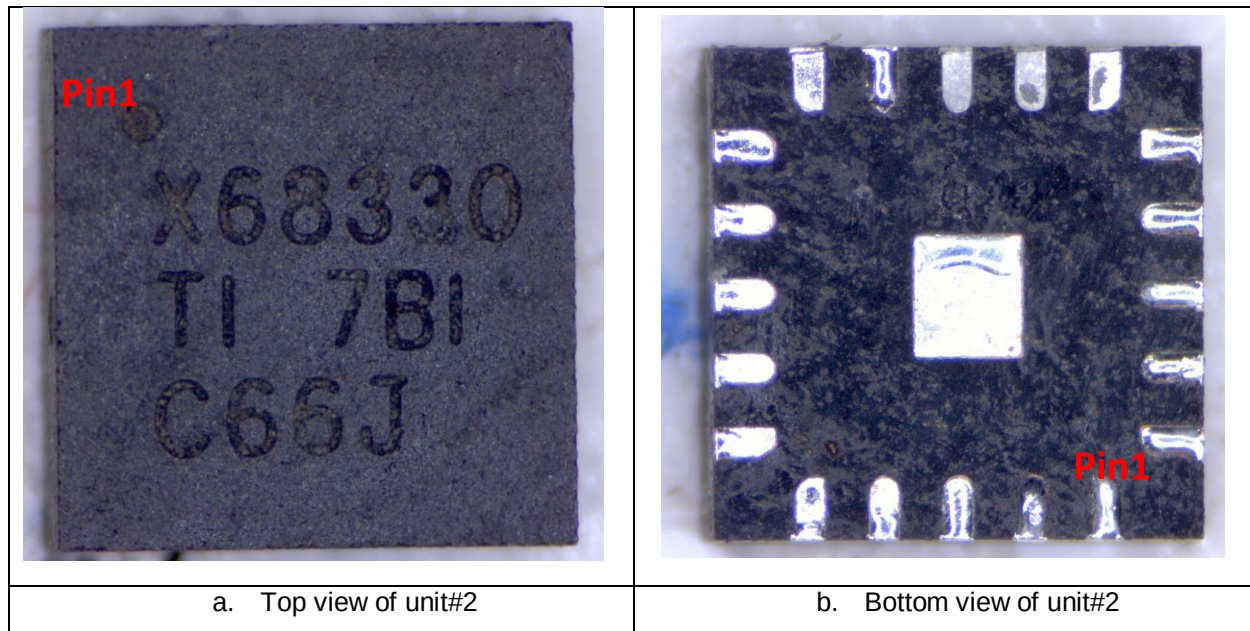
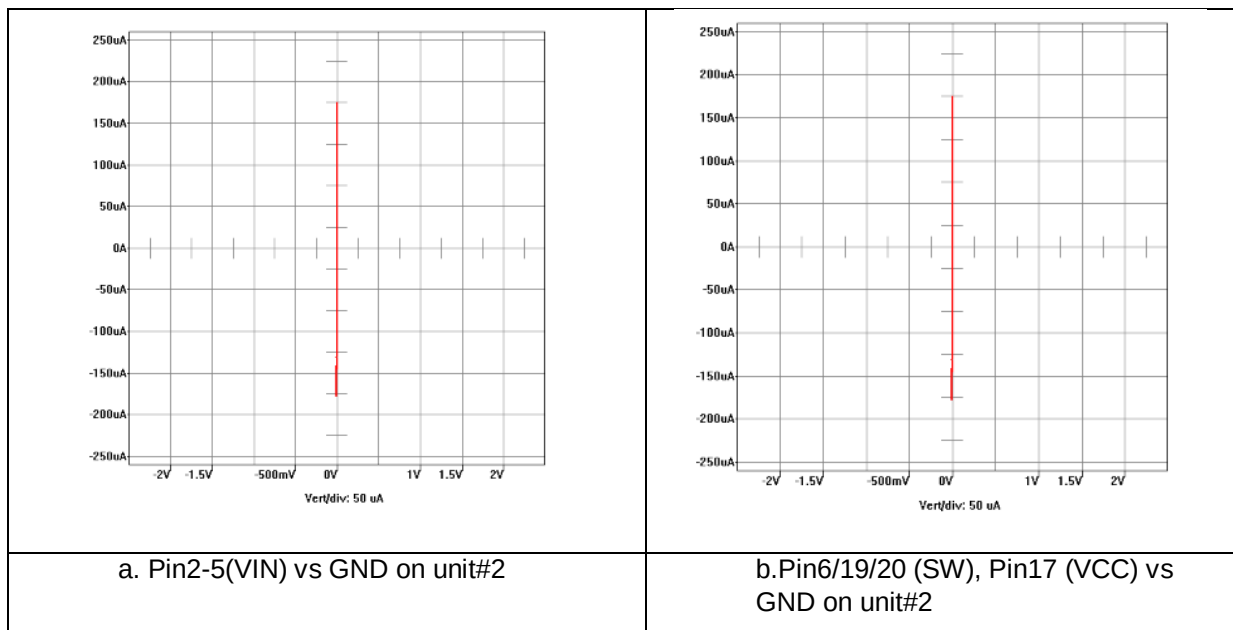
**Unit#2** was submitted to do Curve Trace Test. Short failure was observed at Pin2-5(VIN), Pin6/19/20 (SW), Pin17 (VCC) vs GND on the returned unit#2.

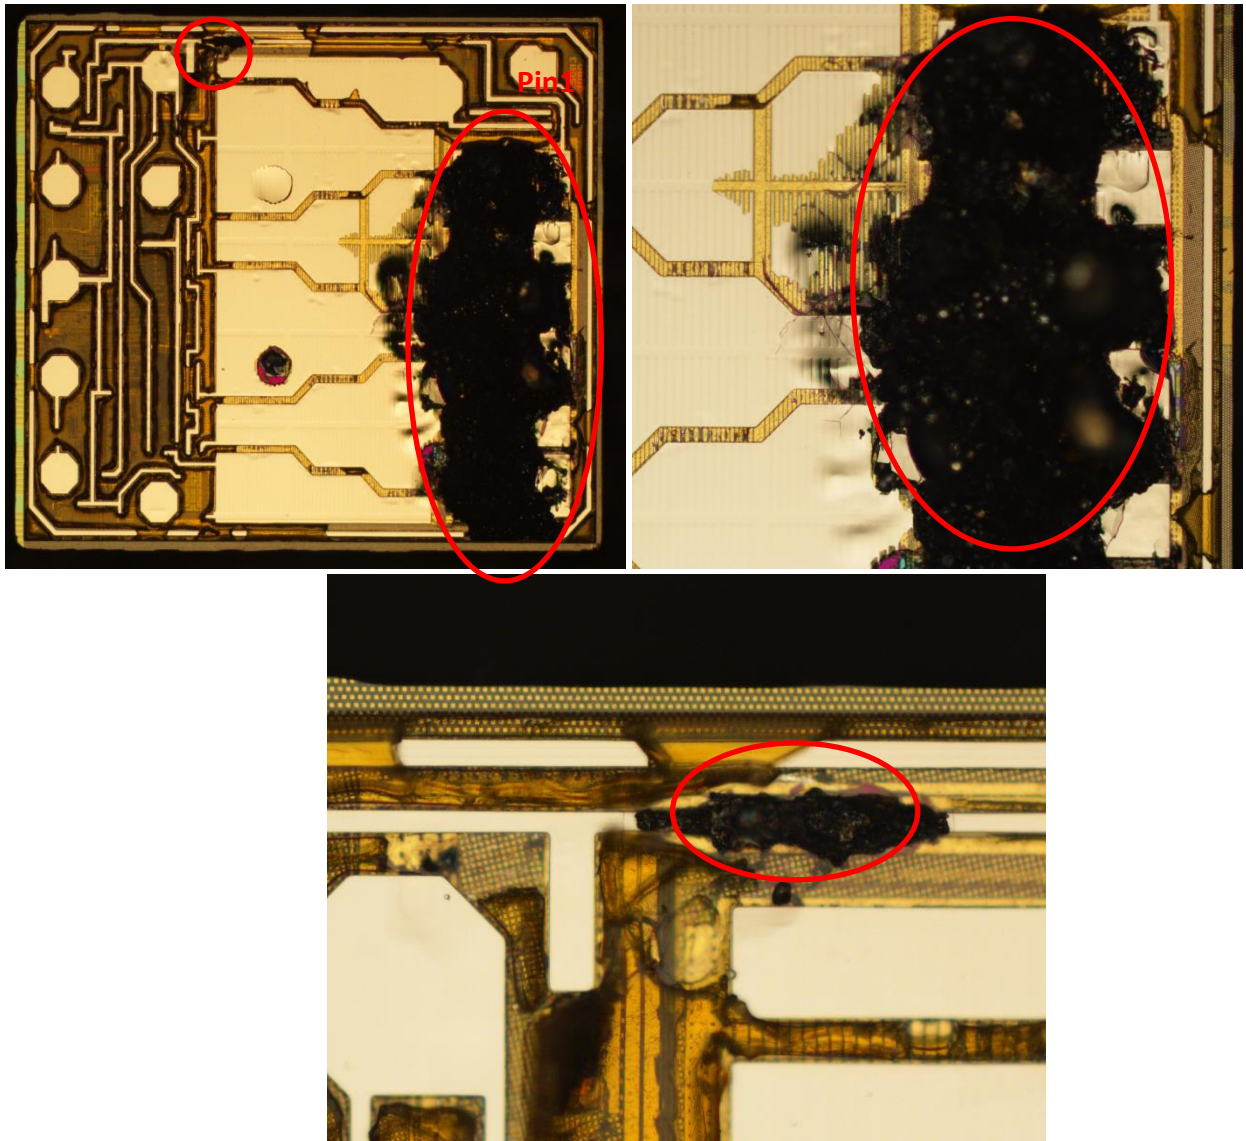
Returned unit#2 was inspected with optical microscope.  
EIPD was observed at the pin2-5 of the returned unit#2.

Fig. 4: Optical images of returned unit. EIPD was observed on the unit#2.

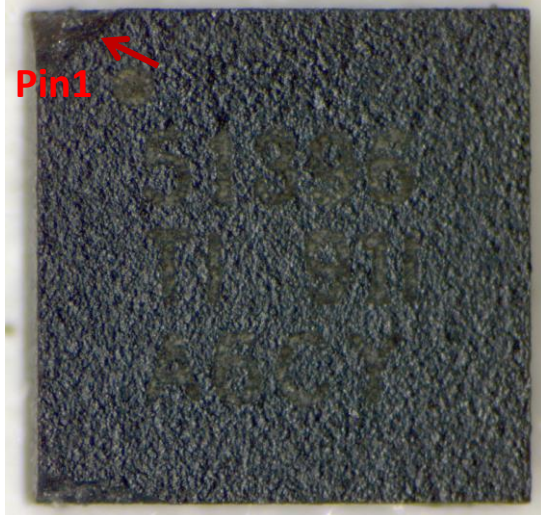
a. Top view of unit#4

**Unit#4:** No open and short was observed.
