TXS0102-Q1 Spike issue

TXS0102-Q1 Noise issue

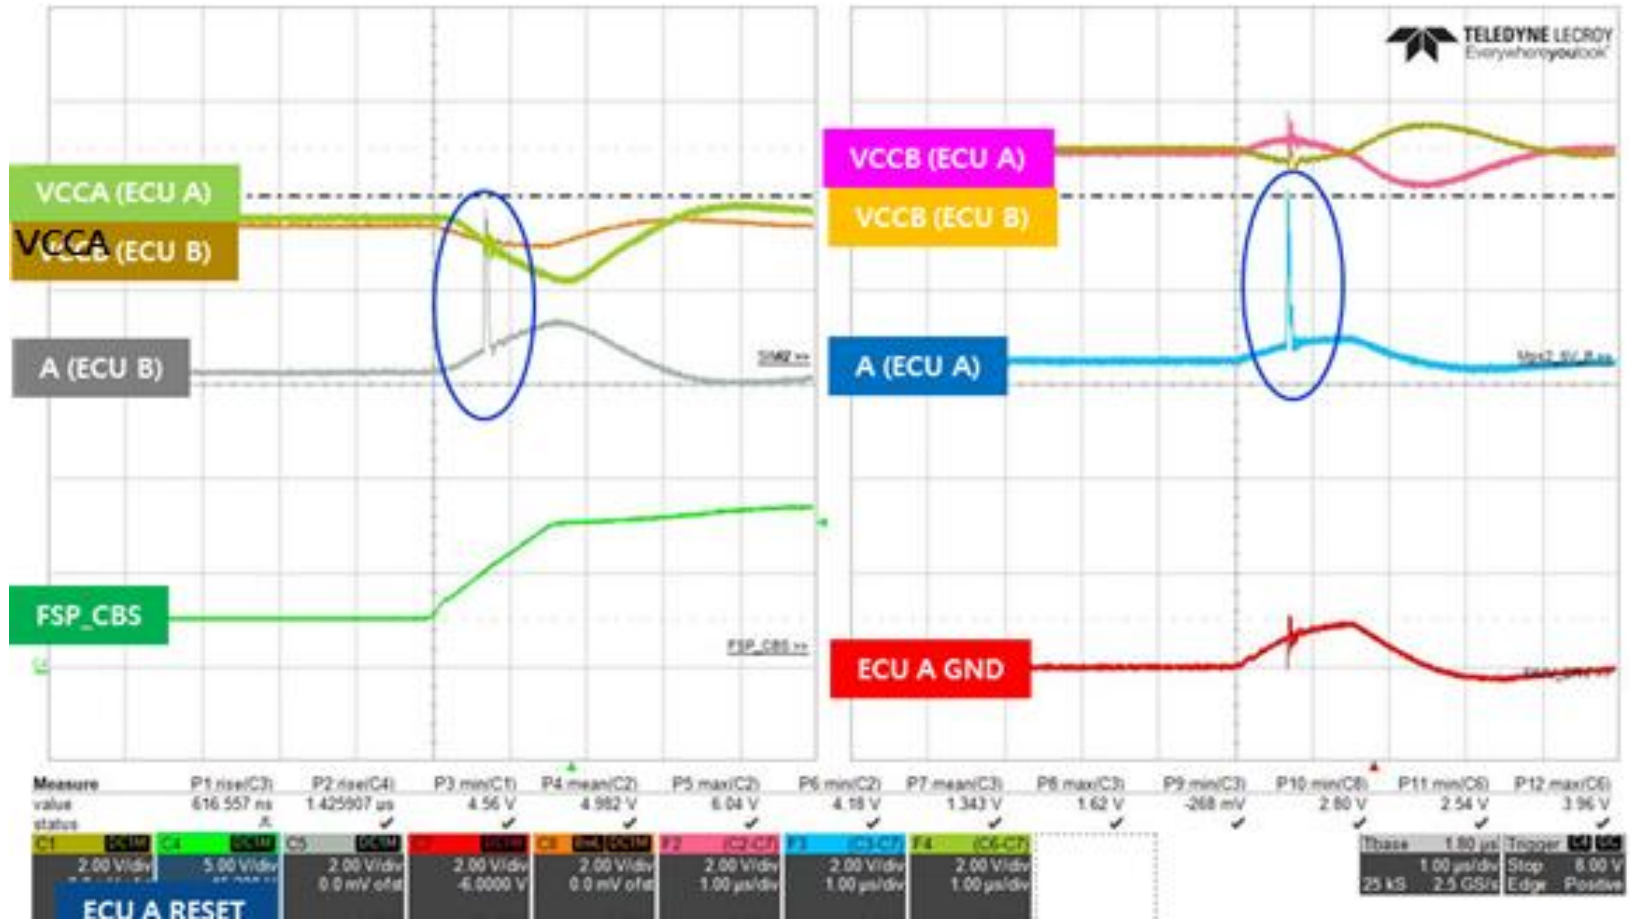
The voltage spikes are occurred on the A pin of TXS0102-Q1 on both ECU-A board and ECU-B board, respectively as above waveform. But these spikes are not occurred when removing each TXS0102-Q1 on the ECU-A and ECU-B boards that is the bypass.

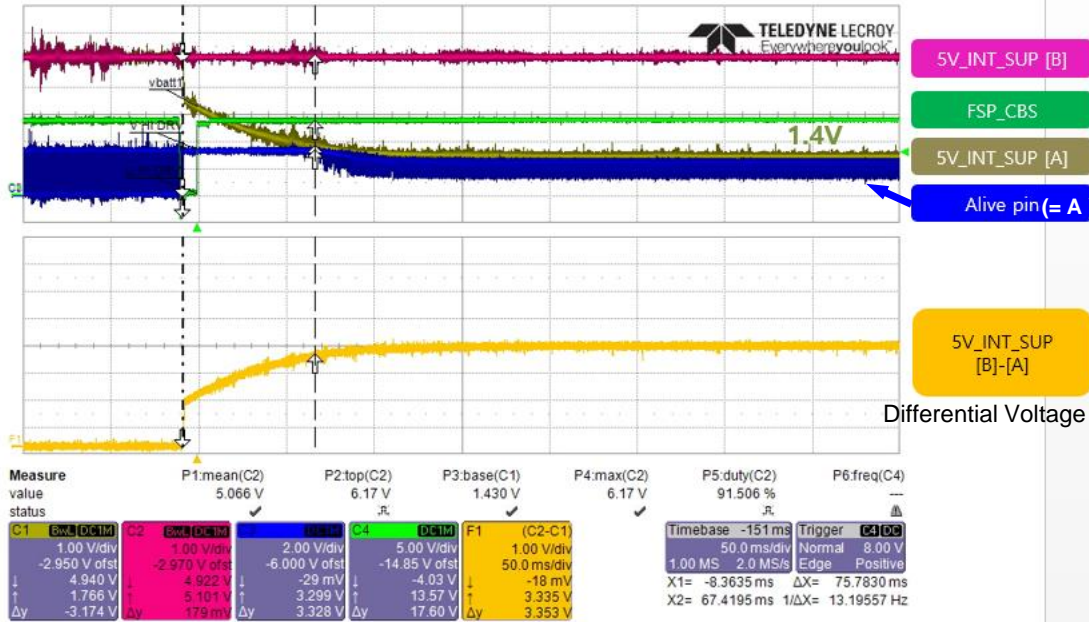
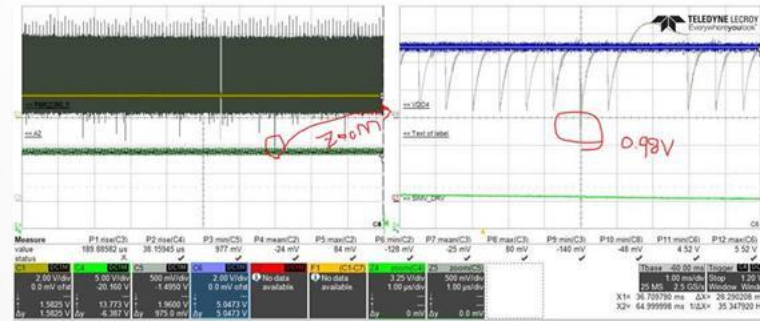
< Zoom : Alive pin (A1) >

The noise are occurred on the A1 pin as waveforms when the voltage differences are around 3.3 ~ 3.9V between 5V_INT_SUP[B] and 5V_INT_SUP[A] for VCCB(B-port supply voltages) of TXS0102-Q1.
