## ***MSP430F5438A Device Erratasheet***

### **1 Revision History**

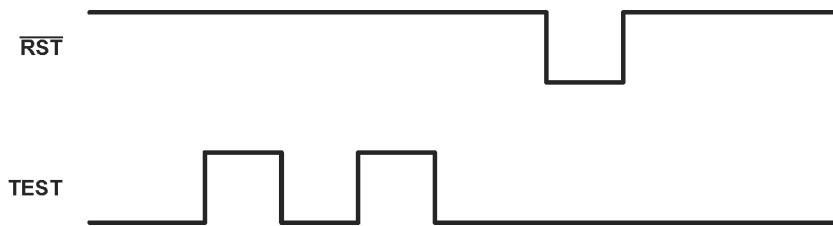
**JTAG20**
**JTAG Module**

<b>Function</b>	BSL does not exit to application code
<b>Description</b>	The methods used to exit the BSL per MSP430 Programming Via the Bootstrap Loader ( <a href="#">SLAU319</a> ) are invalid.
<b>Workaround</b>	<p>To exit the BSL one of the following methods must be used.</p> <ul style="list-style-type: none"> <li>- A Power cycle</li> <li>or</li> <li>- Toggle the TEST pin twice when nRST is high and after 50us pull nRST low.</li> </ul>

Note: This toggling of TEST pins is not subject to timing constraints. The appropriate level transitions on TEST pin, followed by a RST pulse after 50us, are sufficient to trigger an exit from BSL mode.

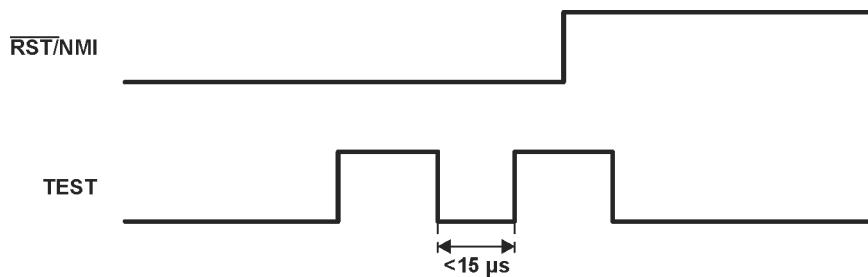
The BSL entry sequence requires that the low phase of the TEST/SBWTCK pin does not exceed 15us. This timing requirement is faster than most PC serial ports can provide, as shown in the following picture. If this requirement is not met, the entry sequence fails and the SYSBSLIND is not set.

An external hardware solution is recommended to provide the appropriate BSL entry sequence. See [http://processors.wiki.ti.com/index.php/BSL\\_\(MSP430\)](http://processors.wiki.ti.com/index.php/BSL_(MSP430)) for recommendations on available BSL hardware.
