Errata

**MSP430F6436 Microcontroller**

This document describes the known exceptions to the functional specifications (advisories).

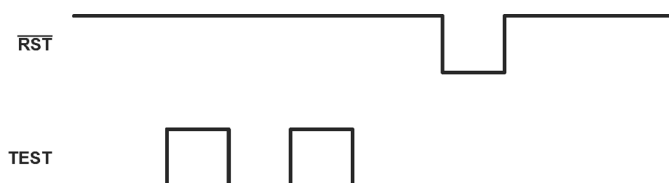
- Toggle the TEST pin twice when nRST is high and after 50us pull nRST low.

Note: This toggling of TEST pins is not subject to timing constraints. The appropriate level transitions on TEST pin, followed by a RST pulse after 50us, are sufficient to trigger an exit from BSL mode.
