F280041 ADC Interrupt Overflow Issue Summary

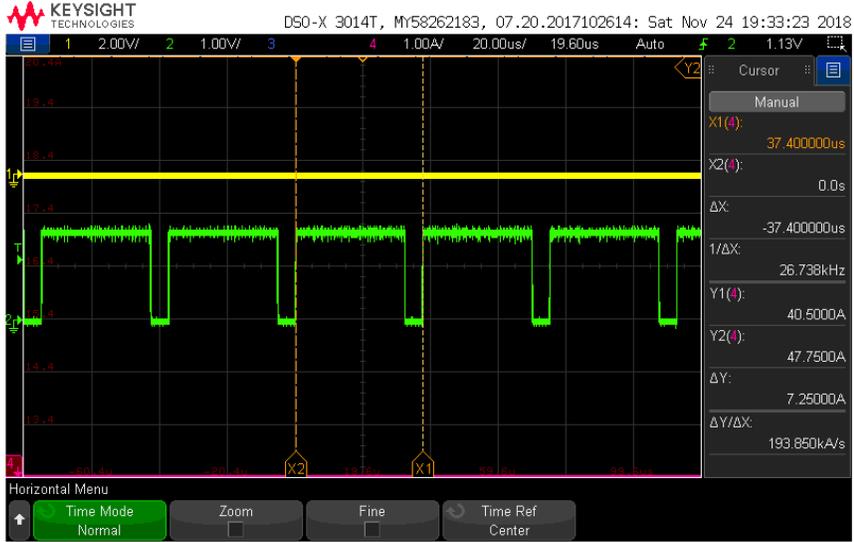
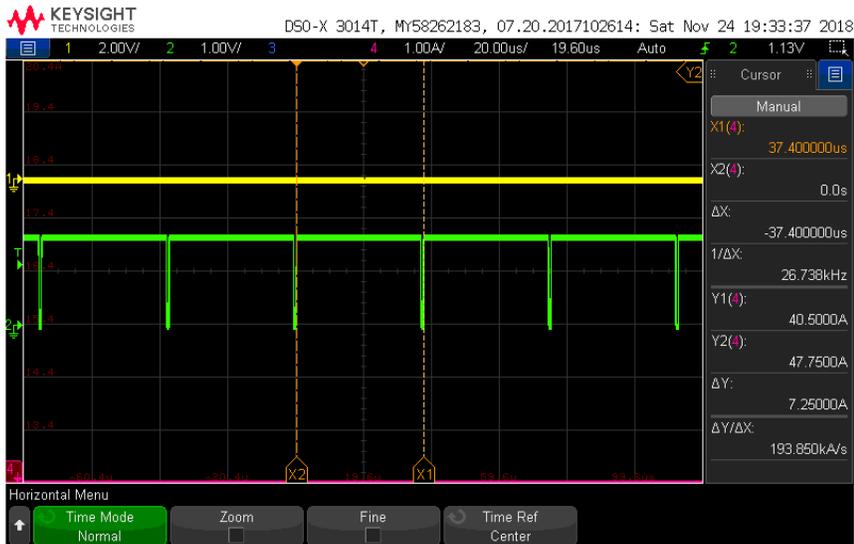
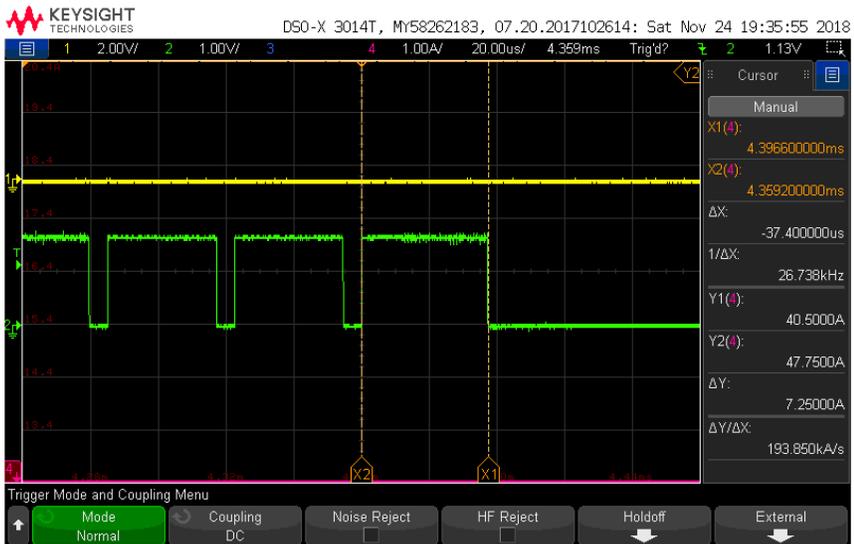
- **Q2:** When the execution time is not integral multiple of sample period, e.g. 2.5x corresponding to 250% ISR utilization ratio, the ADCAINT1 can be serviced again although it's overflow (when 1x or 100% ISR utilization ratio it's not overflow) without clearing ADCINTOVF flag and enabling ADCINT to run in continuous mode, but it's not serviced right after the old ADCAINT1 exited, instead at the timing where is integral multiple of sample period (see captured waveforms below), why?

Note:

- Green (CH2) is GPIO controlled in ADCAINT1 ISR (high when entering and low when exiting);
- Waveform #1 indicates execution time is >2x sample period and overflow occurs, while new ADCAINT1 can be serviced after old ISR exits, but is fixed to start running at the timing where is 3x sample period;
- Waveform #2 indicates execution time is close to 3x sample period and overflow occurs, while new ADCAINT1 can be serviced after old ISR exits, but is fixed to start running at the timing where is 3x sample period;
- Waveform #3 indicates execution time equals to 3x sample period and overflow occurs, while new ADCAINT1 and all following ADCAINT1s can't be serviced anymore;
