## Setup:

TI F28335 communicates via parallel bus (XINTF) with the following nodes:

## Problems:

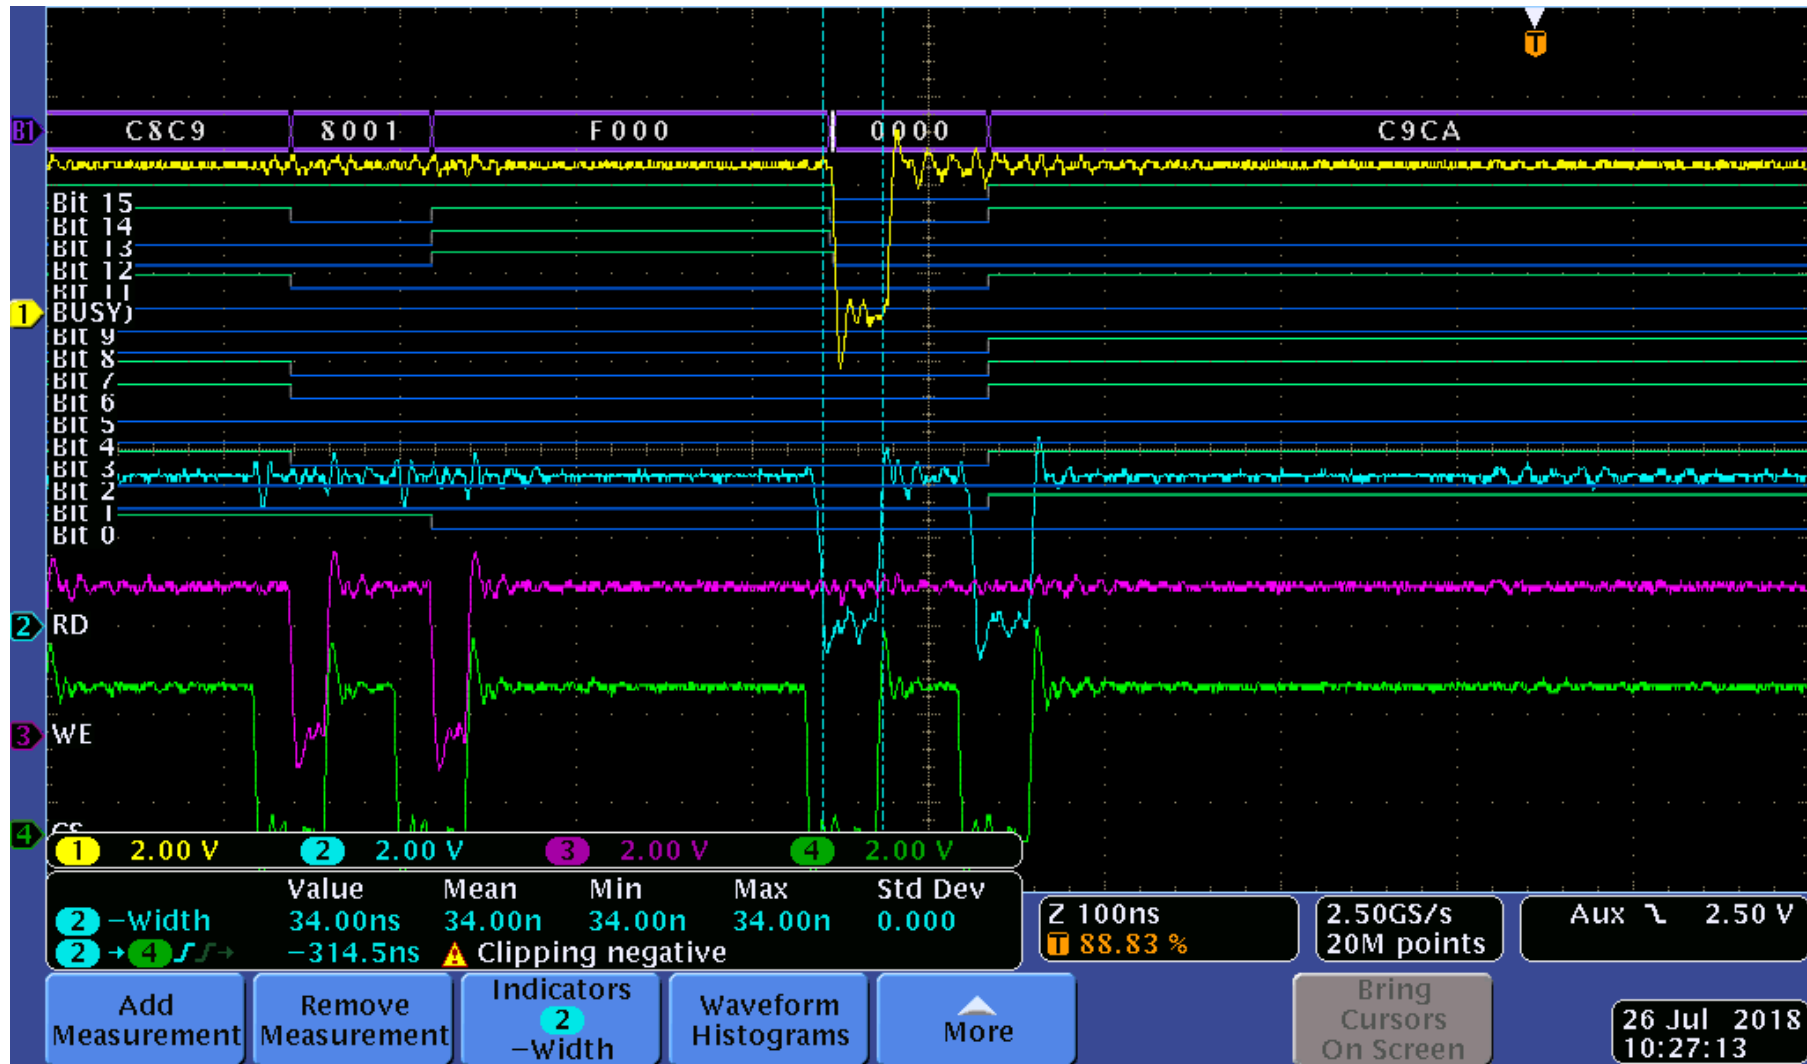
→ Reason for this behavior is probably a wrong reaction/function of the xReady signal. The F28335 finishes its read request although it receives a BUSY signal from the C6747.

a) Ignored xReady signal when XRDACTIVE = 4 (and X2TIMING = 0).

Figure 1: Reading data from 0x8001 F000. Expected value: 0xC7C8 C9CA. Read value: 0x0000 C9CA.  
The first read pulse toggles to HIGH again before xReady is HIGH. → XINTF settings: XRDACTIVE = 4 (X2TIMING = 0)  
xReady (yellow), nRead (cyan), nWrite (magenta), nCS (green), parallel bus (violet)

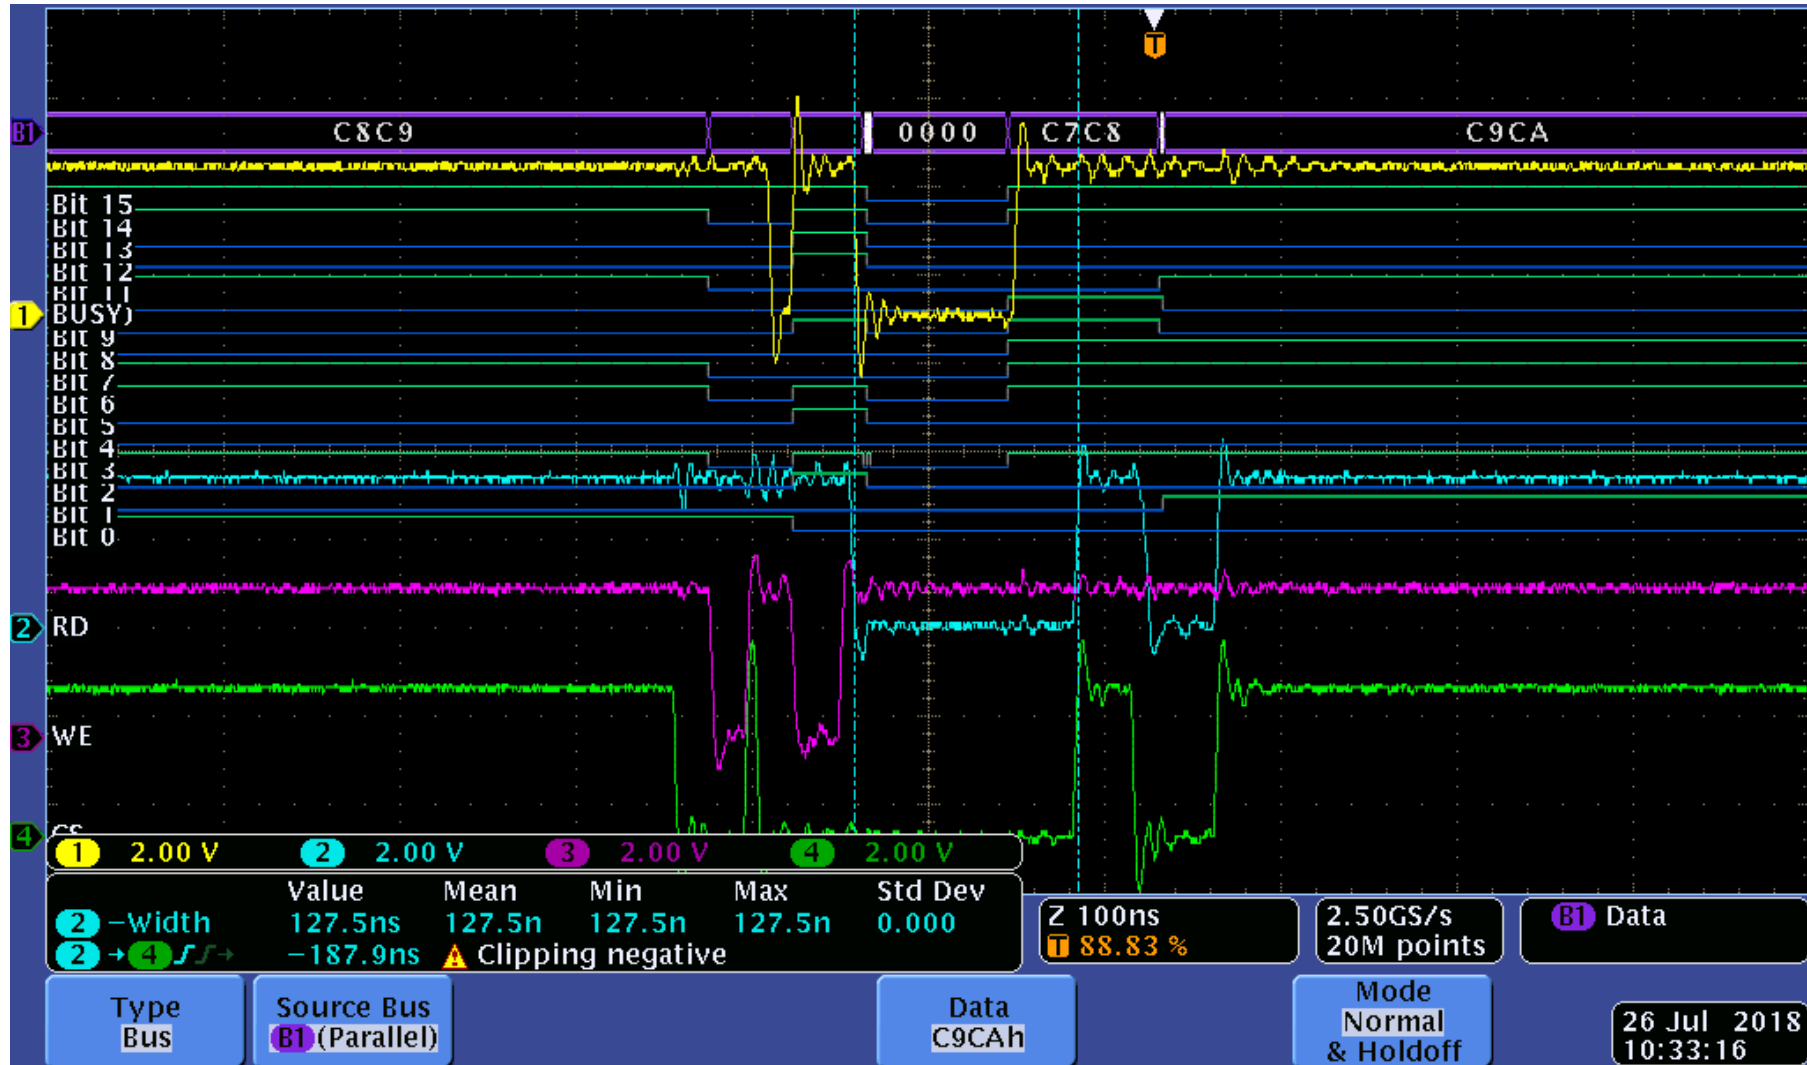
b) Anticipated xReady signal when XRDACTIVE = 5 (and X2TIMING = 0).

Figure 2: Reading data from 0x8001 F000. Value 0xC7C8 C9CA read correctly.  
The first read pulse is prolonged because of the xReady signal. → XINTF settings: XRDACTIVE = 5 (X2TIMING = 0)  
xReady (yellow), nRead (cyan), nWrite (magenta), nCS (green), parallel bus (violet)

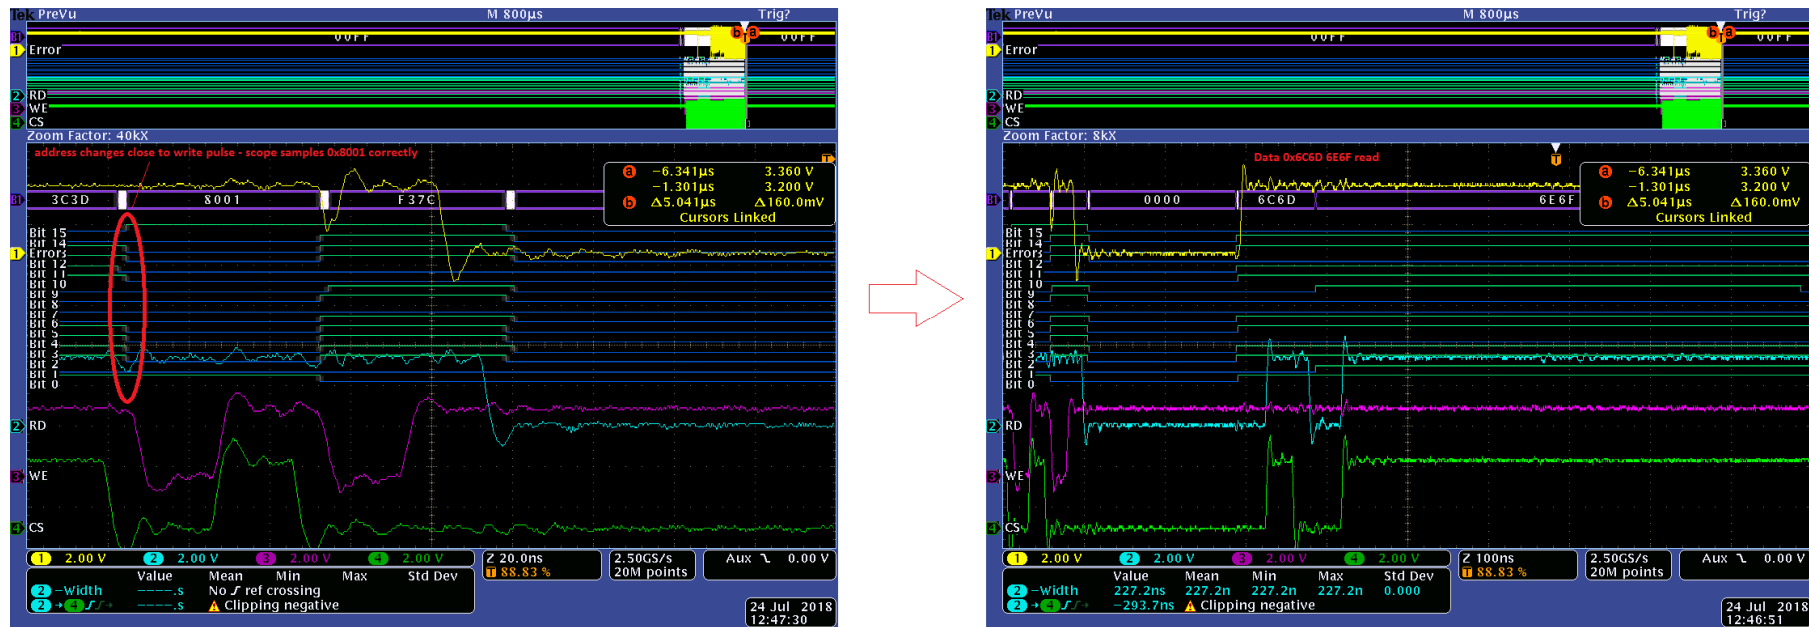
Another issue we came across is that the address where the data is read from the C6747 is corrupted because of wrong XINTF settings. We cannot see the issue on the scope, but when checking the F28335 registers, it is clear, that the wrong address is set.

On C6747 @address 0x8001 F37C the value 0x3B3C 3D3E is stored. When reading from this address, the data 0x6C6D 6E6F is read instead (incorrectly).

Figure 5: Scope recordings of incident. (0x6C6D 6E6F read instead of 0x3B3C 3D3E)  
xReady (yellow), nRead (cyan), nWrite (magenta), nCS (green), parallel bus (violet)

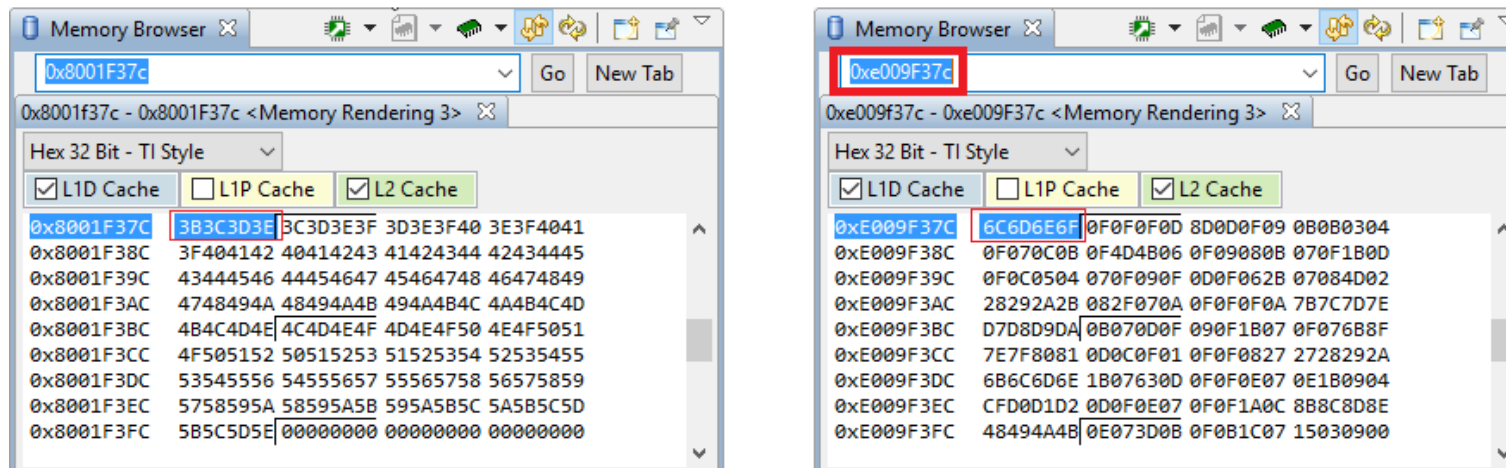
Figure 7: C6747 memory (@address 0x8001F37C and @address 0xE009F37C) at the same time instant as the scope recording

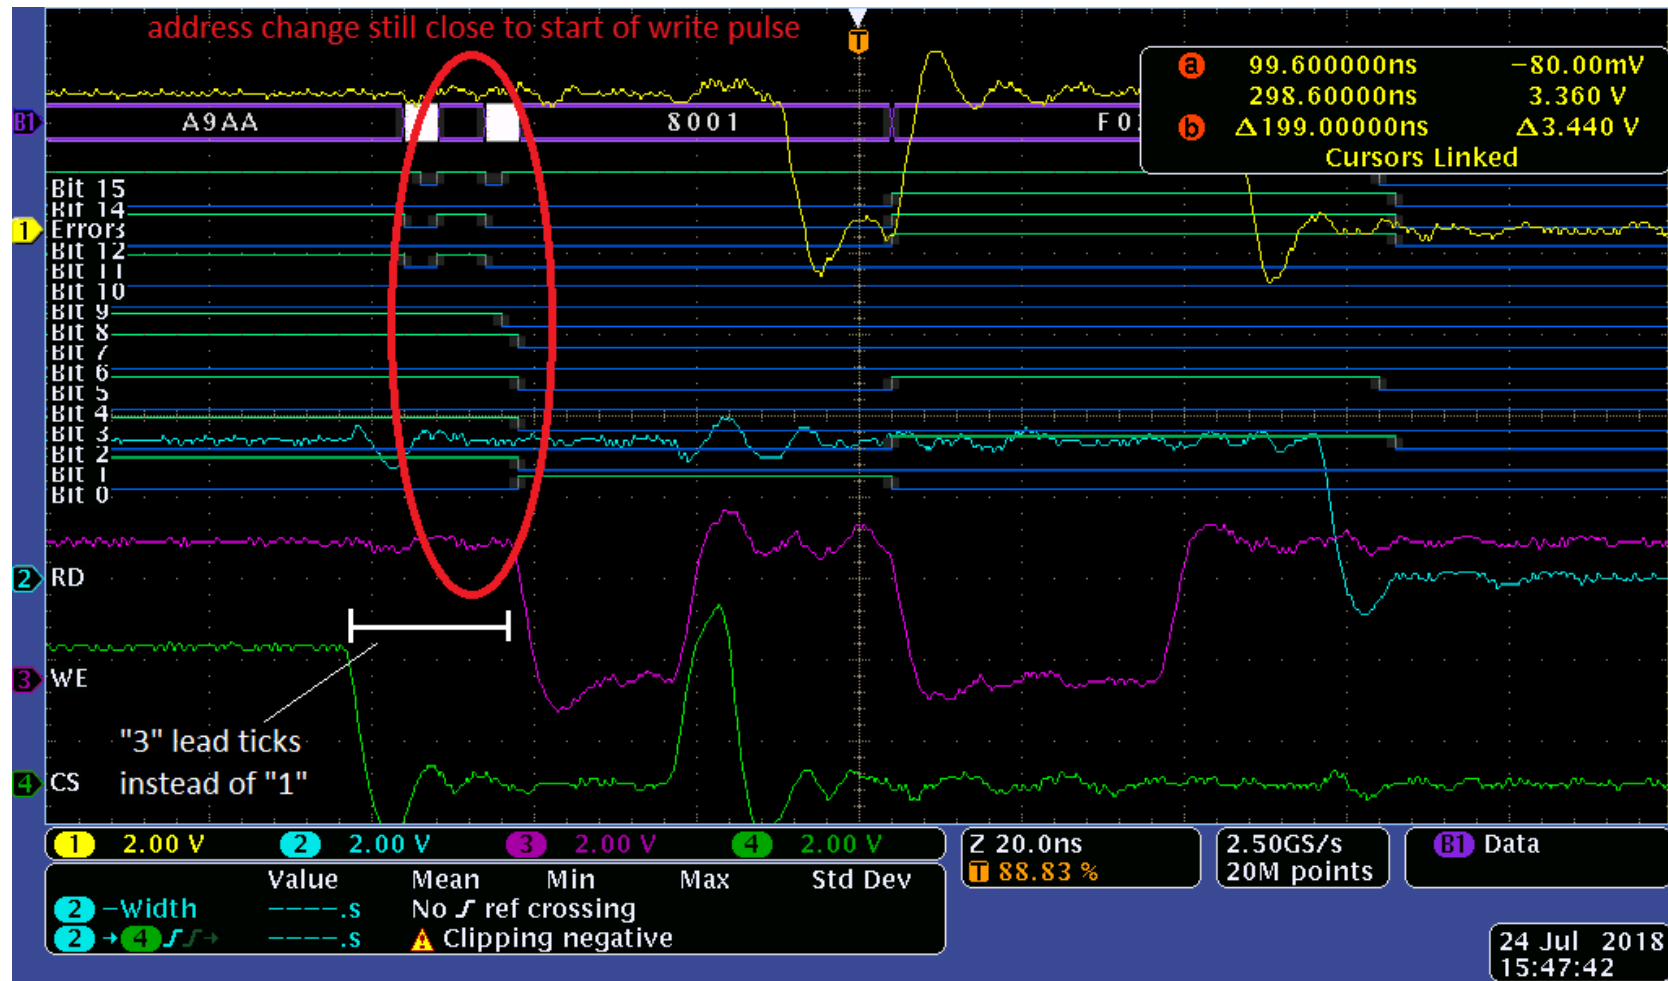
Figure 8: Scope measurement of correct data read after XWRLEAD tick change from "1" to "3"  
 xReady (yellow), nRead (cyan), nWrite (magenta), nCS (green), parallel bus (violet)

The described problem could be solved by increasing the XWRLEAD from "1" to "3". On the scope, however, the timing when the address bits toggle does not really change in relation to the write pulse start. But in the test firmware no communication errors occur. The increased time between CS start (green) and Write start (magenta) can be seen in Figure 8.
