1. Channel B issue always happen before channel A

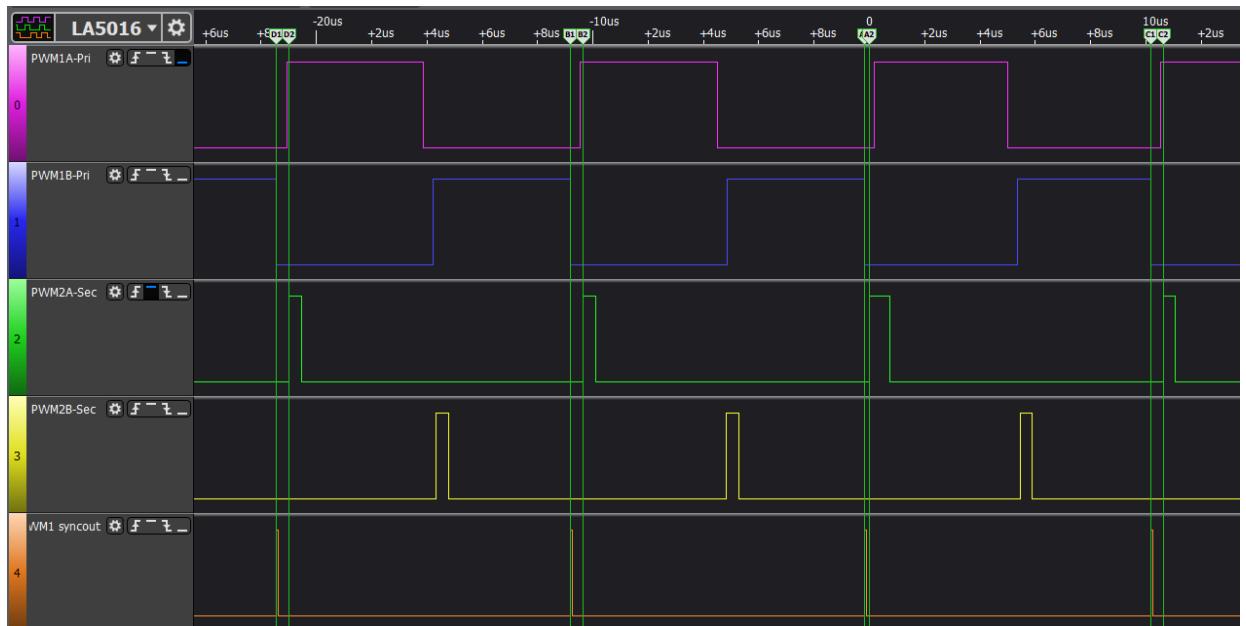
2. The abnormal sec wave dead band seems different. I compare the rising edge and falling edge with PWM syncout single.

So the rising edge depends on the deadband, it seems abnormal one is too short.

In my view, This can also match with why make a delay of the PWM count can solve the issue. It is just choose not update the 'too short' deadband.

Pulse Measurements	
Timing Marker Pairs	
▼ A1 - A2 = 190ns	▼ x
A1 @ -190ns	
A2 @ 0ps	
▼ B1 - B2 = 465ns	▼ x
B1 @ -10.815us	
B2 @ -10.35us	
▼ C1 - C2 = 465ns	▼ x
C1 @ 10.16us	
C2 @ 10.625us	
▼ D1 - D2 = 465ns	▼ x
D1 @ -21.44us	
D2 @ -20.975us

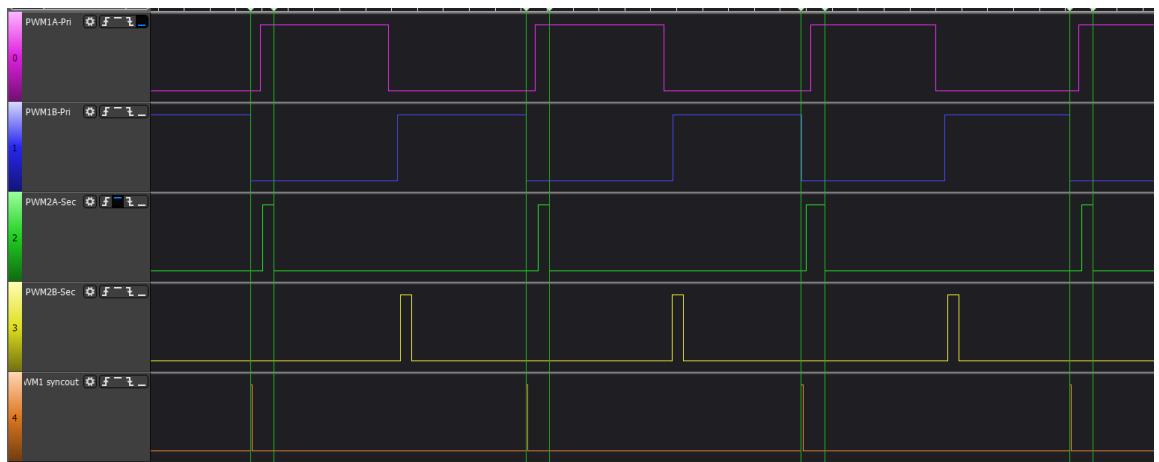
The falling edge depends on the CMPA, it is the same for abnormal and normal, so it is OK.

Timing Marker Pairs	
▼ A1 - A2 = 910ns	▼ x
A1 @ -190ns	
A2 @ 720ns	
▼ B1 - B2 = 910ns	▼ x
B1 @ -10.815us	
B2 @ -9.905us	
▼ C1 - C2 = 910ns	▼ x
C1 @ 10.16us	
C2 @ 11.07us	
▼ D1 - D2 = 910ns	▼ x
D1 @ -21.44us	
D2 @ -20.53us

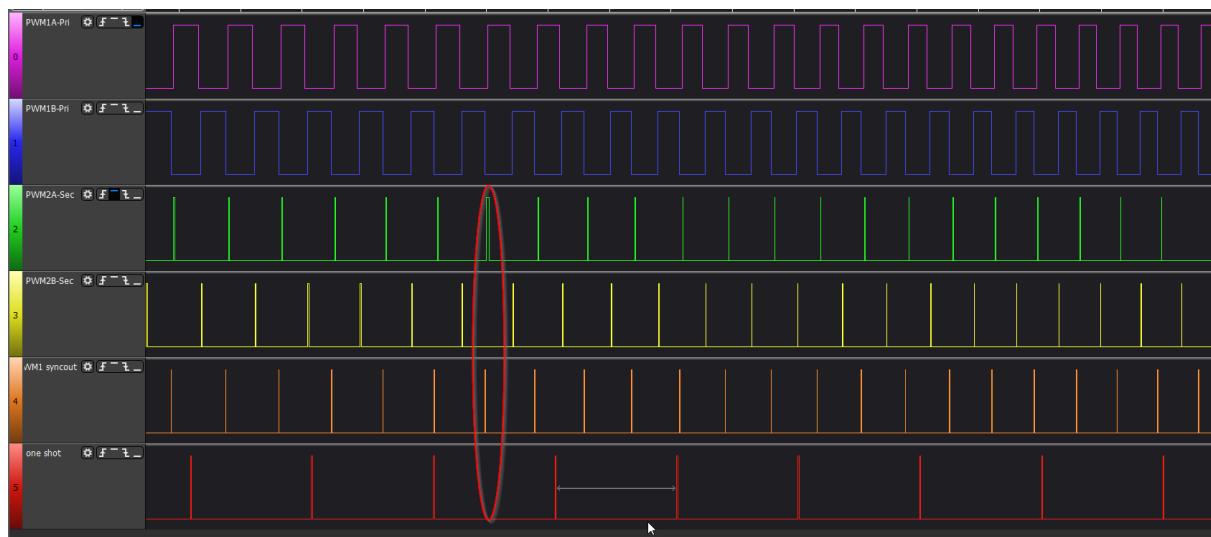
At last, I also make a debug GPIO to see the rough time of one shot reload enable.

It will happen one shot reload is happen really near PWM counter = zero, which makes analysis more difficult.
