Test setup:

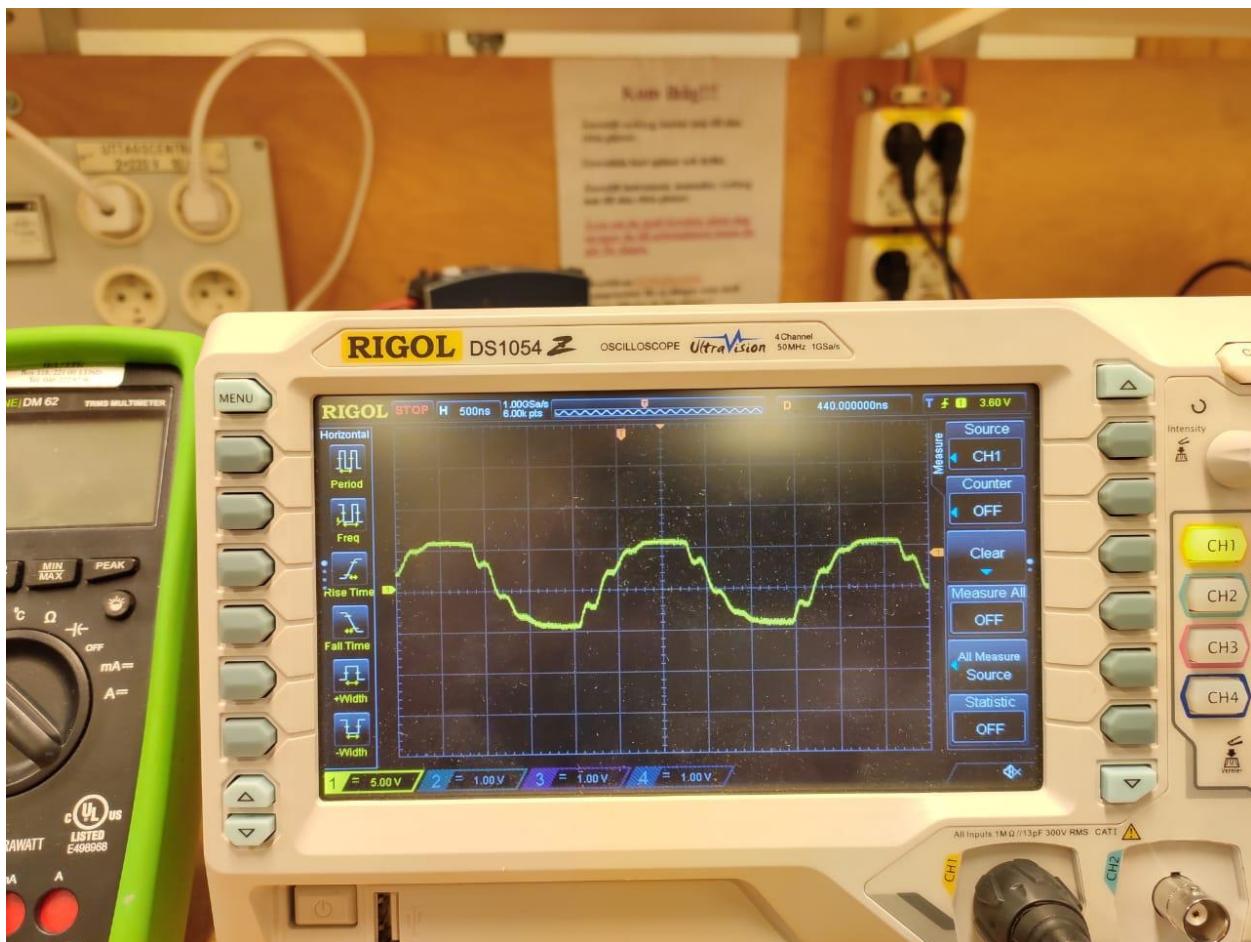
Voltage swing measured between Pin 3 & Pin 1 of T2, transformer

5 V swing at T2, as seen from the scope reading above.

The same 5 V swing is absent at T1, it's just few mVs.

Hence U1 is faulty in driving T1, what do you guys think?

Only the old boards VEE is within acceptable limits, do you guys think changing the transformer driver IC SN6505B will make both the gate driver work?
