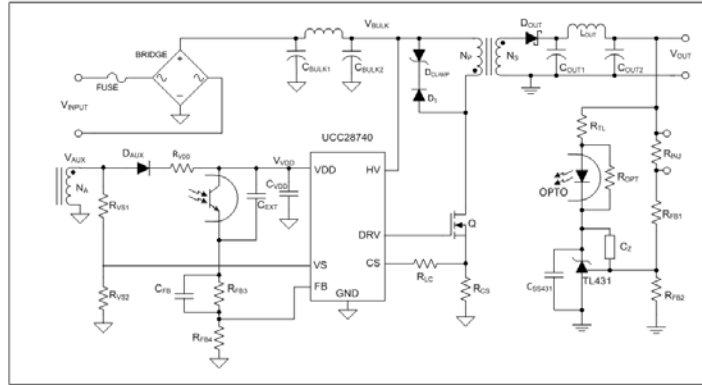
4. Small Signal Stability Recommendations.
 - a. To check loop stability you can evaluate the UCC28740 FB pin and the designs output voltage to check for stability.
 - i. They should be DC with very little ripple voltage.
 - ii. If these pins have large signal sinusoidal ripple the cause is most likely small signal loop stability.
 - iii. If these pins have large triangular or square waves on them most likely it is large signal stability issue.
 - b. I noticed the feedback loop was type 3 compensation and you were depending on the opto for the high frequency pole.
 - i. This is not the typical compensation network that is used for the UCC28740. However, it can be used if you use a network analyzer to compensate the voltage loop.
 - c. The UCC28740 data sheet recommends using a capacitor (CFB) across RFB3 (R63 in your design) to filter out high frequency noise.

- i. I notice this design does not have this capacitor. You might consider adding it to make the design less susceptible to noise.
- ii. The data sheet recommends setting this time constant to 1 ms and then fine tune the capacitor as needed.
