Date: 24-09-2025

Technical Support Request: Issues with BQ7697204 AFE via SPI

Host Microcontroller: STM32U535RET6

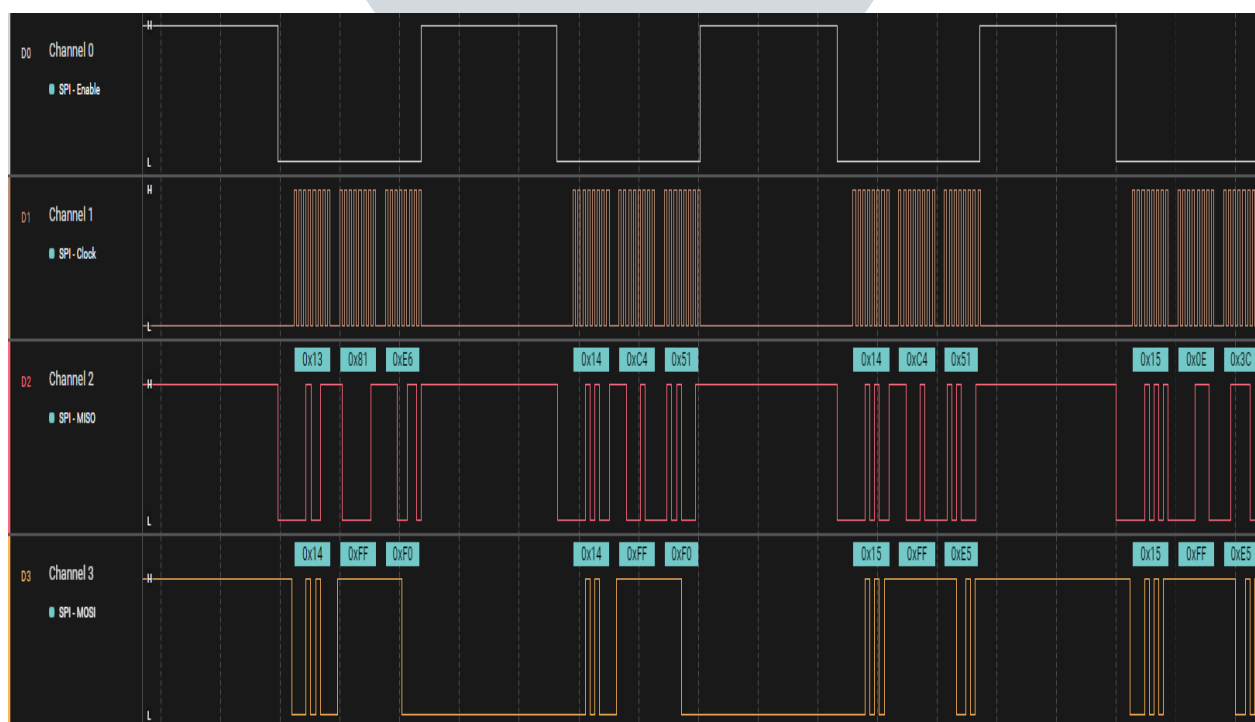
SPI Transaction Example Implementation Details:

- Commands used: **0x14** and **0x15** to fetch the 16-bit cell voltage value.
- The transaction sequence followed:
 1. Send command **0x14**, followed by dummy byte **0x00**, and CRC of the first two bytes using the transmit–receive function.
 2. Apply a delay of 800 μ s.
 3. Repeat the same transaction to receive the first 8 bits of the reading from the MISO pin.
 4. Repeat with command **0x15** in the same sequence to obtain the full 16-bit value.
- After reception, the host controller verifies the received frame's CRC for data integrity.

- High frequency of CRC failures.

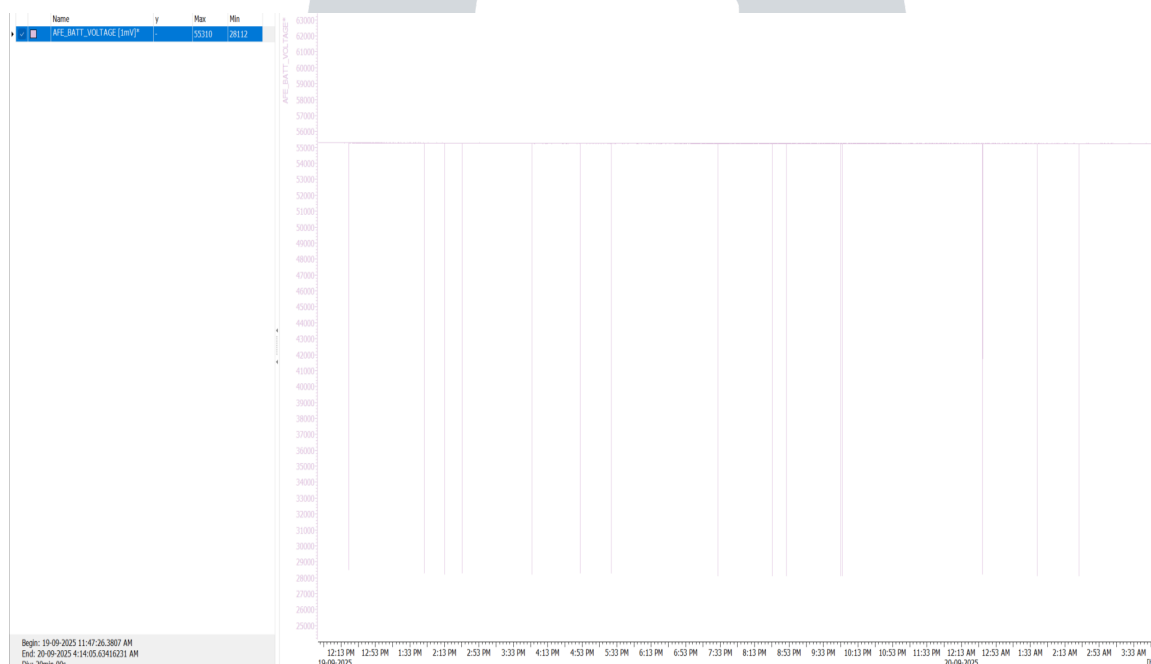
Battery voltage readings obtained through commands **0x34** and **0x35** show abnormal/unrealistic values even in CRC-passed frames.

- Multiple samples report the battery voltage dropping to **28112 mV**, which is not realistic.
- This behaviour makes the data unreliable, despite CRC validation.
