Question

On the recently manufactured (B2) boards, inrush current appears to occur more easily as a general tendency.
Are there any possible causes for this?

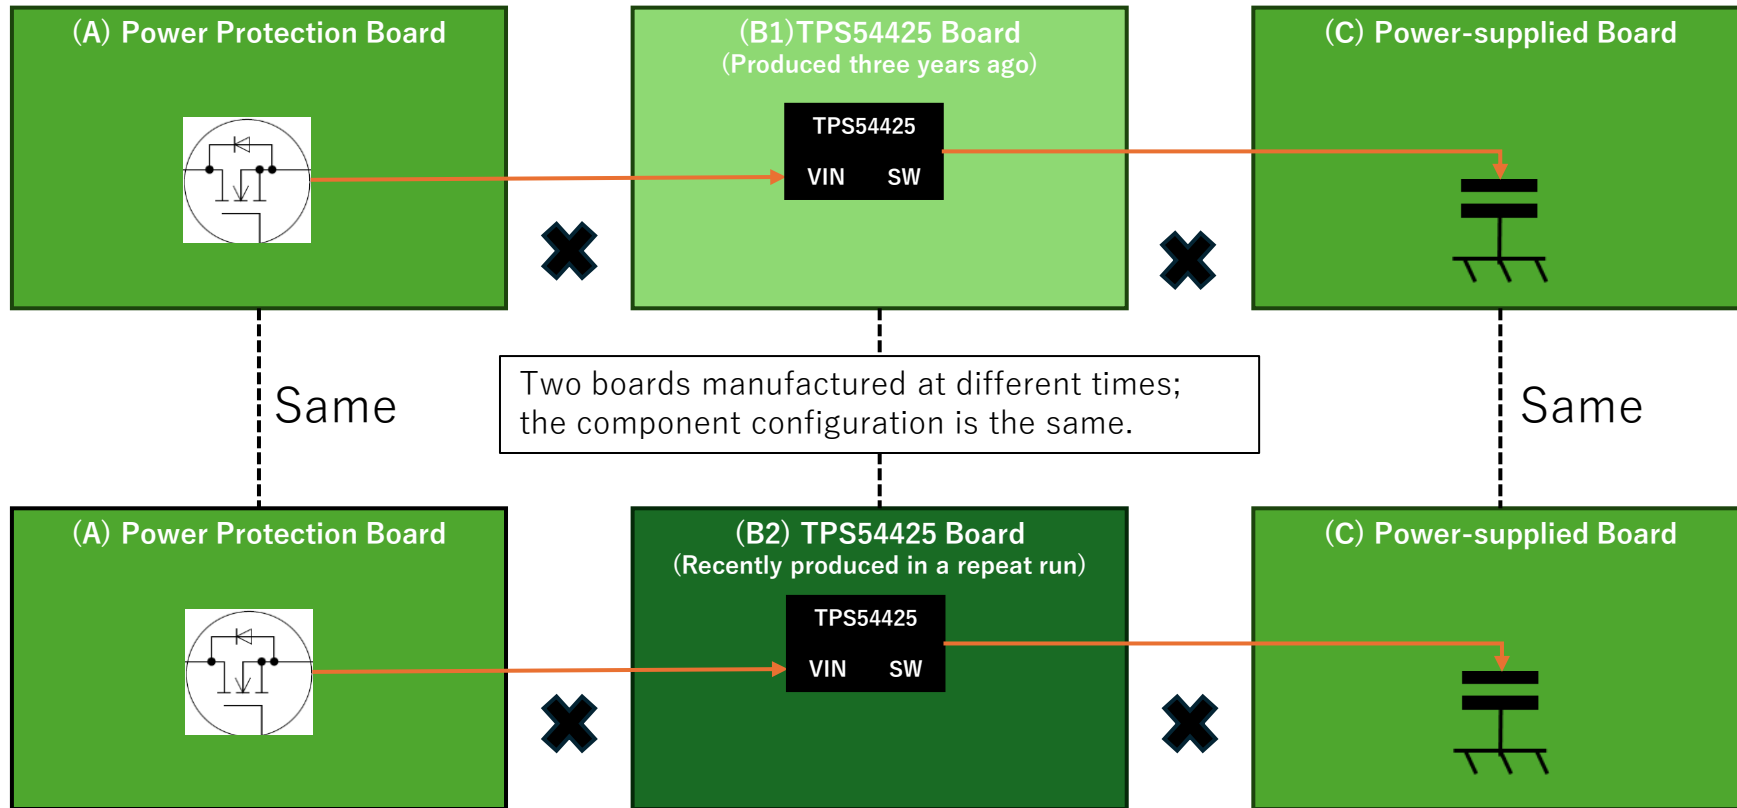
The above operation check was conducted using the same individual boards for (A) and (C), while (B1) and (B2) were swapped. There are more than ten boards each of (B1) and (B2). All (B2) boards tend to generate a larger inrush current than (B1), and as a result, the system is more likely to shut down.

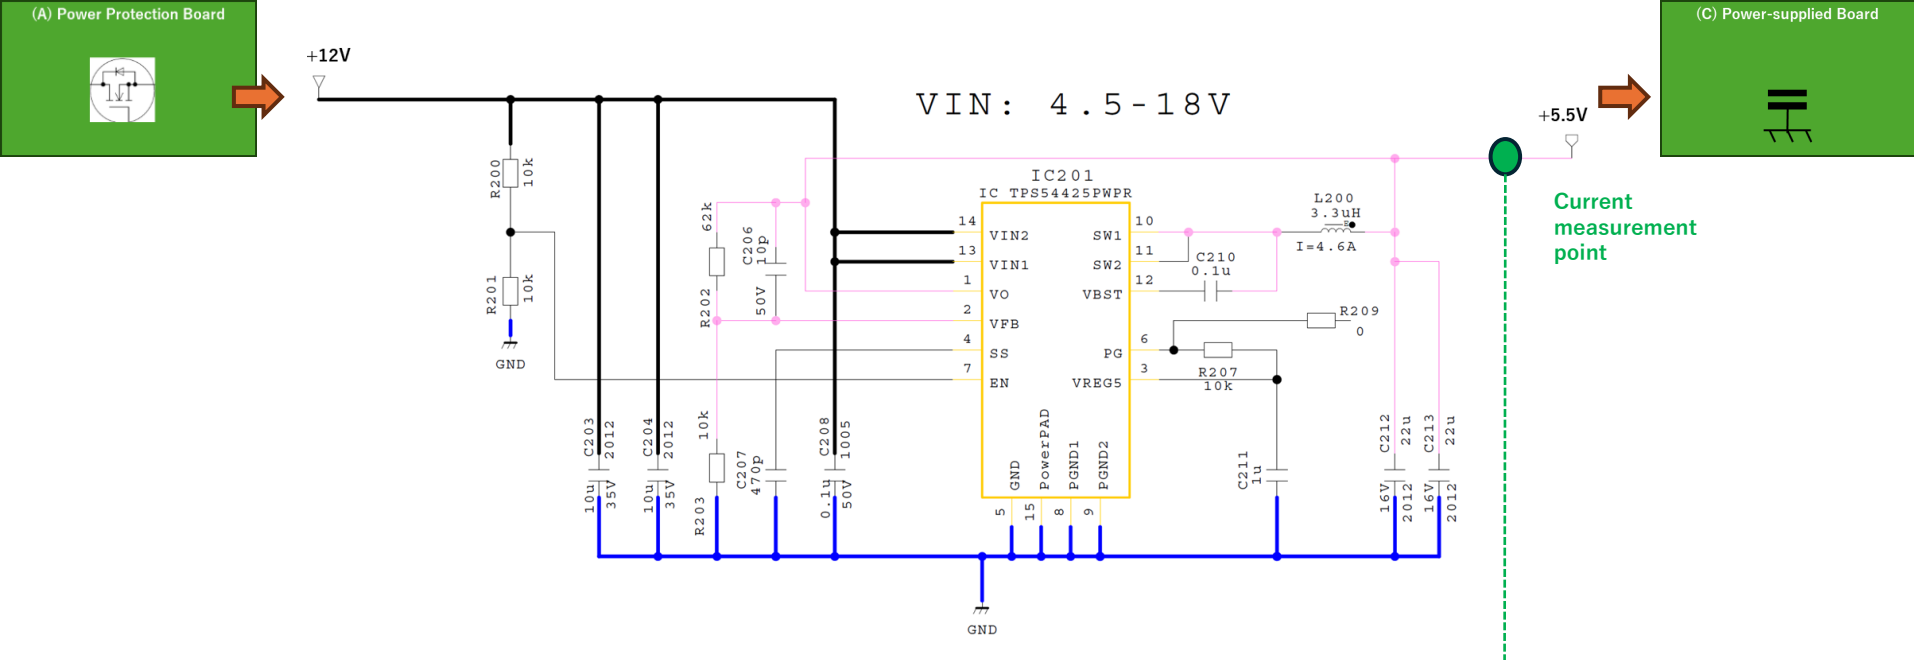
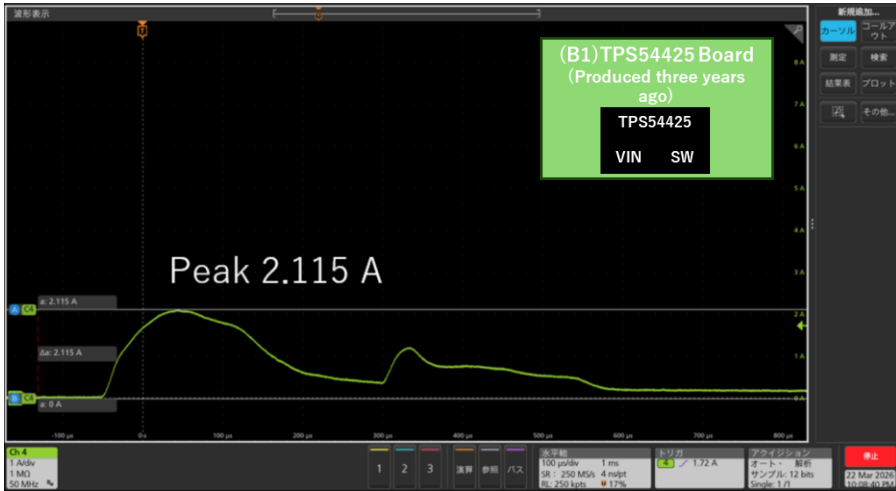
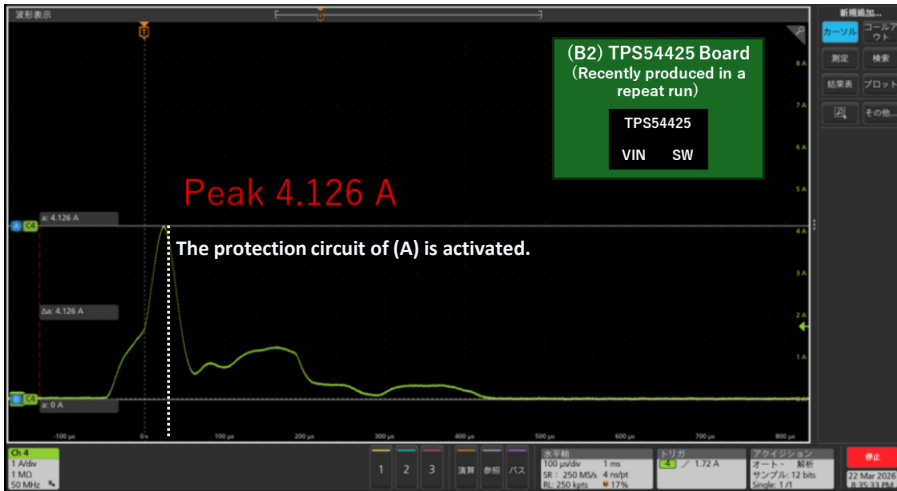
There is no branch in the power line.
