FAILURE ANALYSIS REPORT 2020

FBP-1164: S2 Battery

Permanent Fault Issue

Board S/N: 1808P4113650474

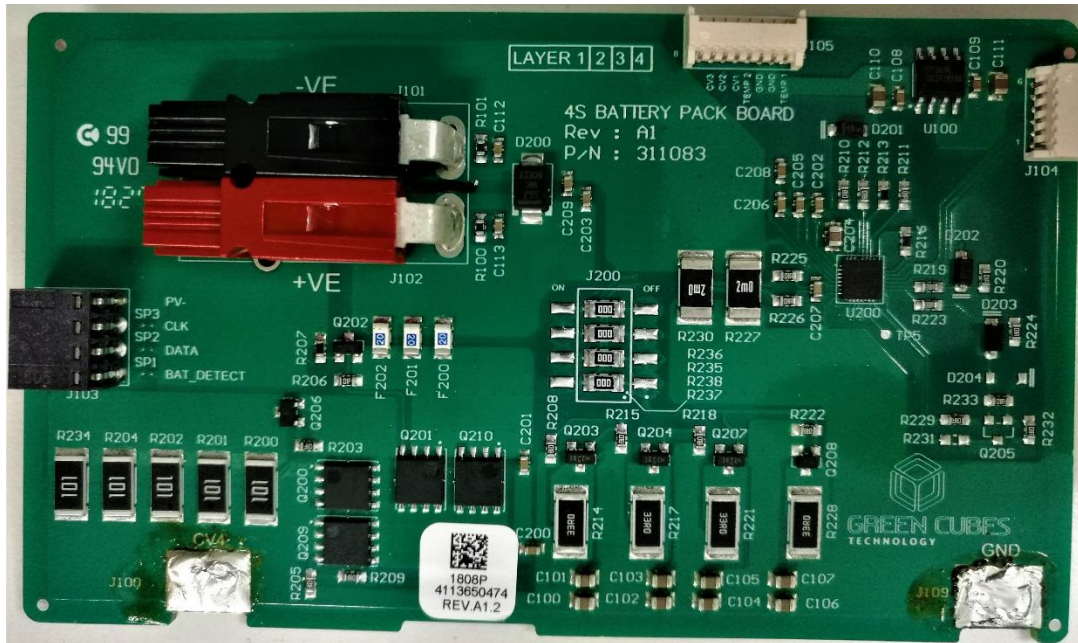
○ Battery Board Top View

Check List	1808P4113650474
Component Removed	NO
Bad Soldering	NO
Component Burned/ Burned Mark	NO
Scratches on board	NO
Pad lifted on PCB footprint	NO
Board Damaged	NO

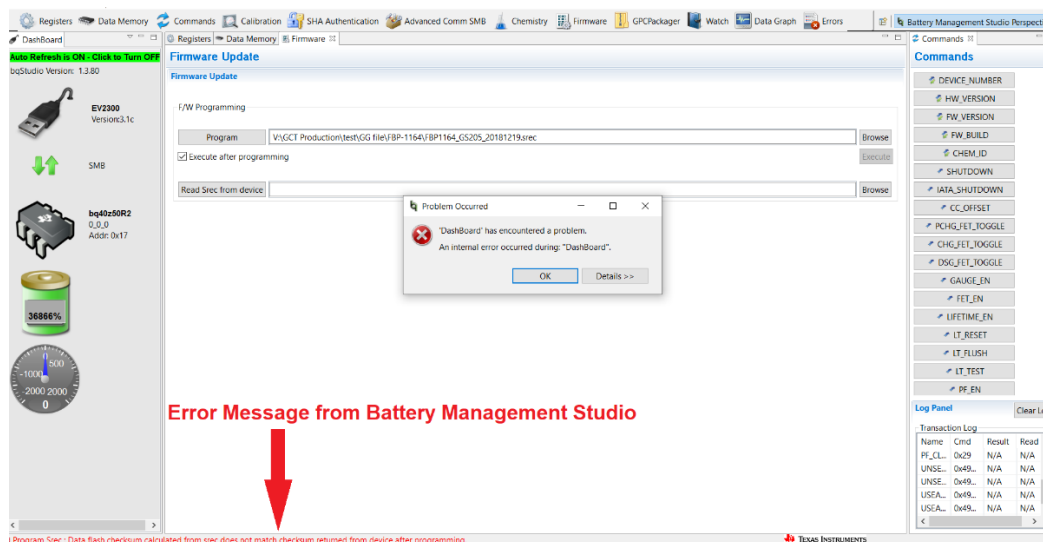
- In addition, re-program GG file into the BQ IC is fail and return error “Data flash checksum from srec does not match checksum returned from device after programming”
- Highly suspected BQ flash memory is corrupted or damaged.

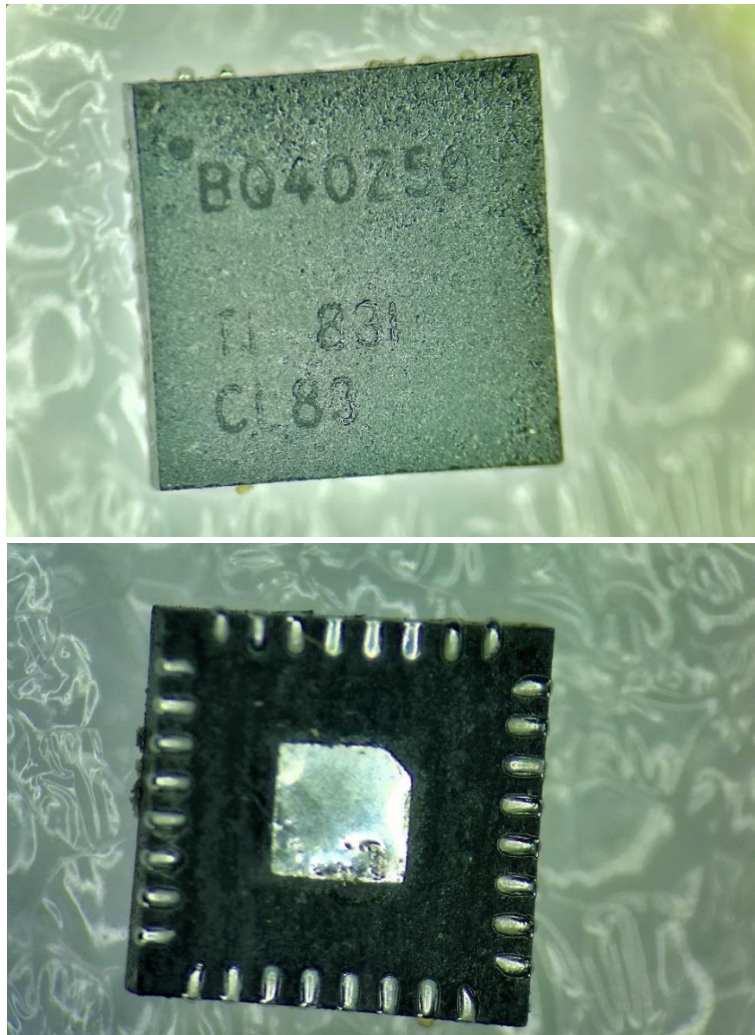
4. Visual Check under microscope

- No physical damaged or burnt mark found on the BQ IC body on top as well as bottom.
- Besides that, no pin is found shorted or damaged.
