I have removed the possibly damaged IC from the PCB and made measurements between SW-GND, Vin-GND and Vout-GND. The results were as follows; SW-GND=2 Mega ohm, Vin-GND= ~500k ohm and Vout-GND=Short. I replaced the IC with new TPS61252 IC and the output of the circuit was 5.08V as expected and everything was working ok.

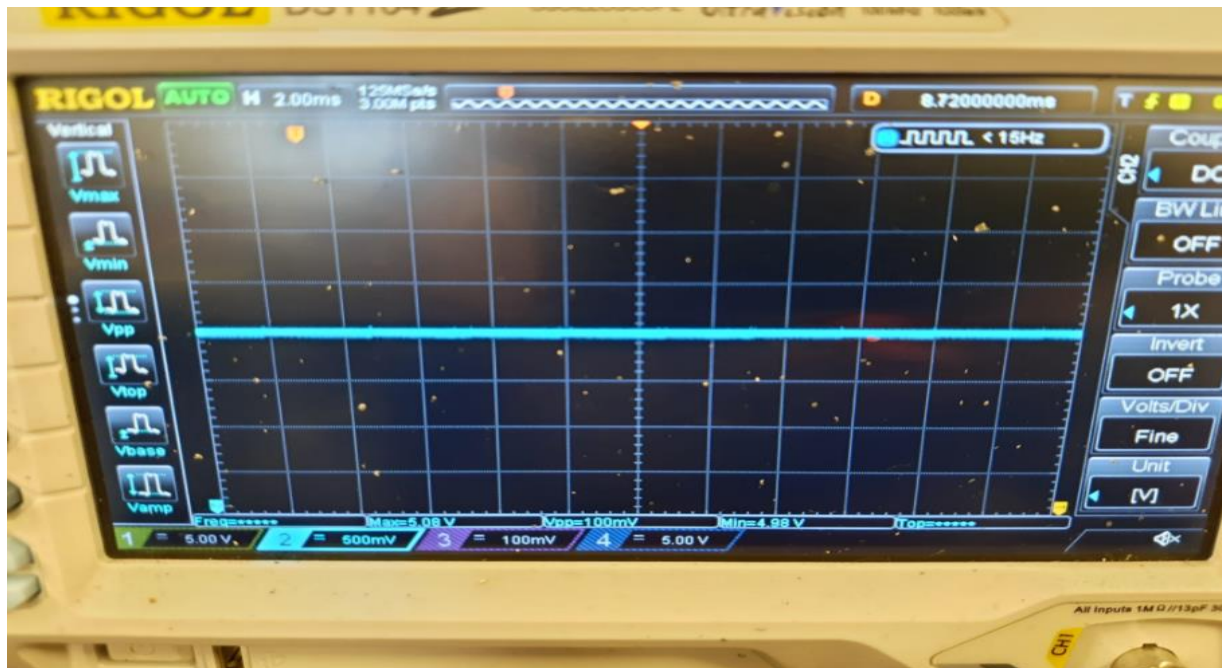
Figure 1: 5V output when motors are not connected. Vpp of ripple was 100mV, Vmax 5.08V and Vmin=4.98V

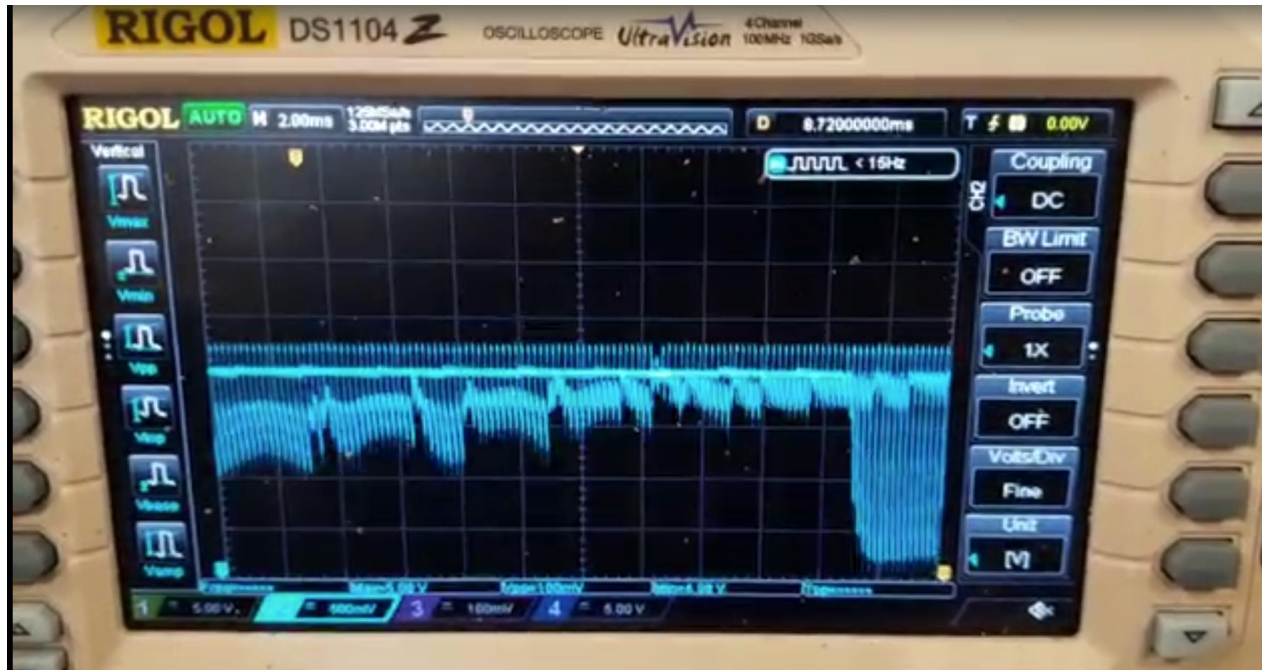
Figure 2: Waveform captured during first startup of the PCB with two motors connected

What I saw is when PCB is first started and motors are connected, (or during transitions) the voltage drop occurs, the 5V line drops to around 4.7V for very small amount of time then jumps to normal level (around 5V).

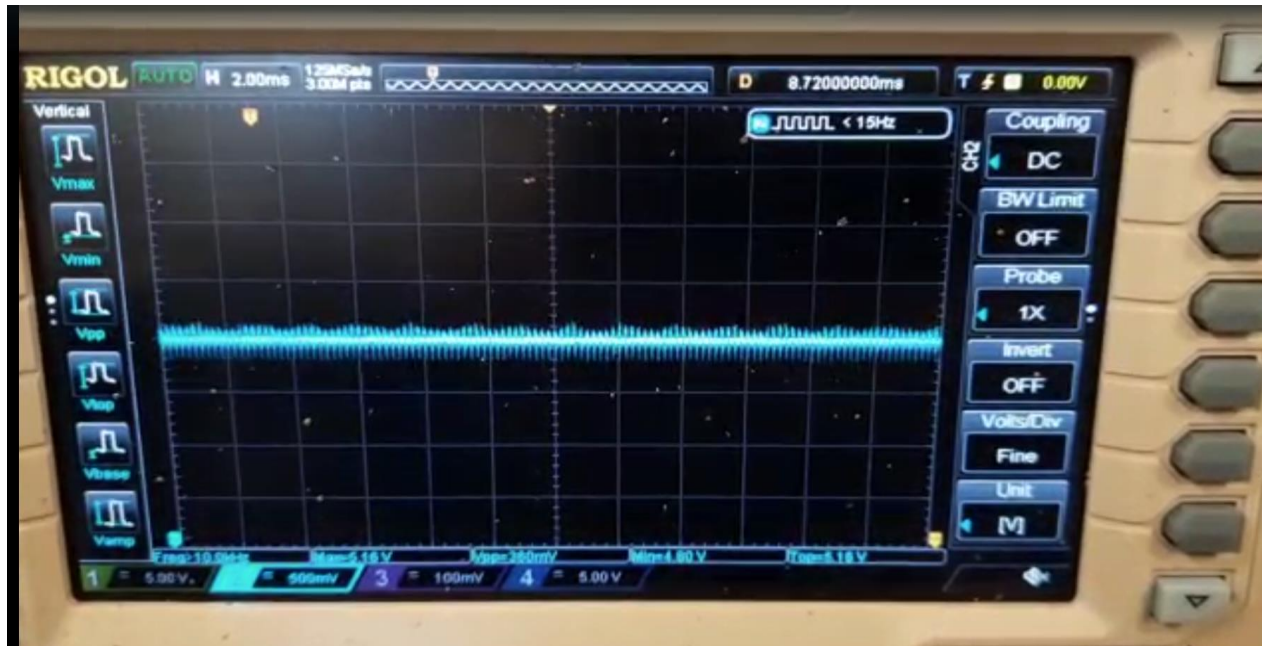
Figure 3: 5V output during go forward command. Both motors are working (at 80% of full speed). Vpp of ripple = 360mV, Vmin = 4.80V and Vmax=5.16V

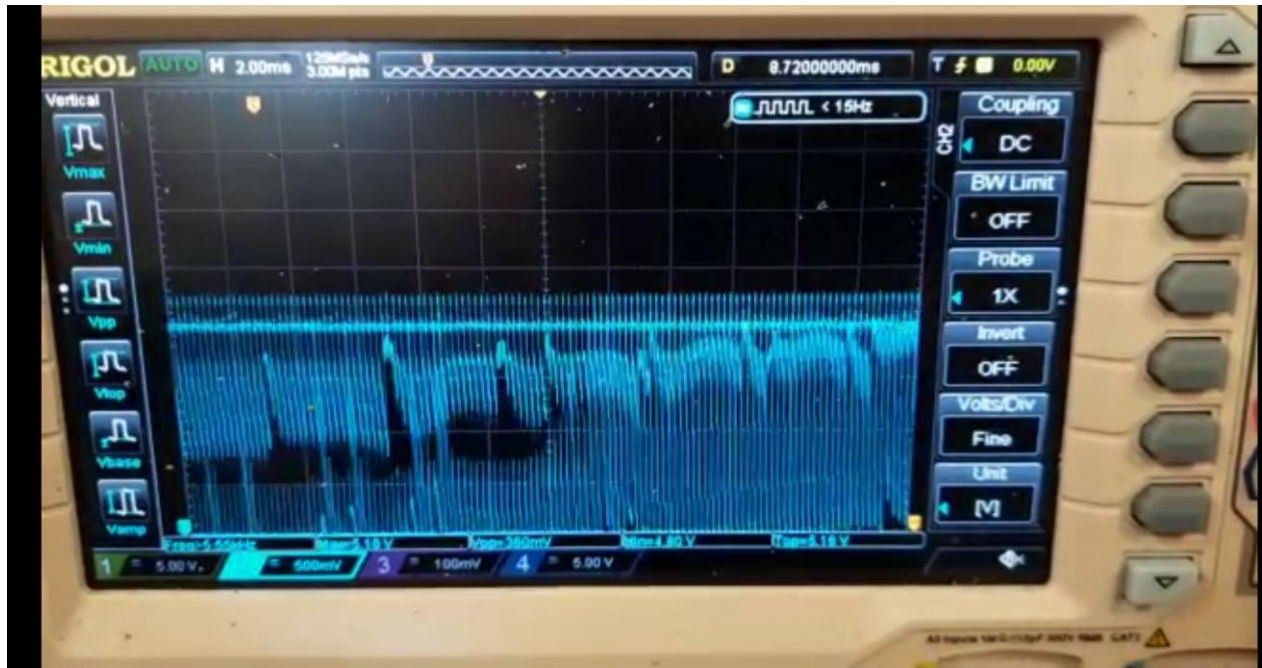
Figure 4: Waveform captured during transition from go forward to go right command.

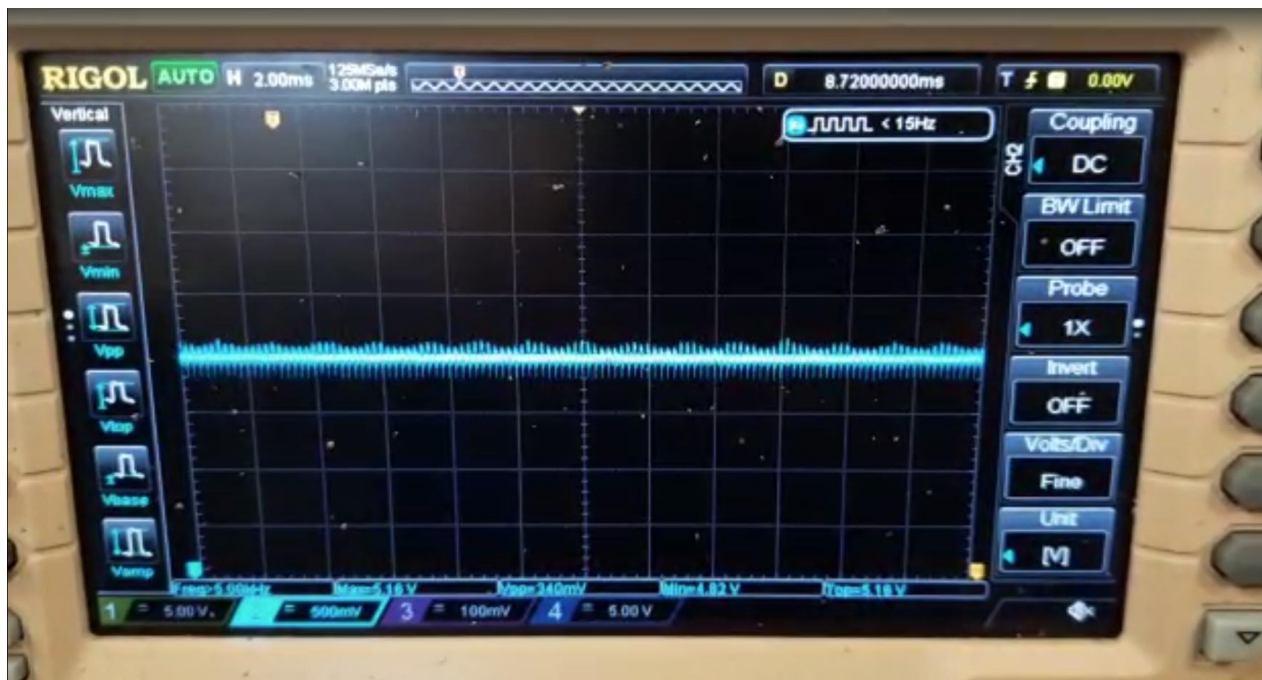
Figure 5: Waveform captured during go right command. Vpp=340mV, Vmin=4.82V and V max = 5.16V.

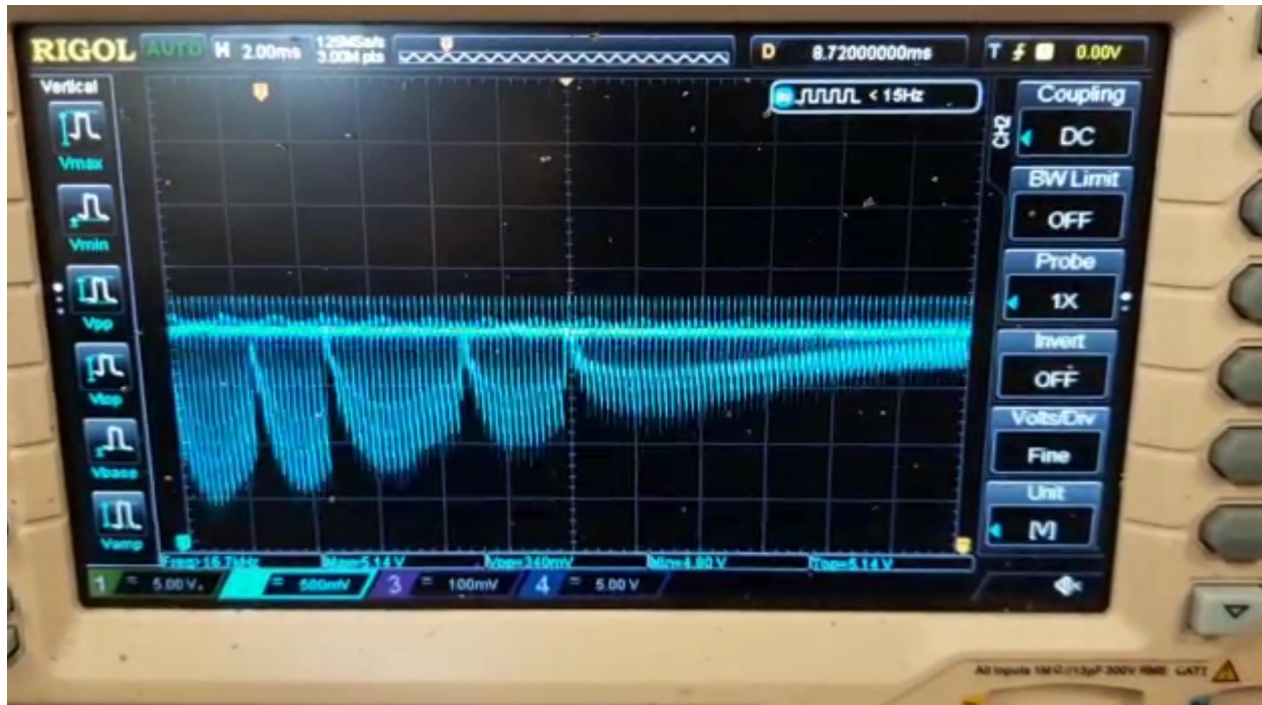
Figure 6: Waveform captured during transition from go right to go left command.

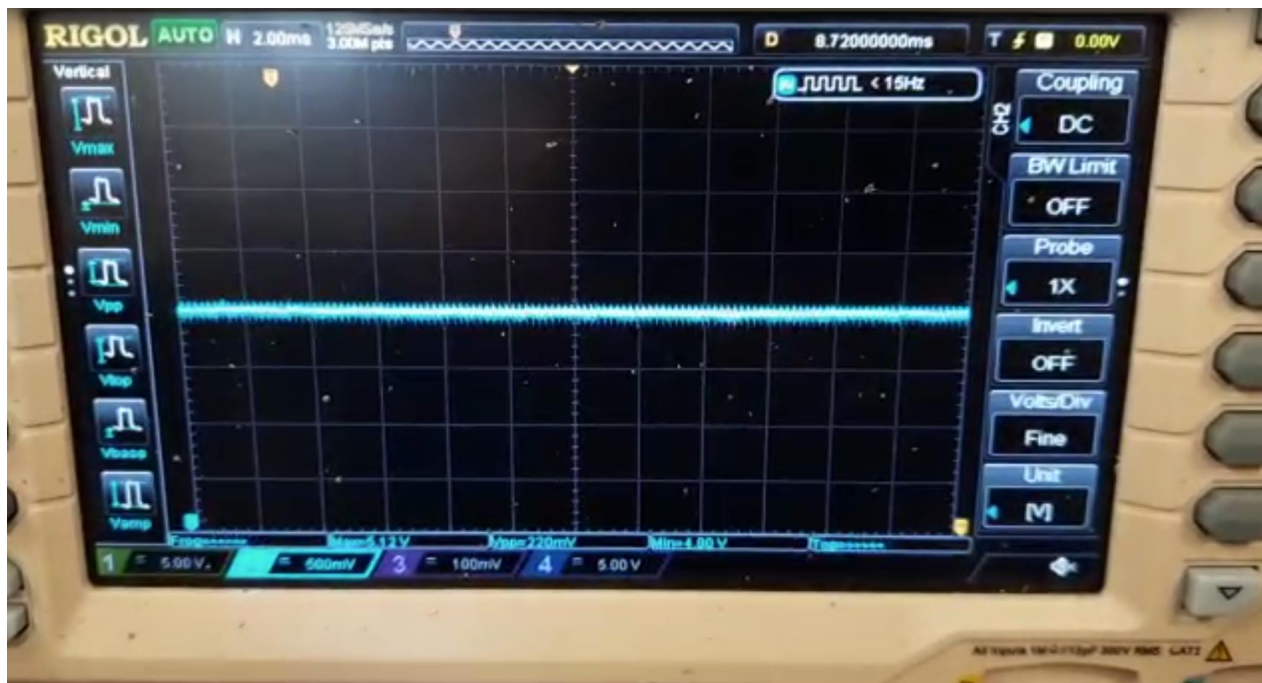
Figure 7: Waveform captured during go left command. $V_{pp}=220\text{mV}$, $V_{min}=4.9\text{V}$ and $V_{max} = 5.12\text{V}$.

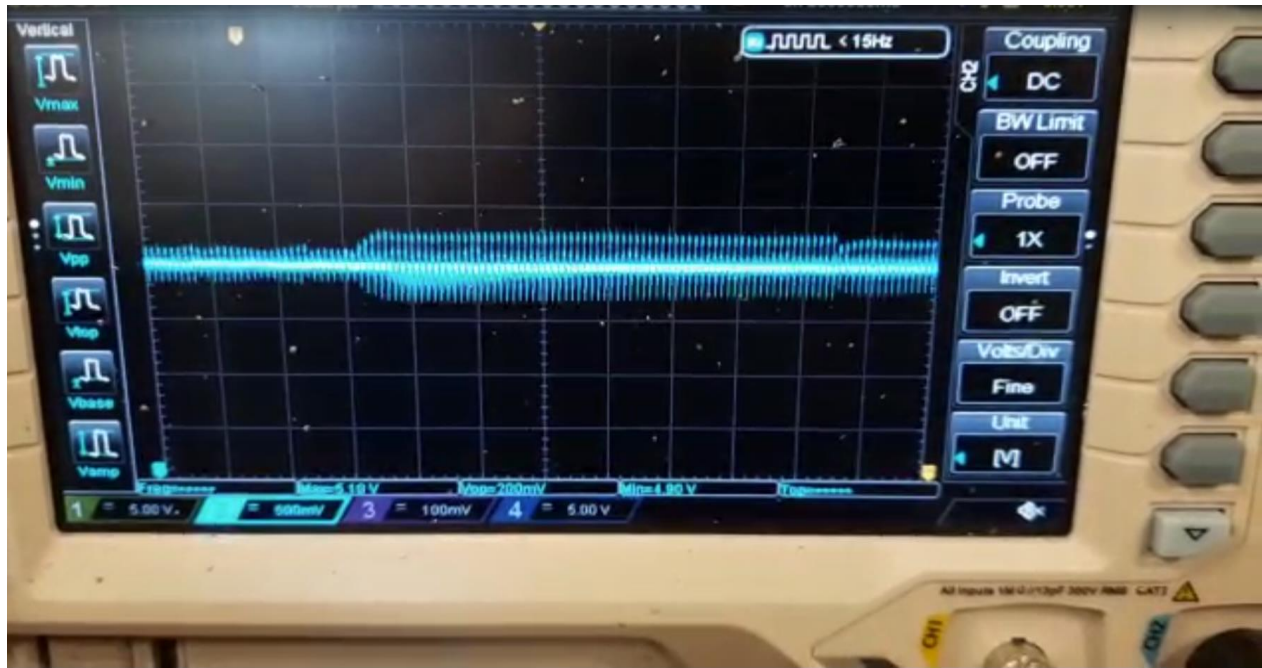
Figure 8: Transition from move left to move backward

Before transition the motor 2 was in CW direction, when move backward command comes, motor 2 changes the direction to CCW and as you mentioned, maybe the charging occurs as in the above picture.

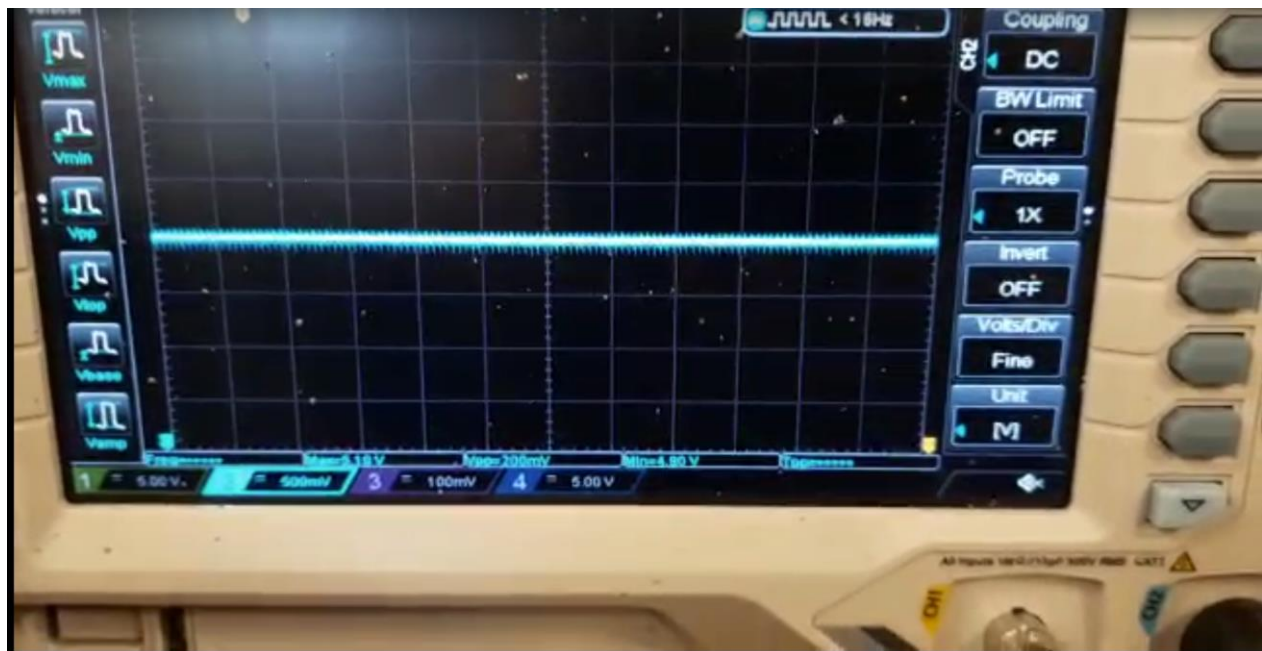
Figure 9: Waveform during move backward command, both motors are on; $V_{max} = 5.1V$, V_{pp} of ripple = $0.2V$ and $V_{min} = 4.9V$

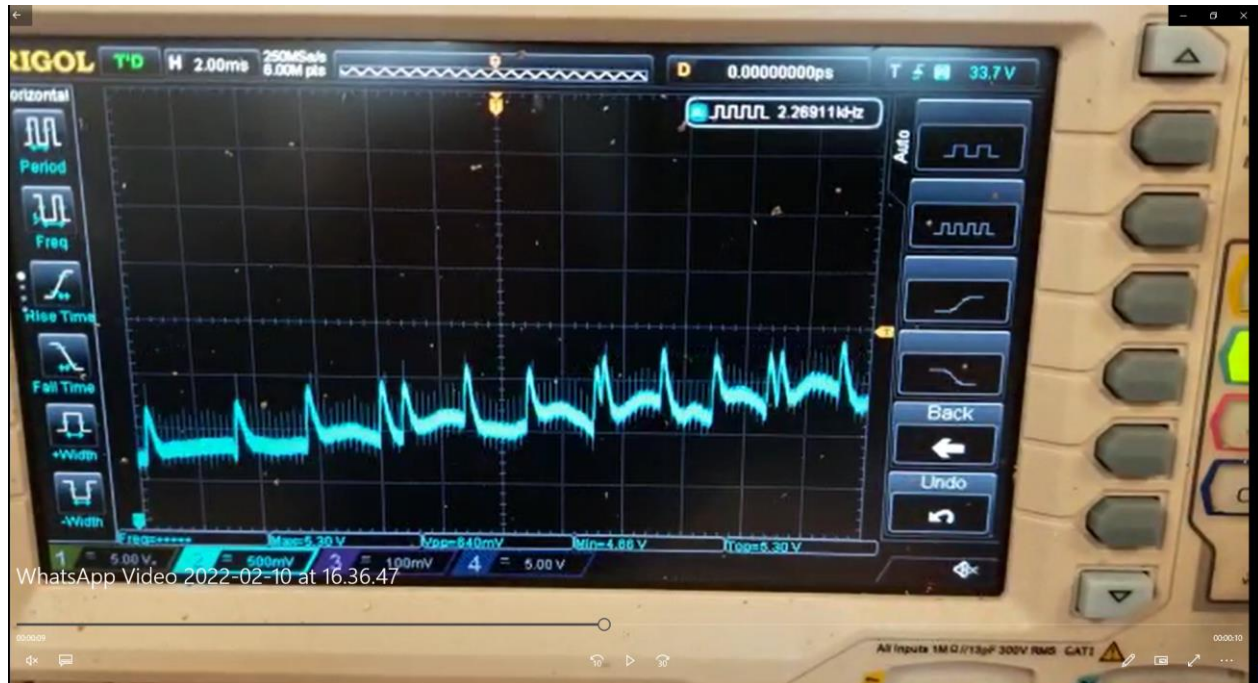
Figure 10: Waveform during transition from move forward to move backward. $V_{max}=5.3$ $V_{min}=2.92V$ (although the screen shows around 4.7V, The 2.92 V appears for very short time)

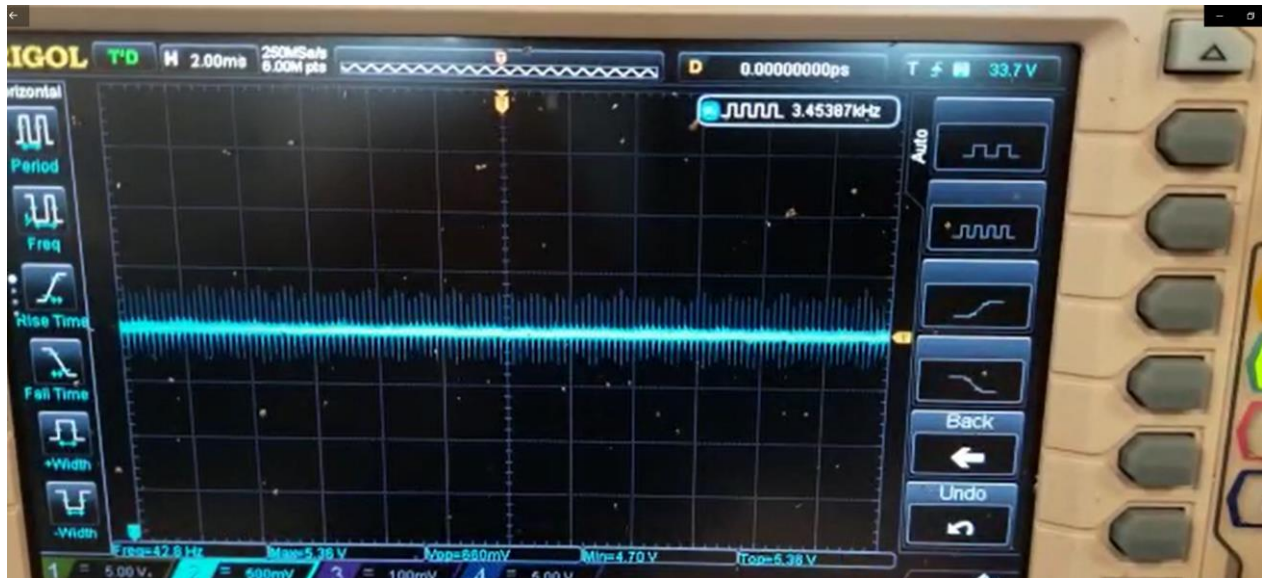
After transition, the 5V line becomes somehow stable, with $V_{max}=5.3$, $V_{min}=4.7$ and V_{pp} of ripple = $\sim 700mV$.

Figure 11: Waveform captured on 5V line, (normal operation move backward or move forward, both motor are on with full speed). $V_{pp}=600\text{mV}$, $V_{min}=4.7\text{V}$ and $V_{max}=5.3\text{V}$
