Errata Report - For TI

Phenomenon + Some Facts

Analysis of the Reason for Errata 1

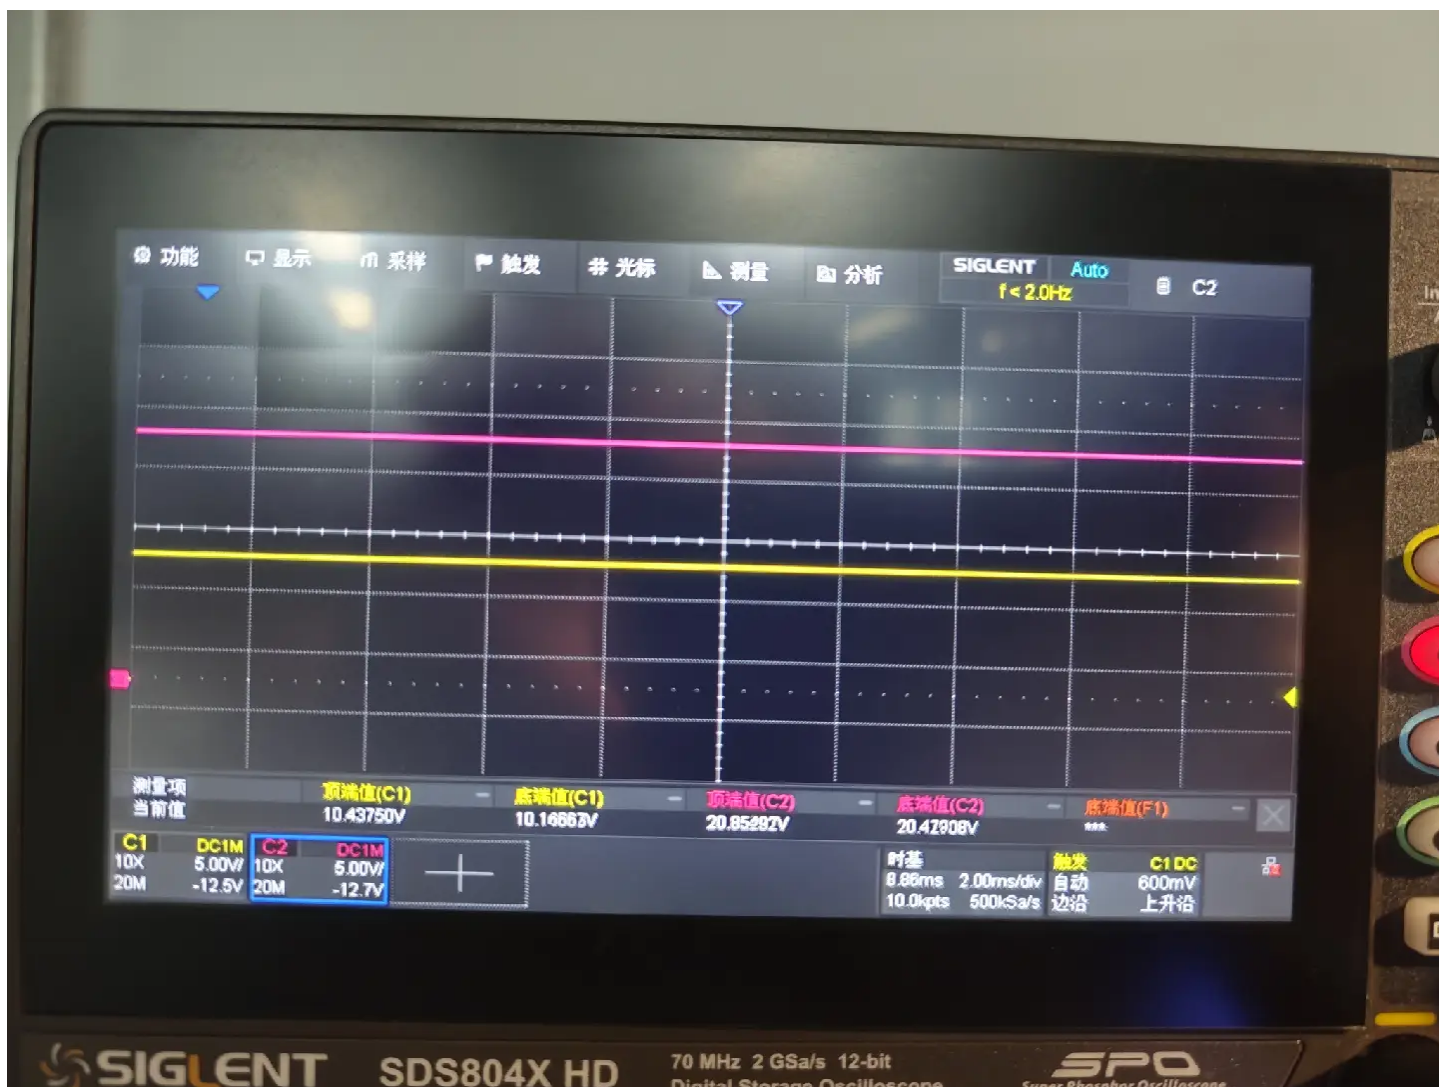
Static measurement, VC5X/BAT voltage is accurate, waveform is stable

Static DC measurement

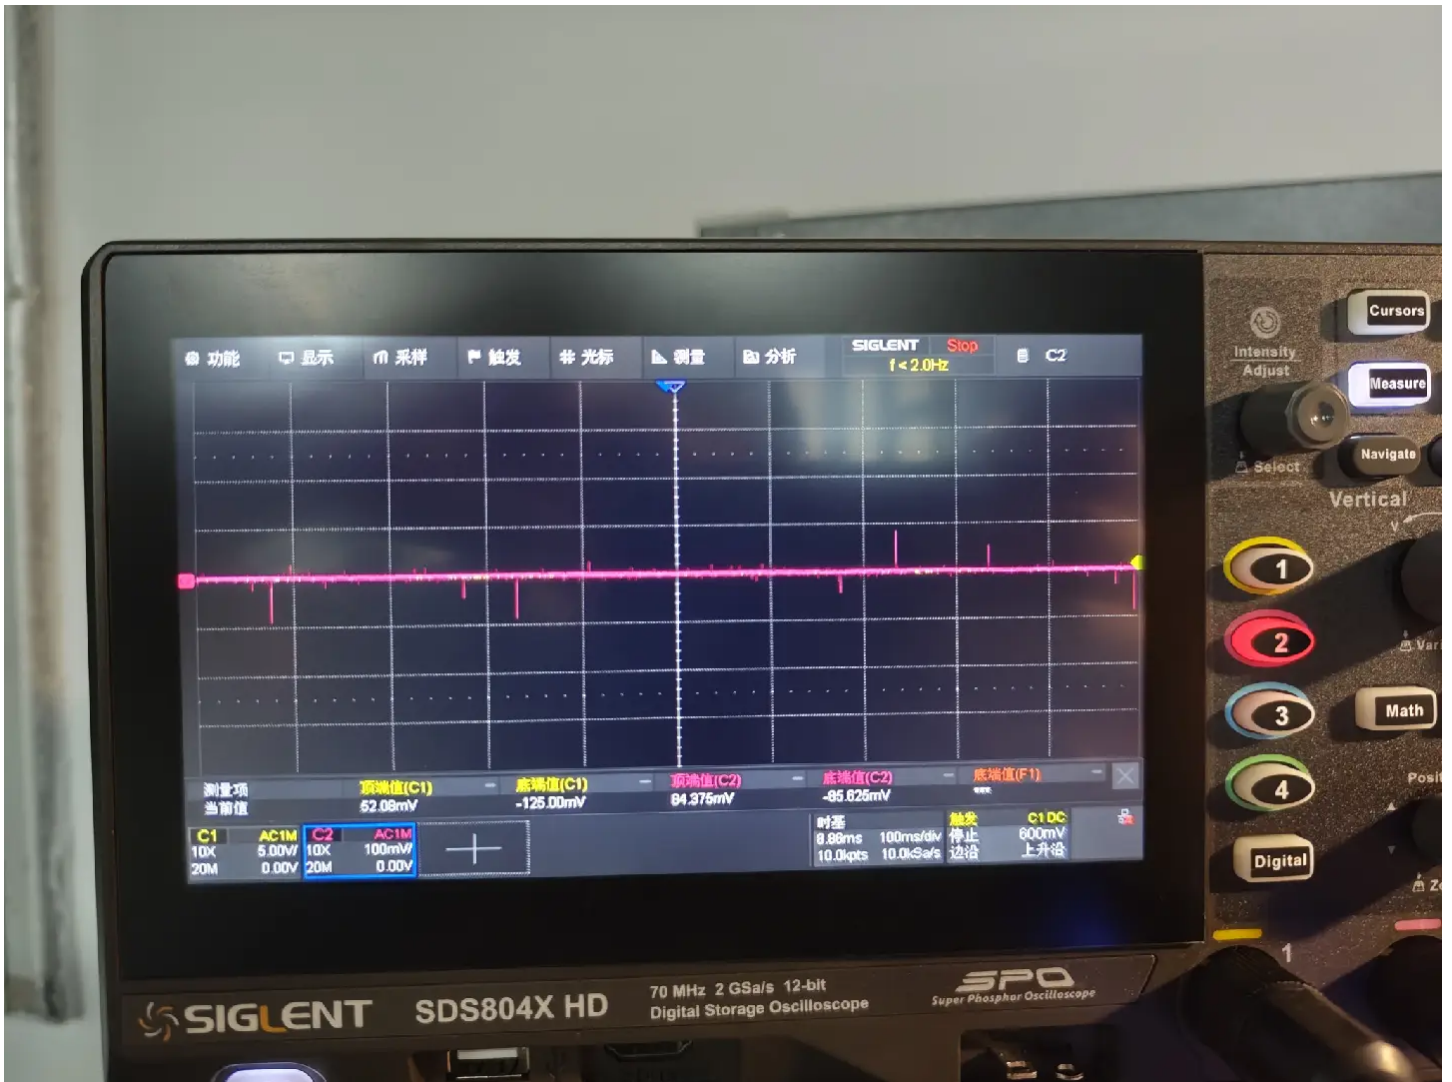
Static AC measurement

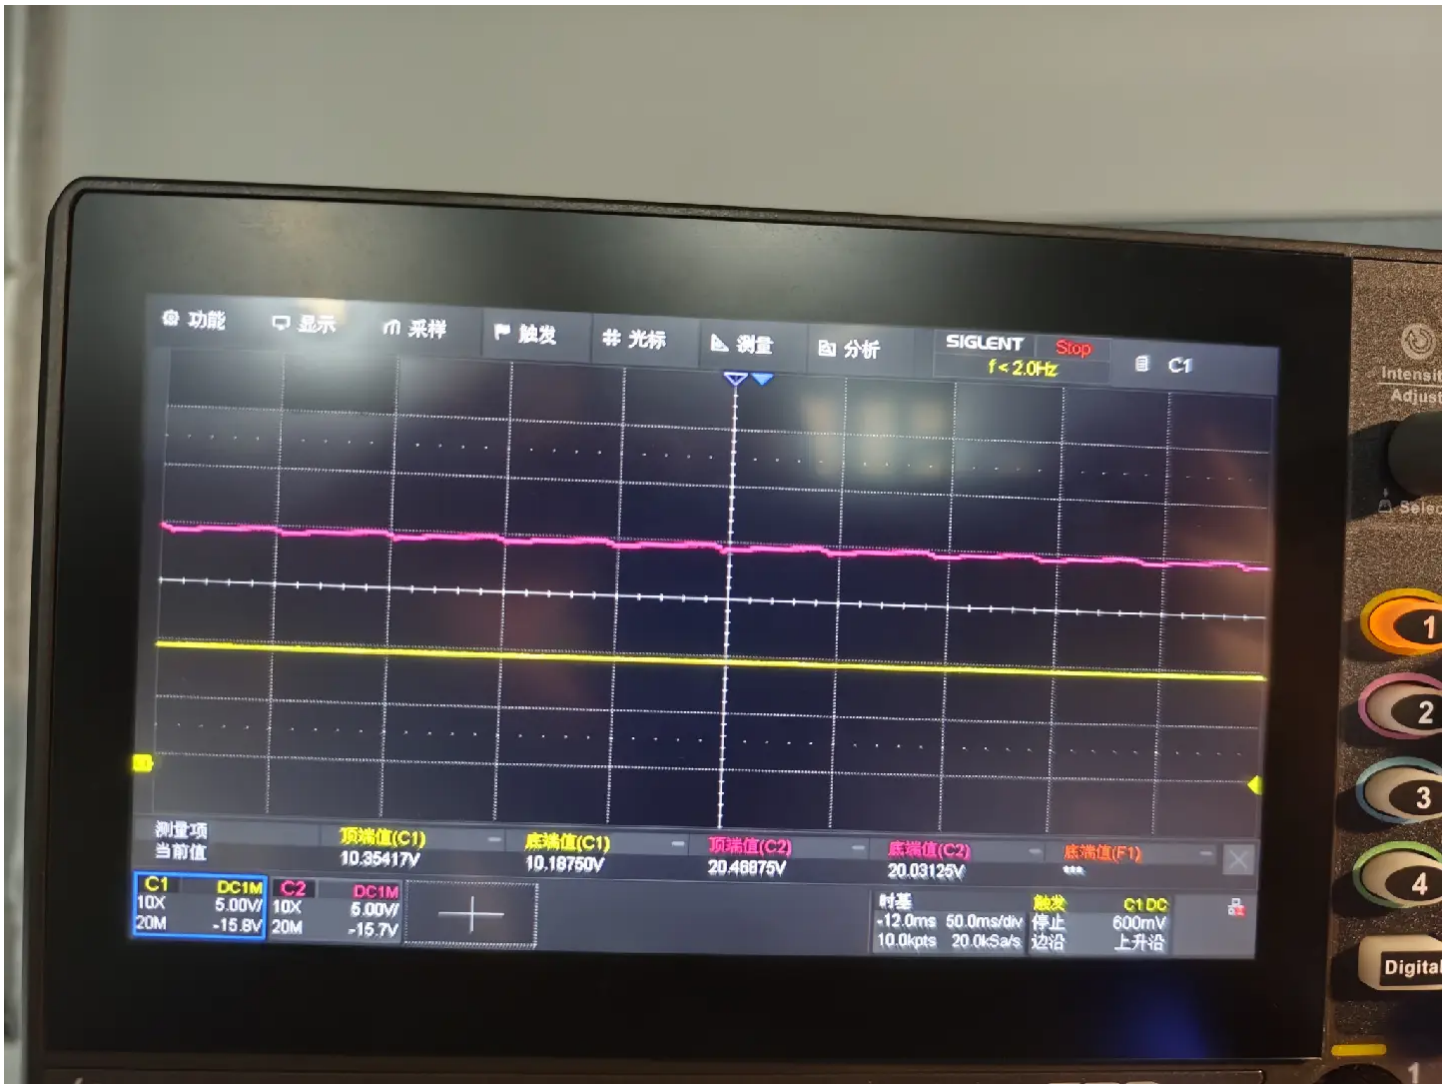
After connecting the charger and powering on, there is jitter on the BAT pin relative to ground, which disappears after a period of time. At this time, the stable voltage of BAT is slightly lower than that before power-on.

Charger connection jitter

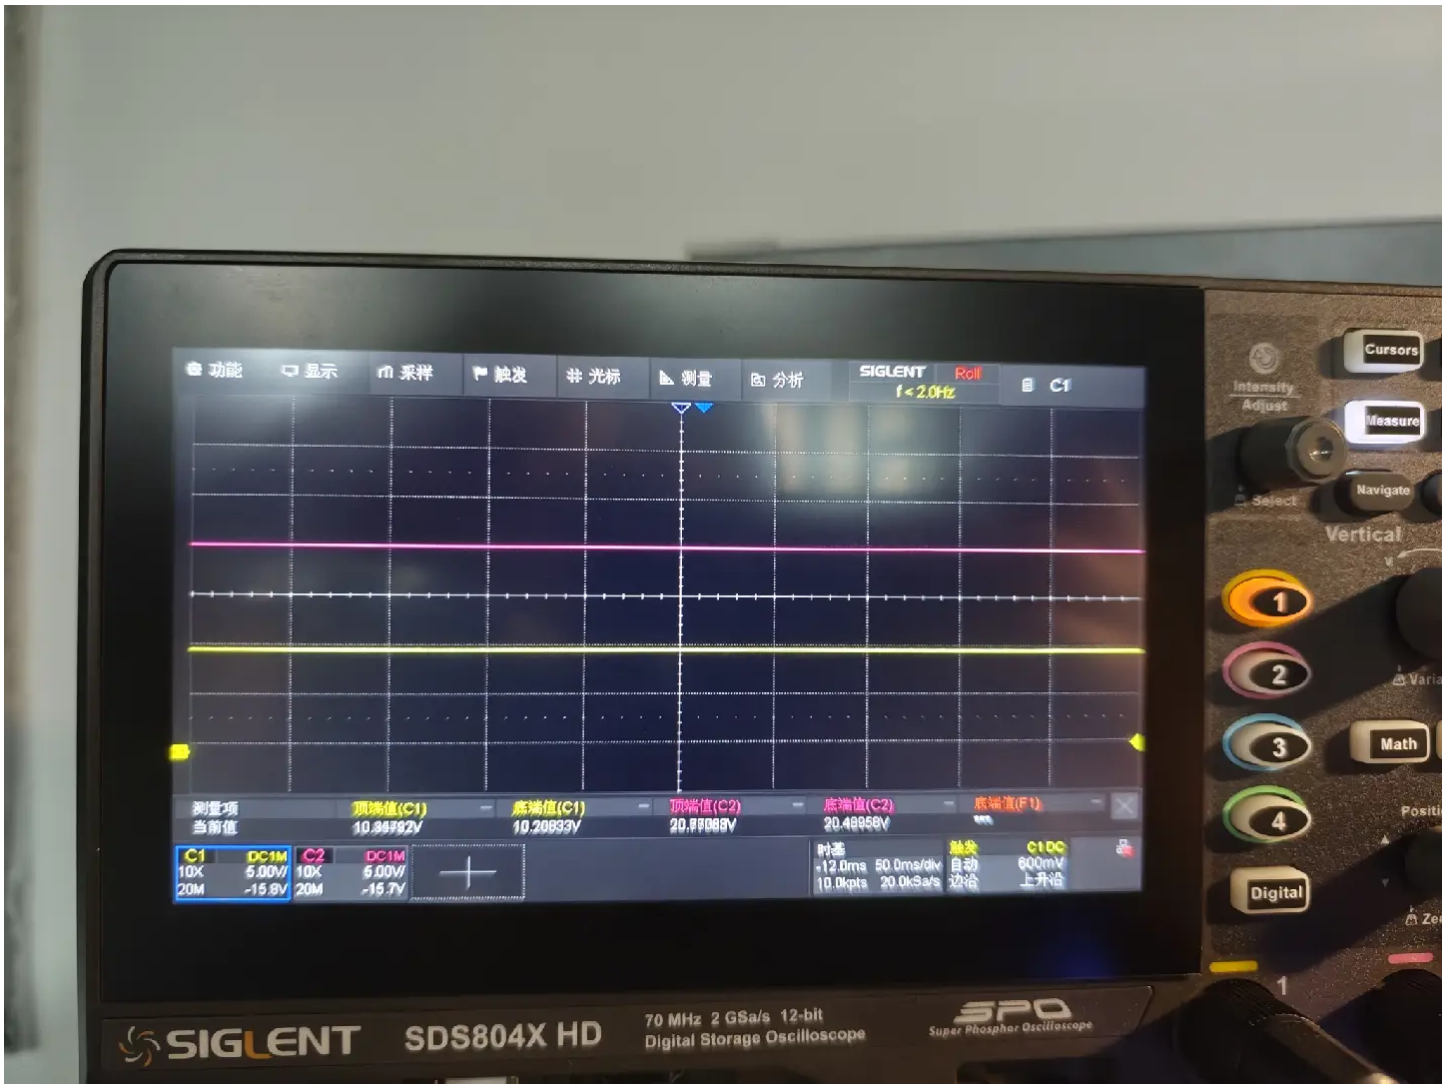
Stabilization after jitter

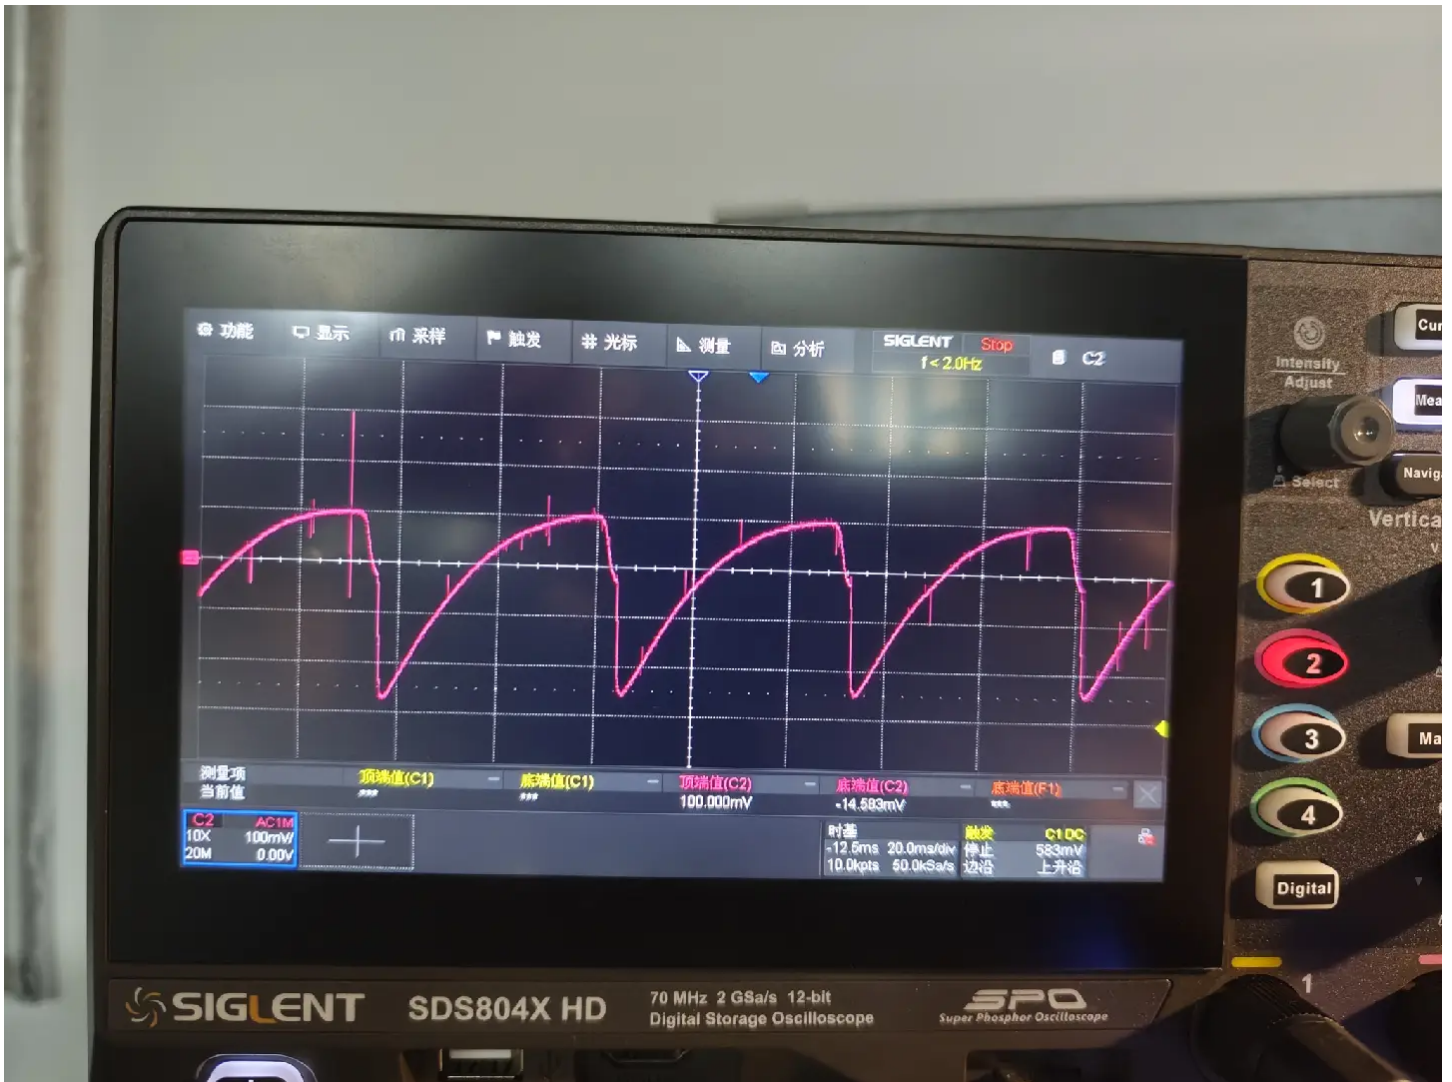
AC amplification during shaking

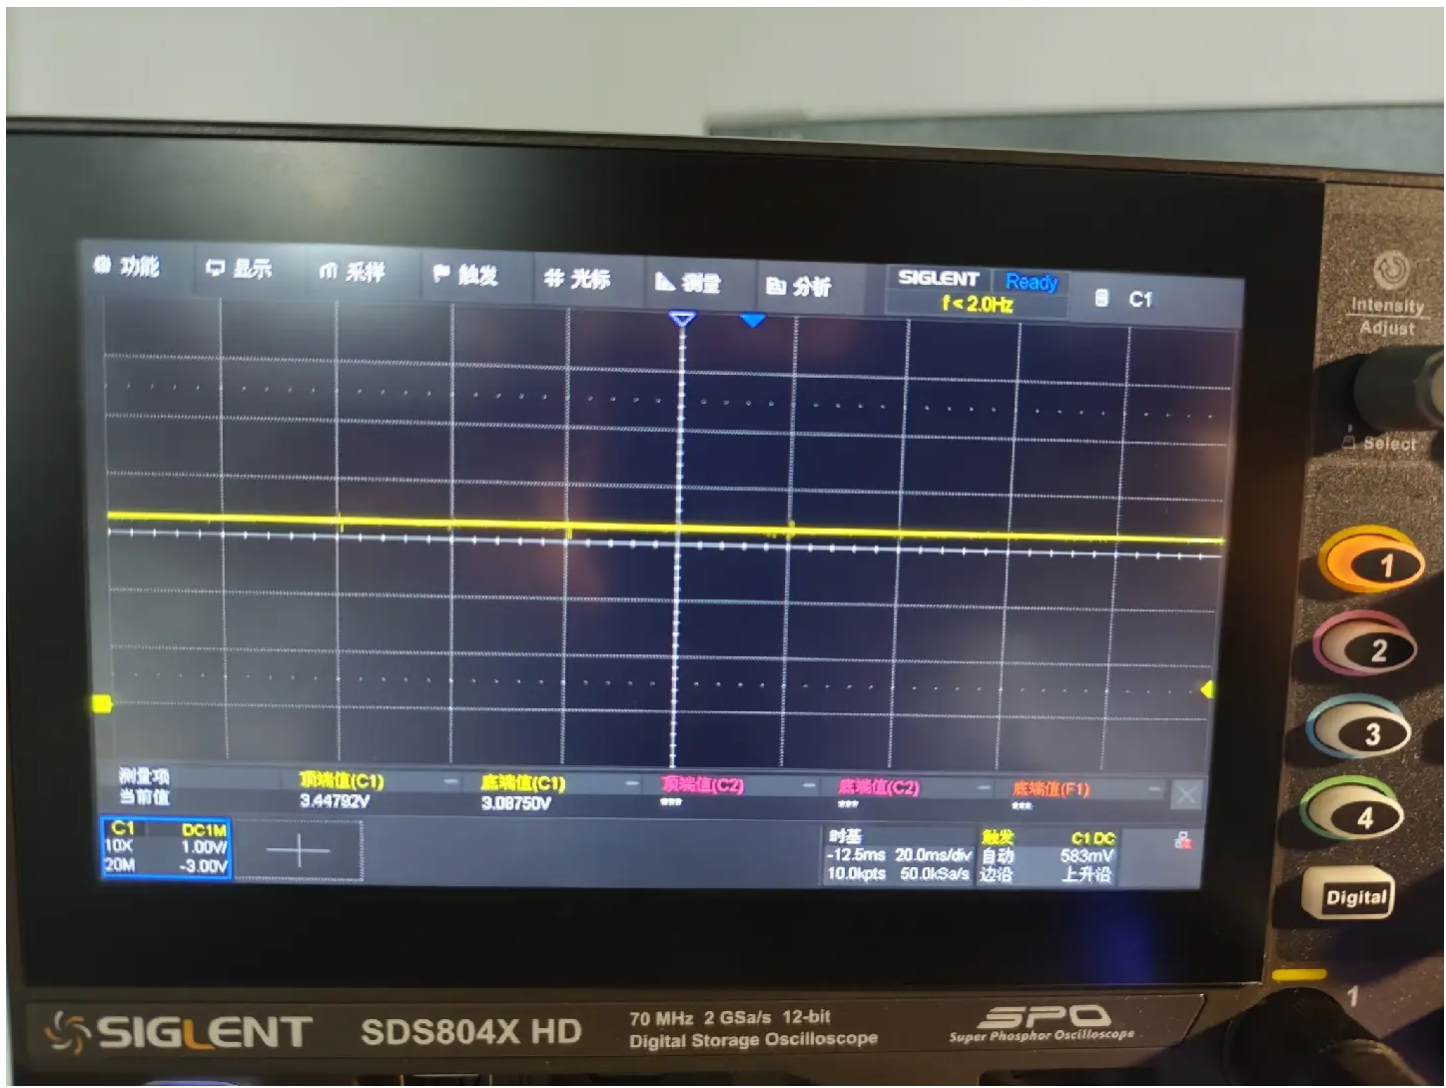
The DC stability of the CAP2 network is OK, stabilized at 3V3. The AC stability is OK after the charger is powered on.

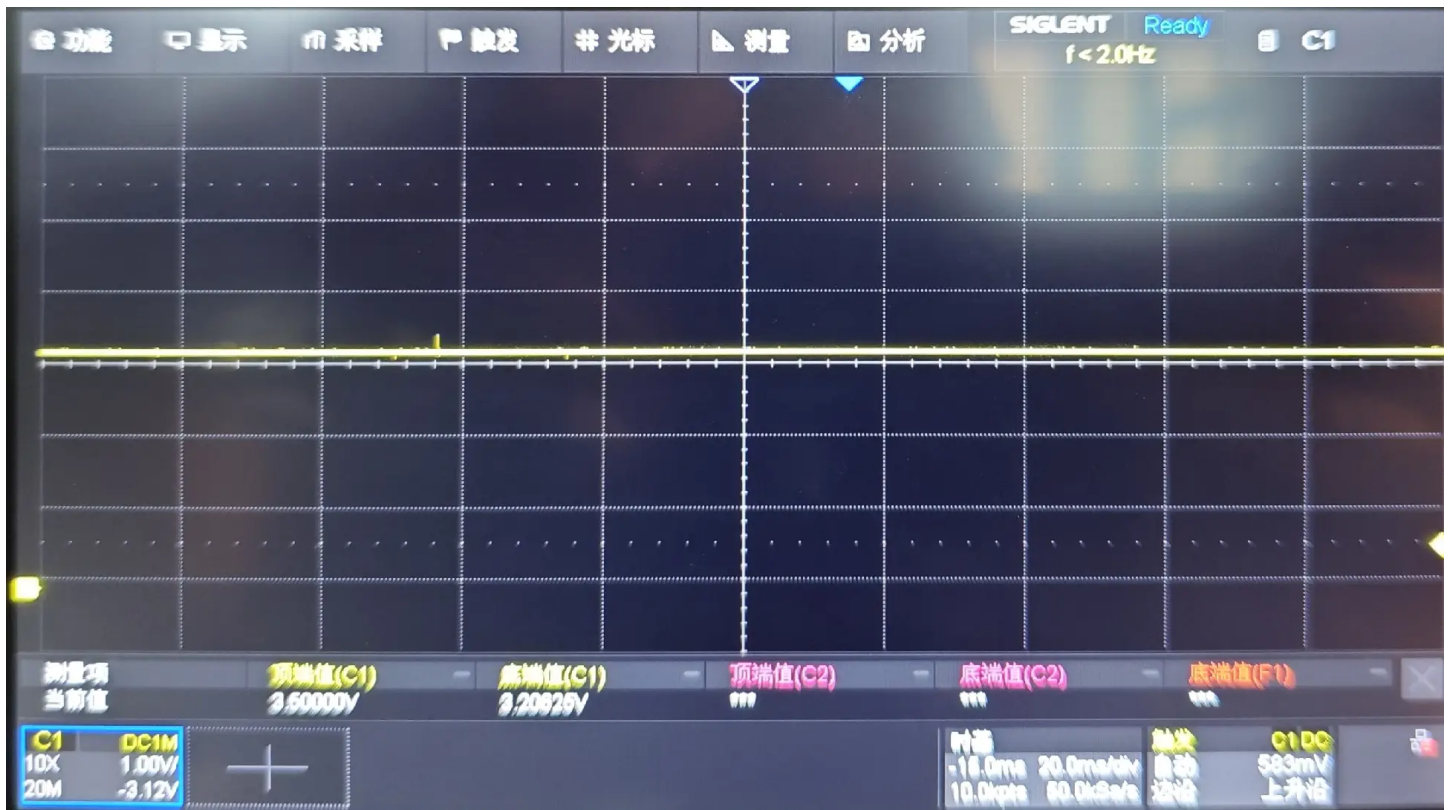
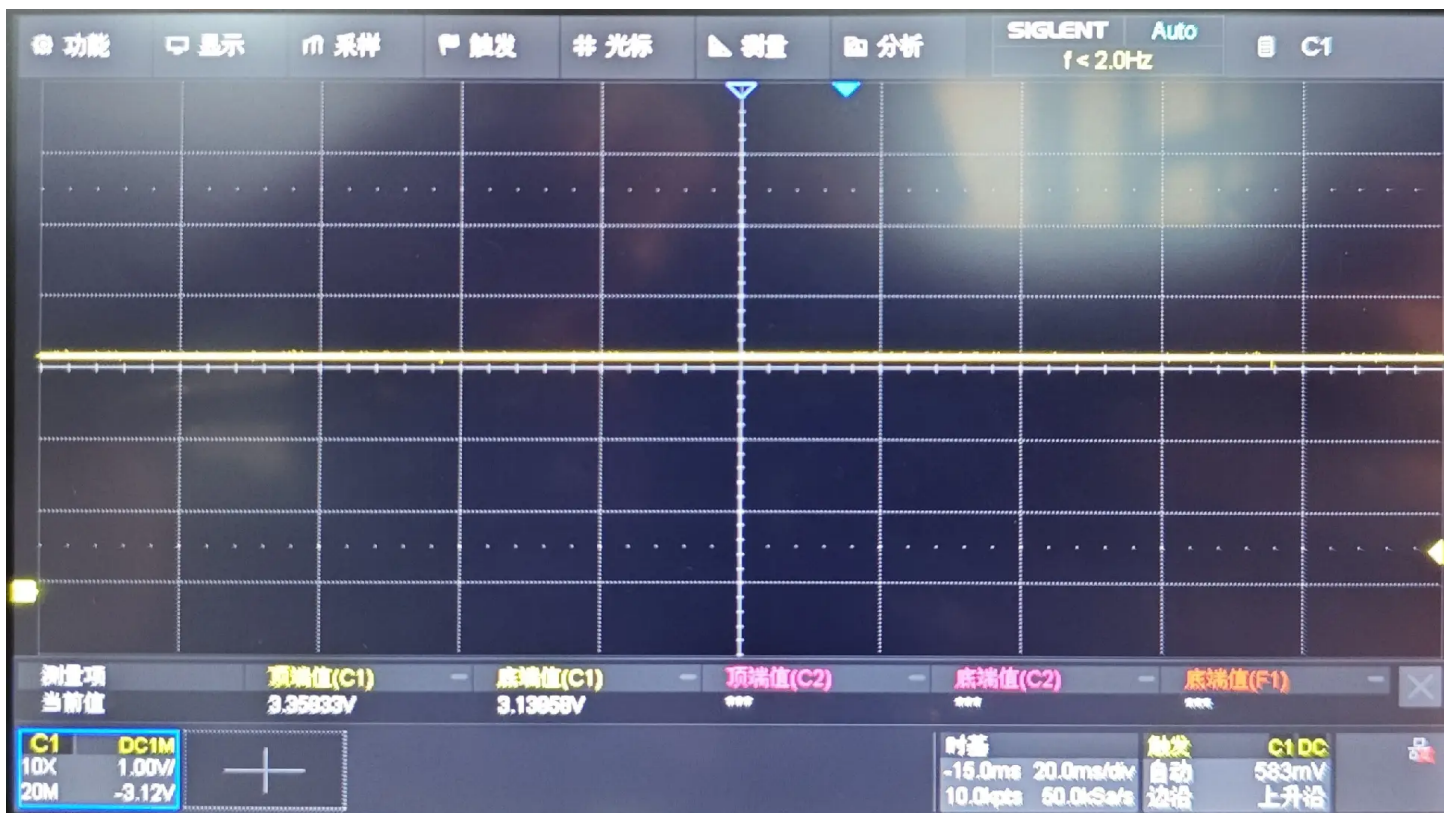
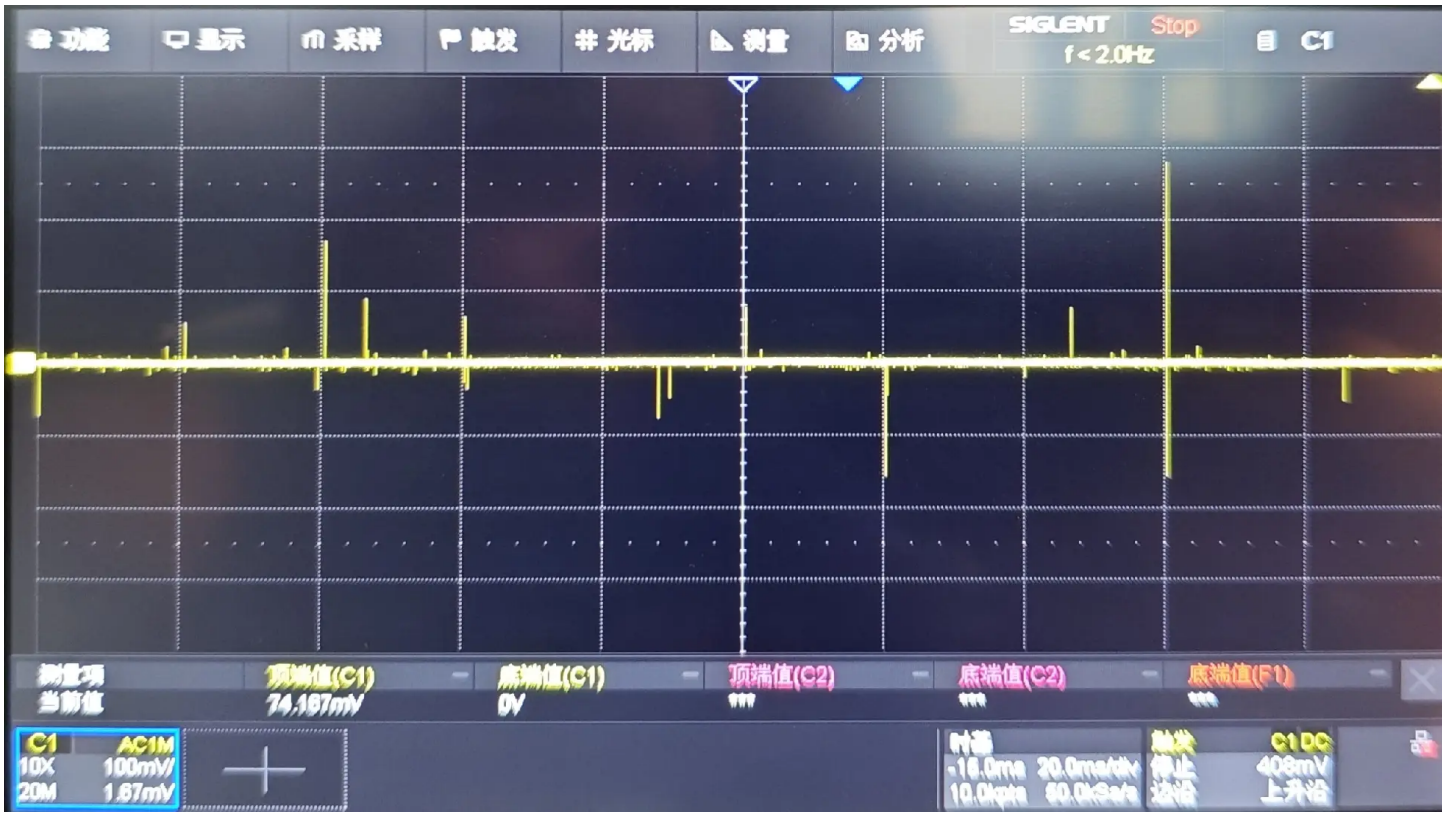
The DC stability of the CAP1 network is OK, remaining stable at 3V3. After the charger is powered on, there are small spikes in AC stability, and these small spikes do not disappear after the charger is removed.

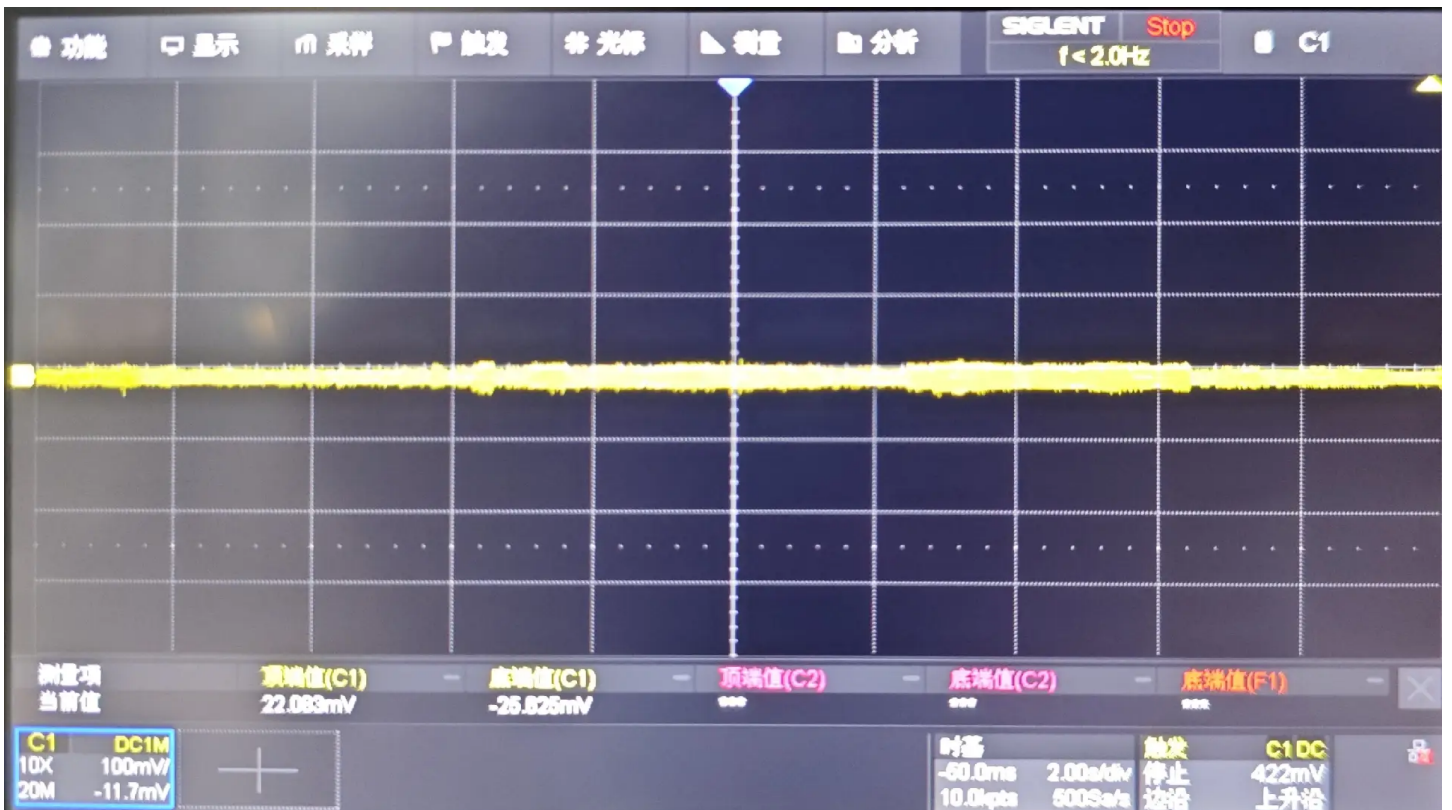
TS1 static long-term voltage waveform

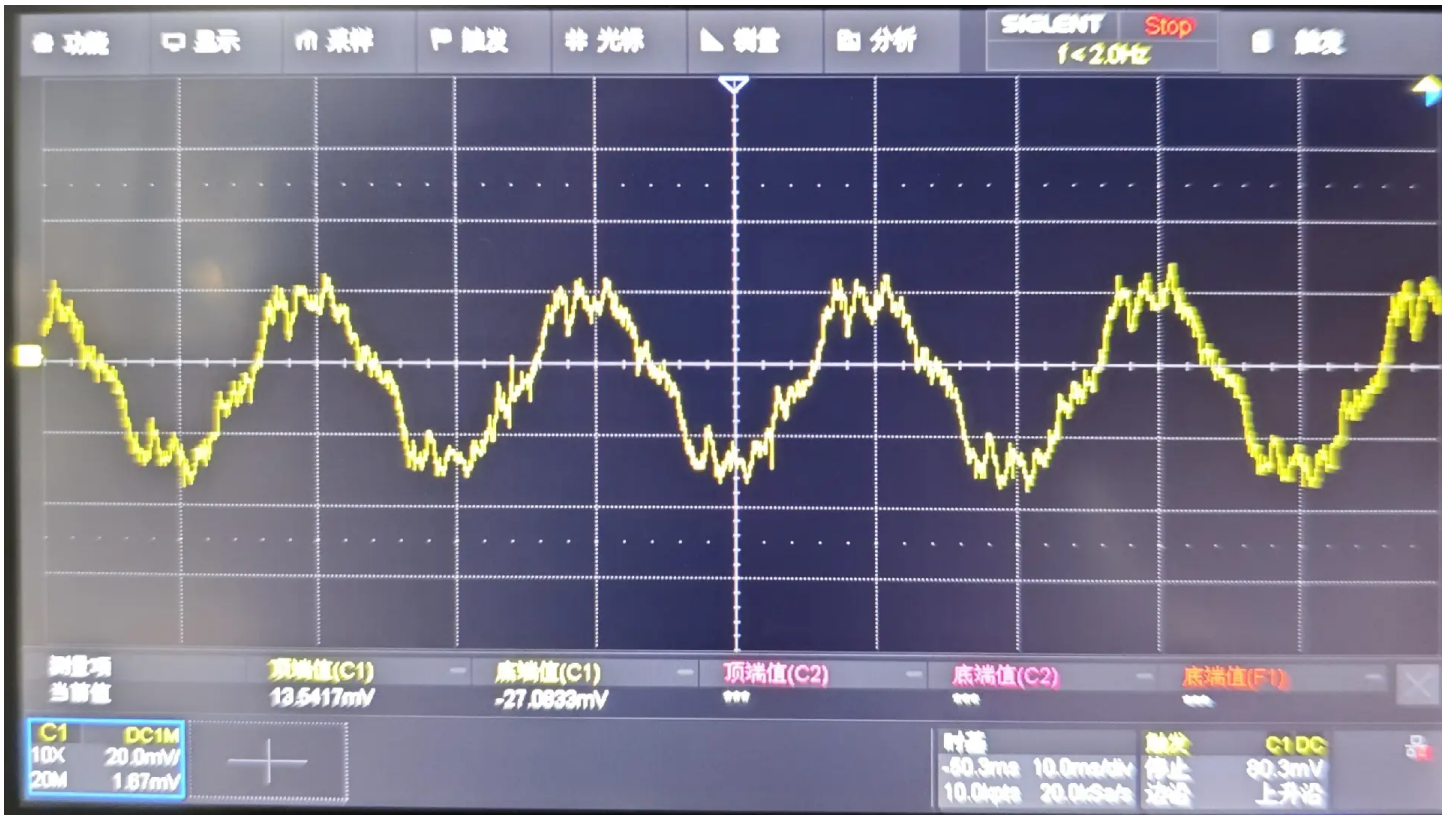
T1 static AC waveform, triangular wave frequency amplitude constant

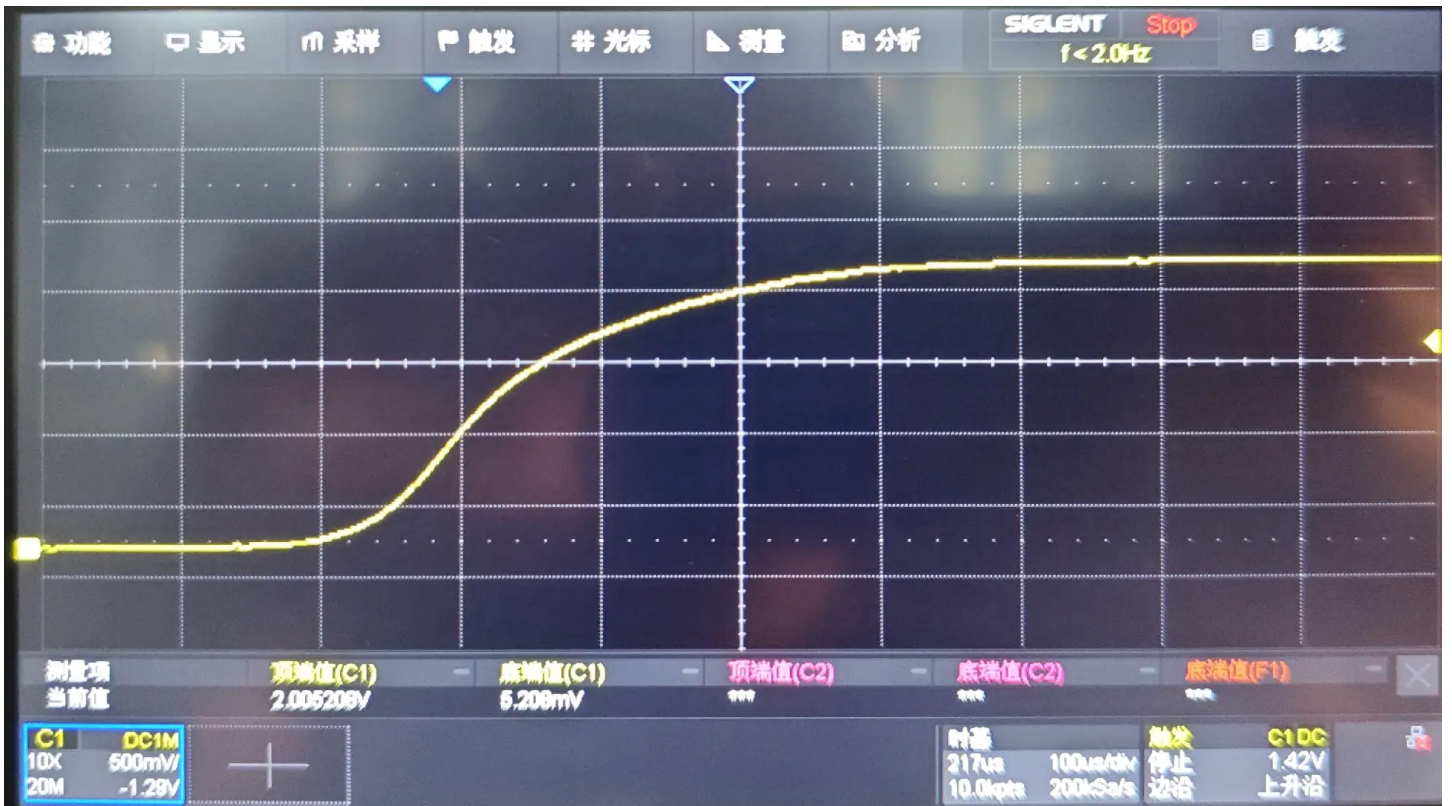
Charger output instant TS1 rising edge

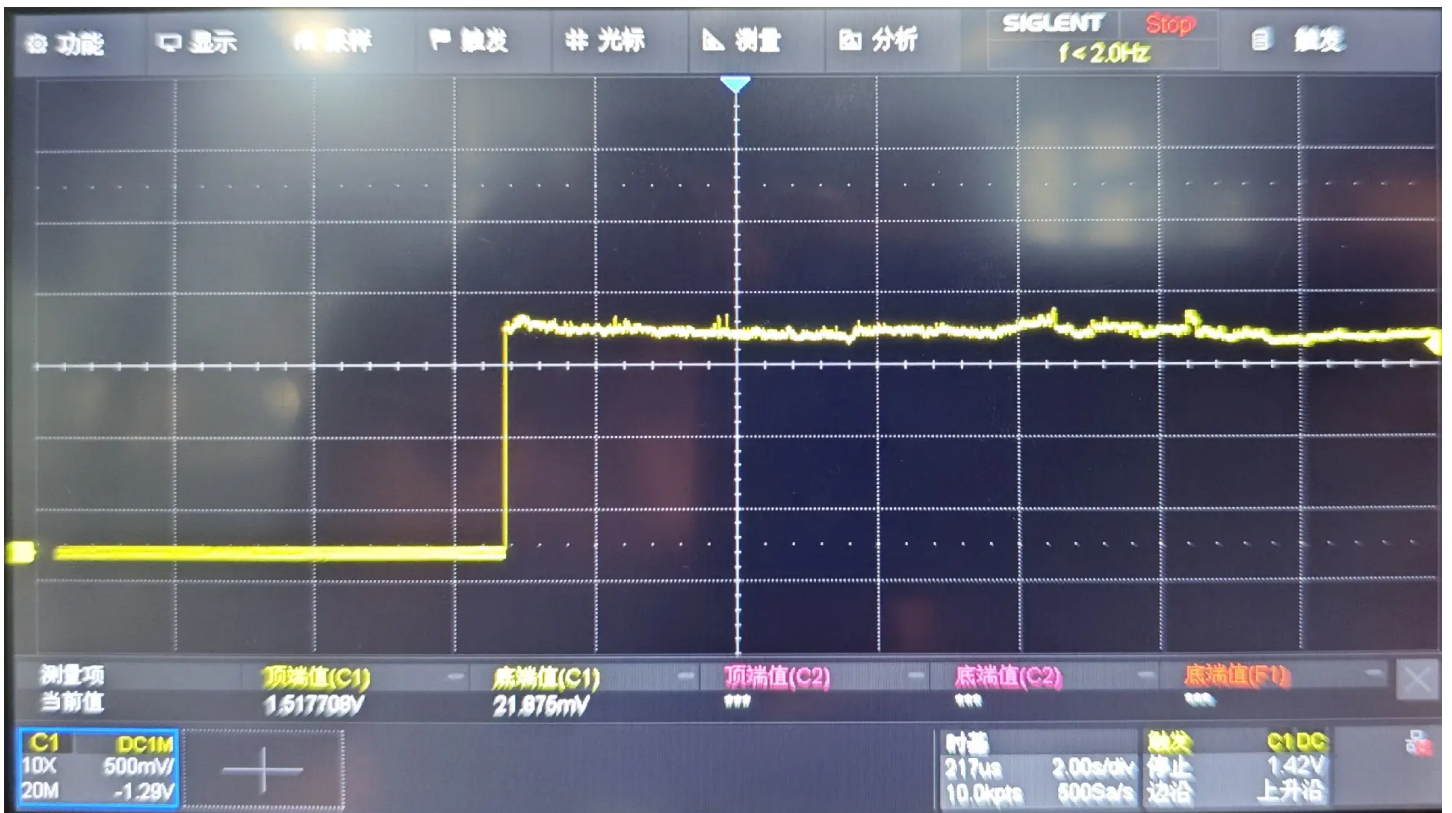
TS1 rising edge after long tracking

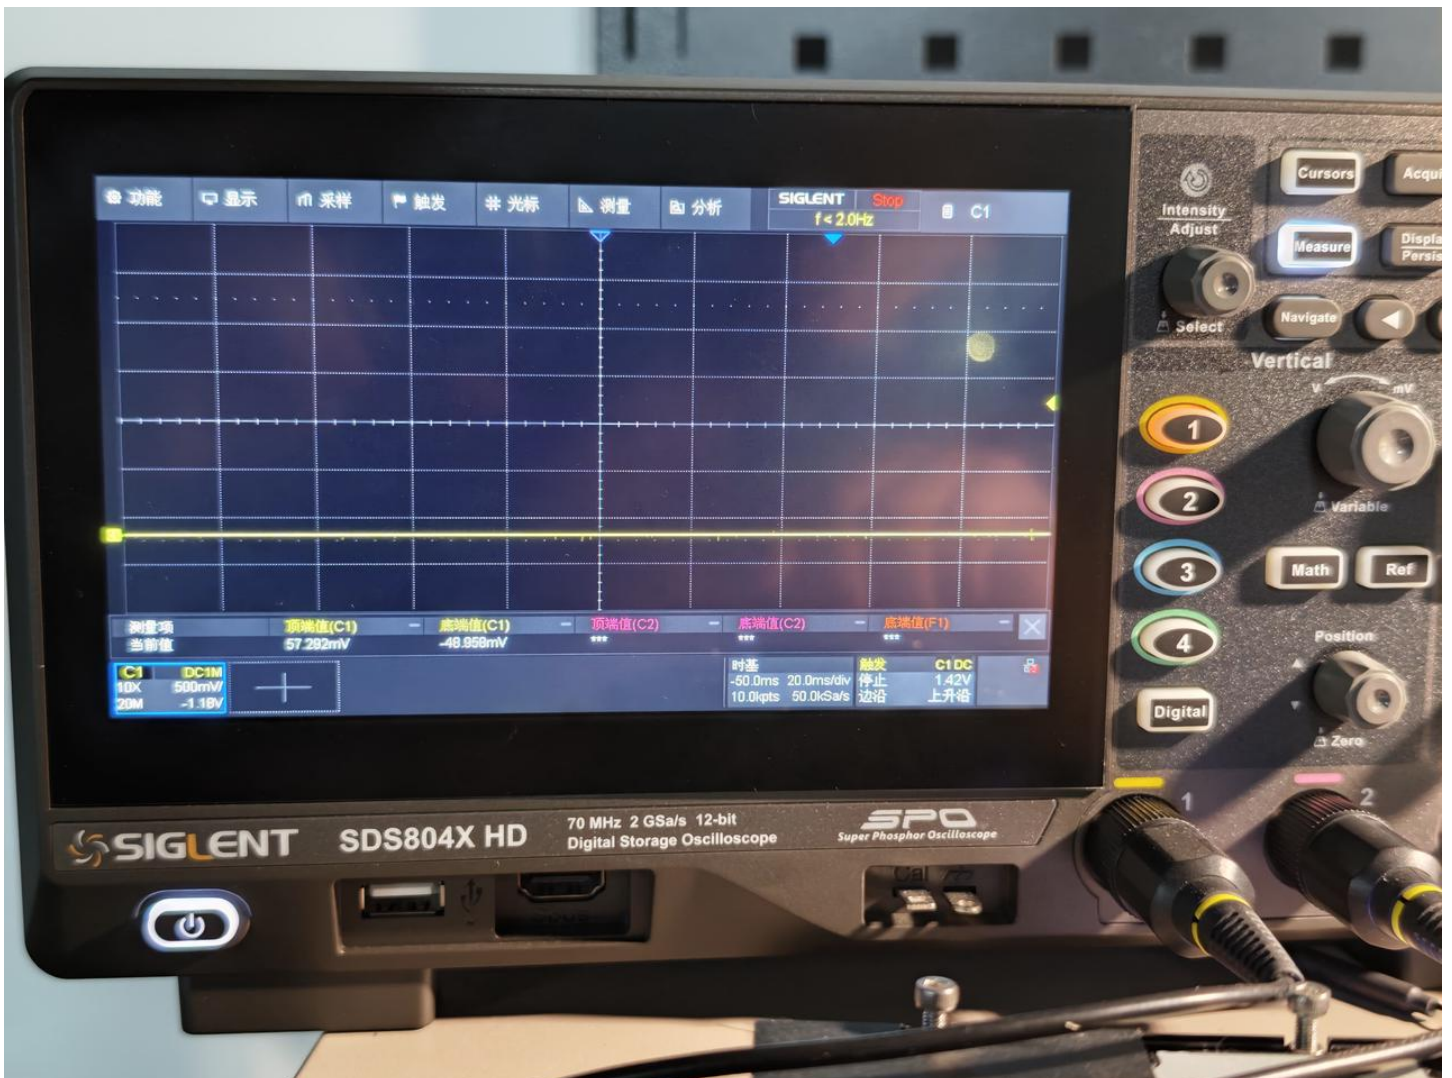
Curve of TS2 before charger output

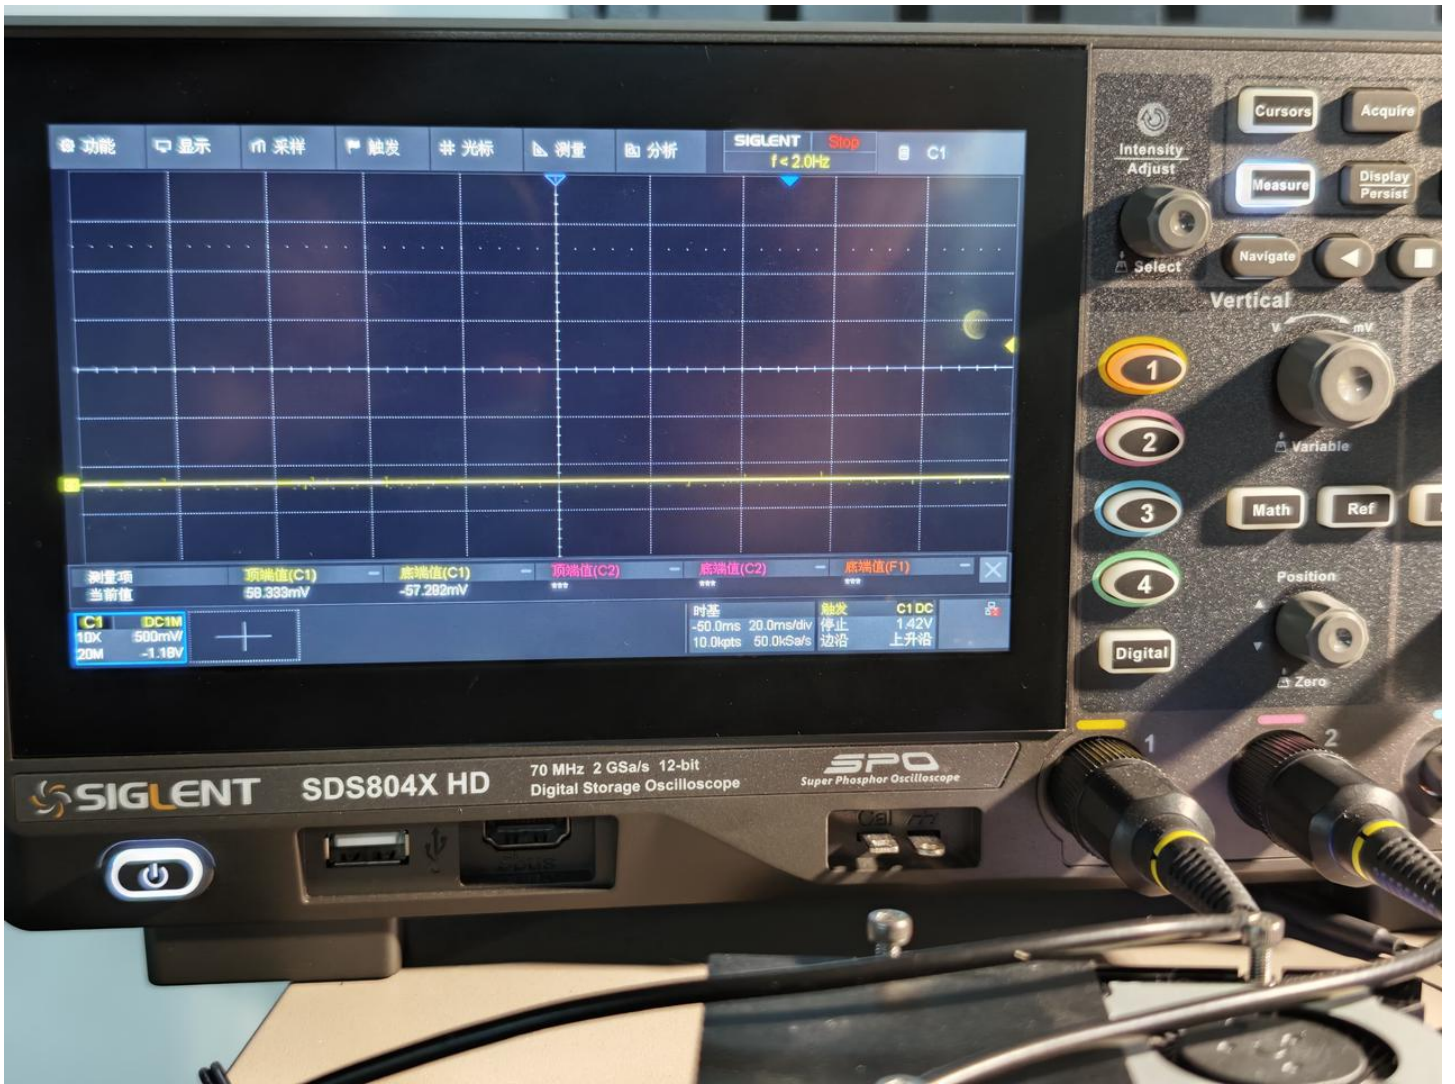
Curve of TS2 after charger output

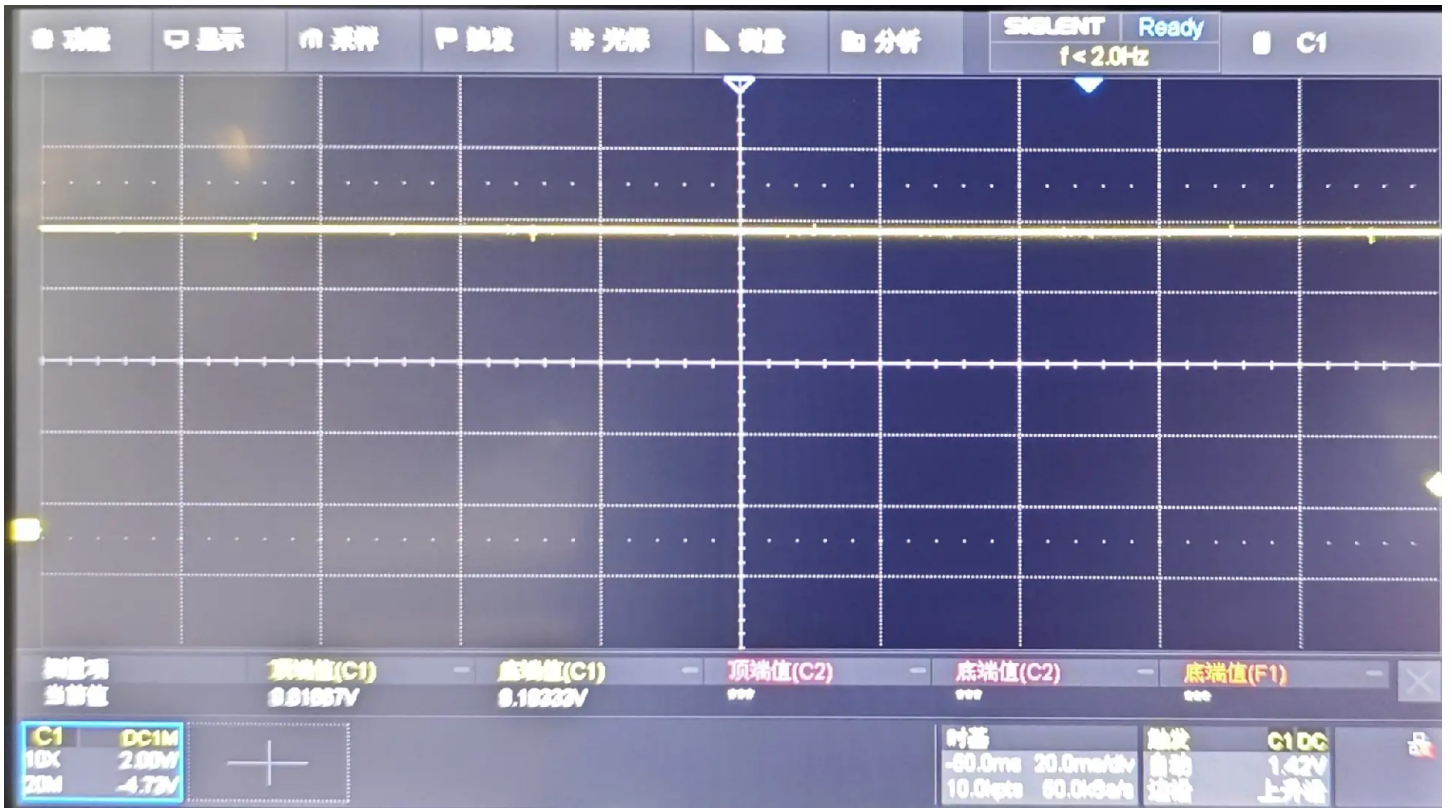
REGSRC at rest
