Errata Report - For TI

Phenomenon + Some Facts

Analysis of the Reason for Errata 1

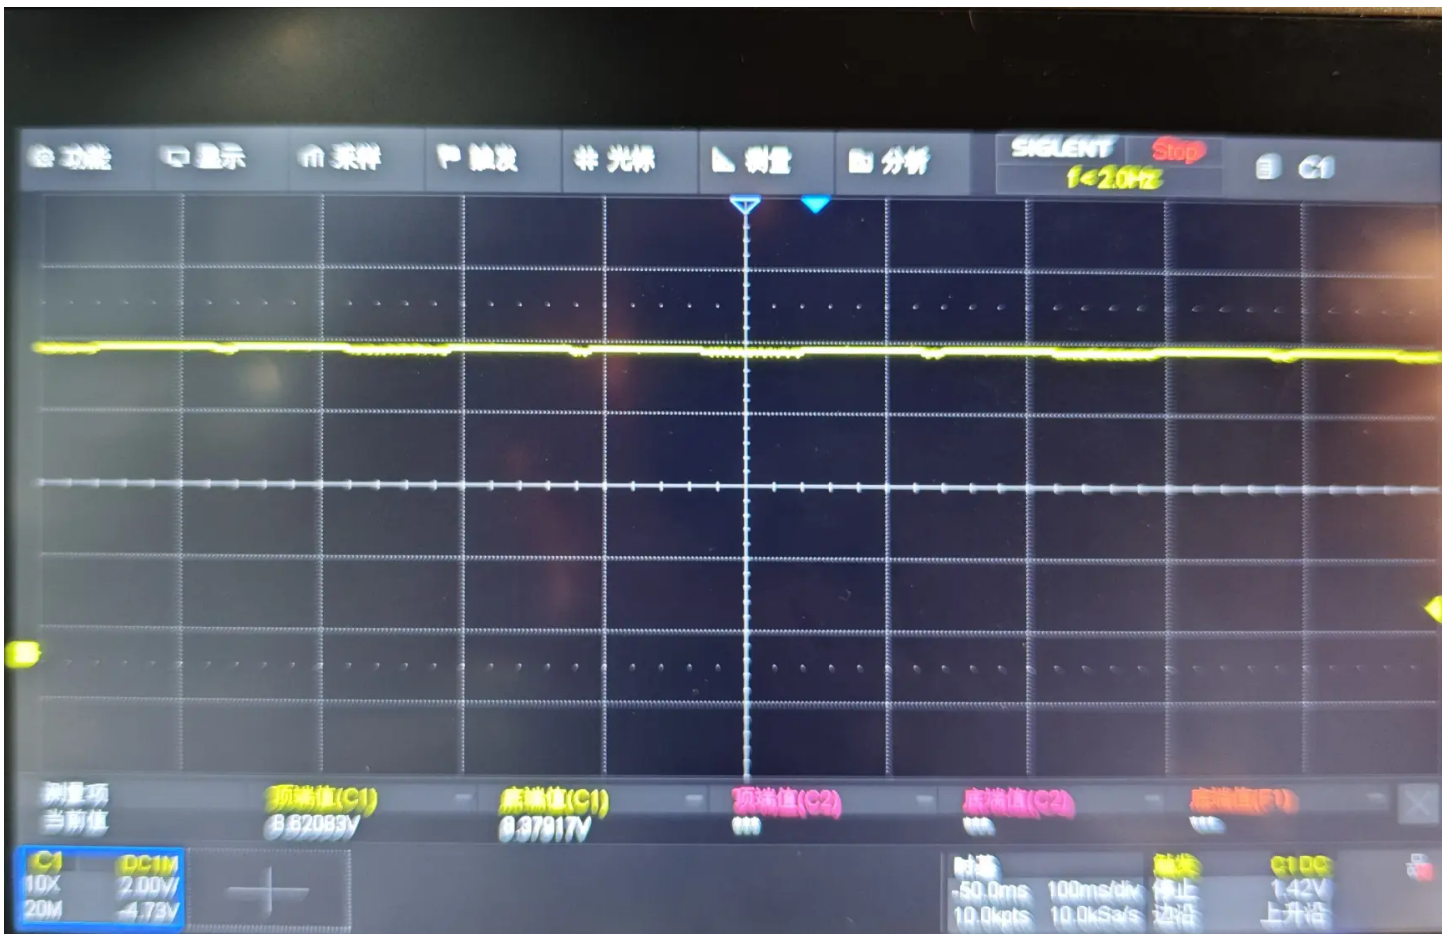
REGSRC at charger output

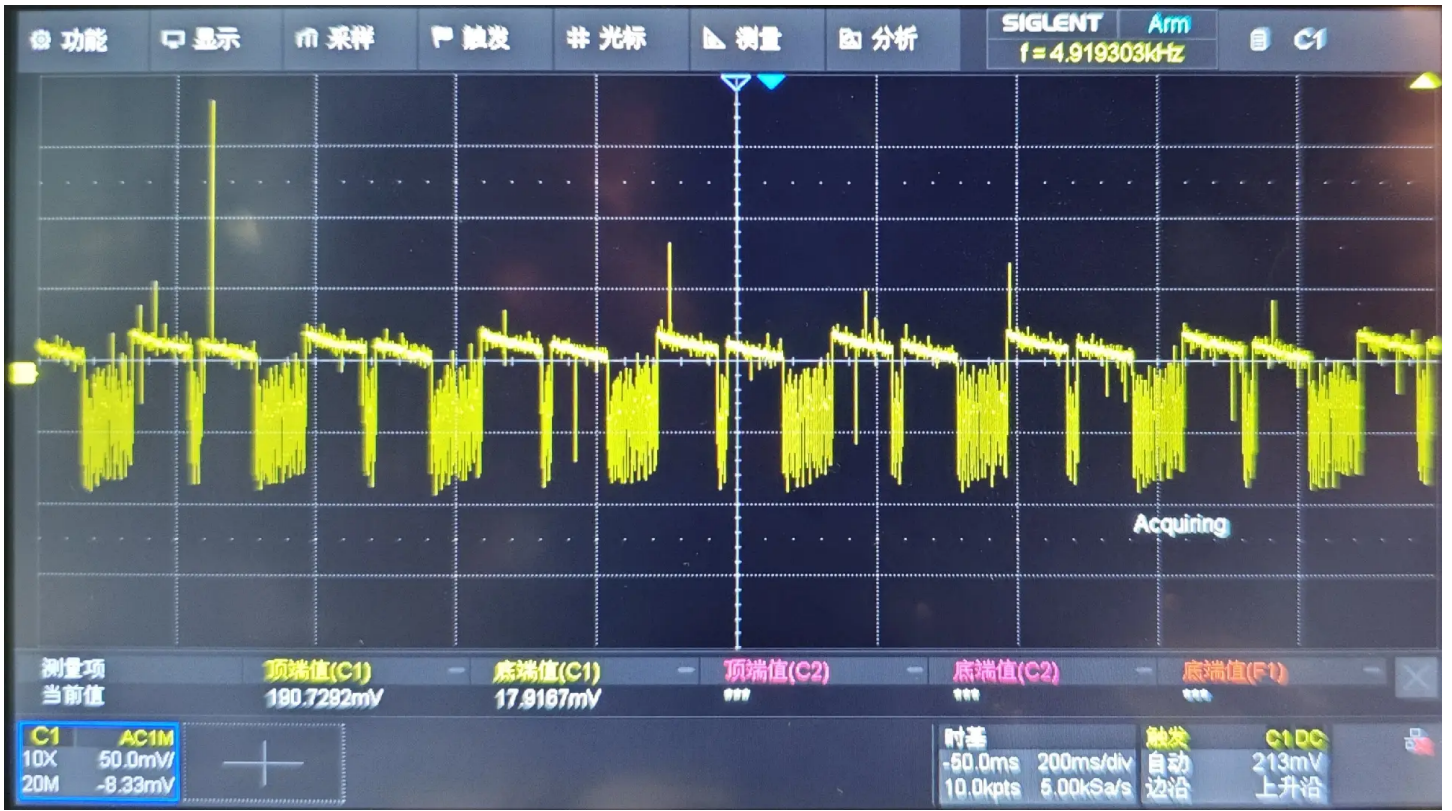
AC of REGSRC when the charger outputs

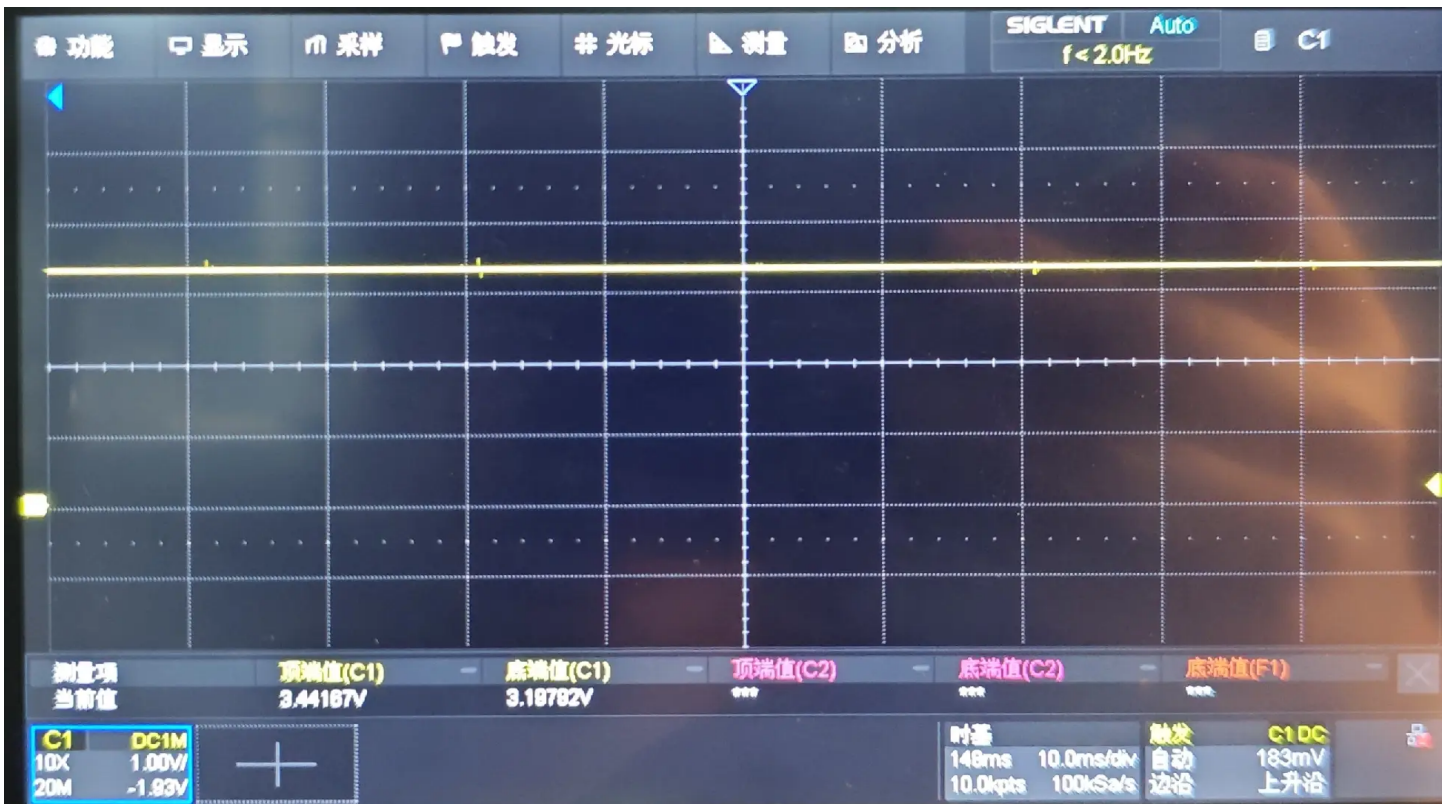
REGOUT at rest

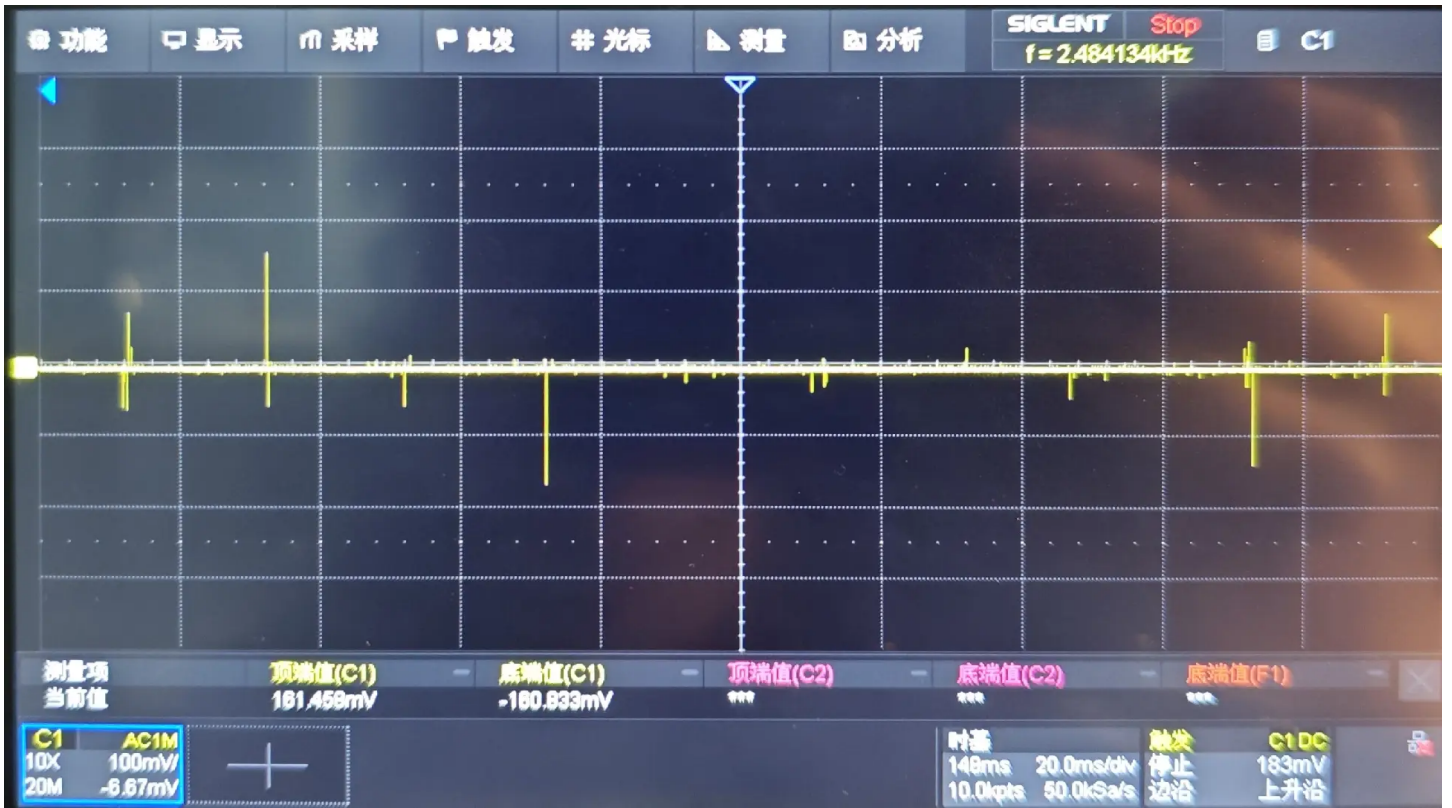
REGSRC at charger output
