IGBT Damage Phenomenon Description

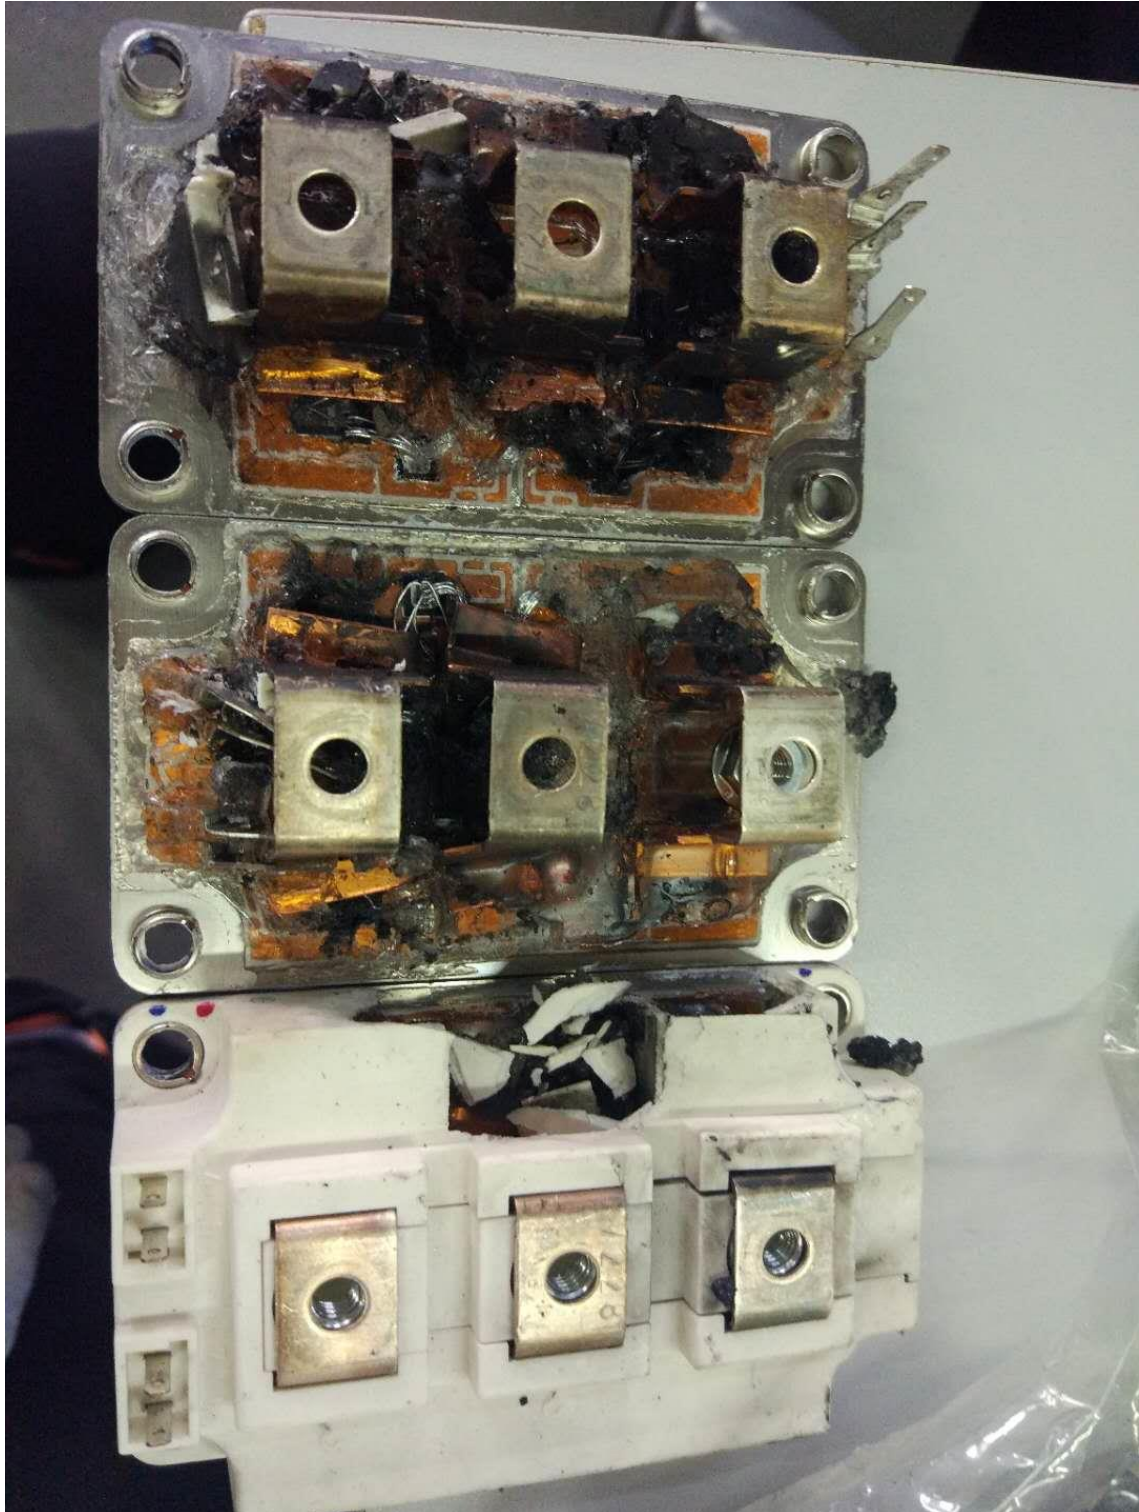
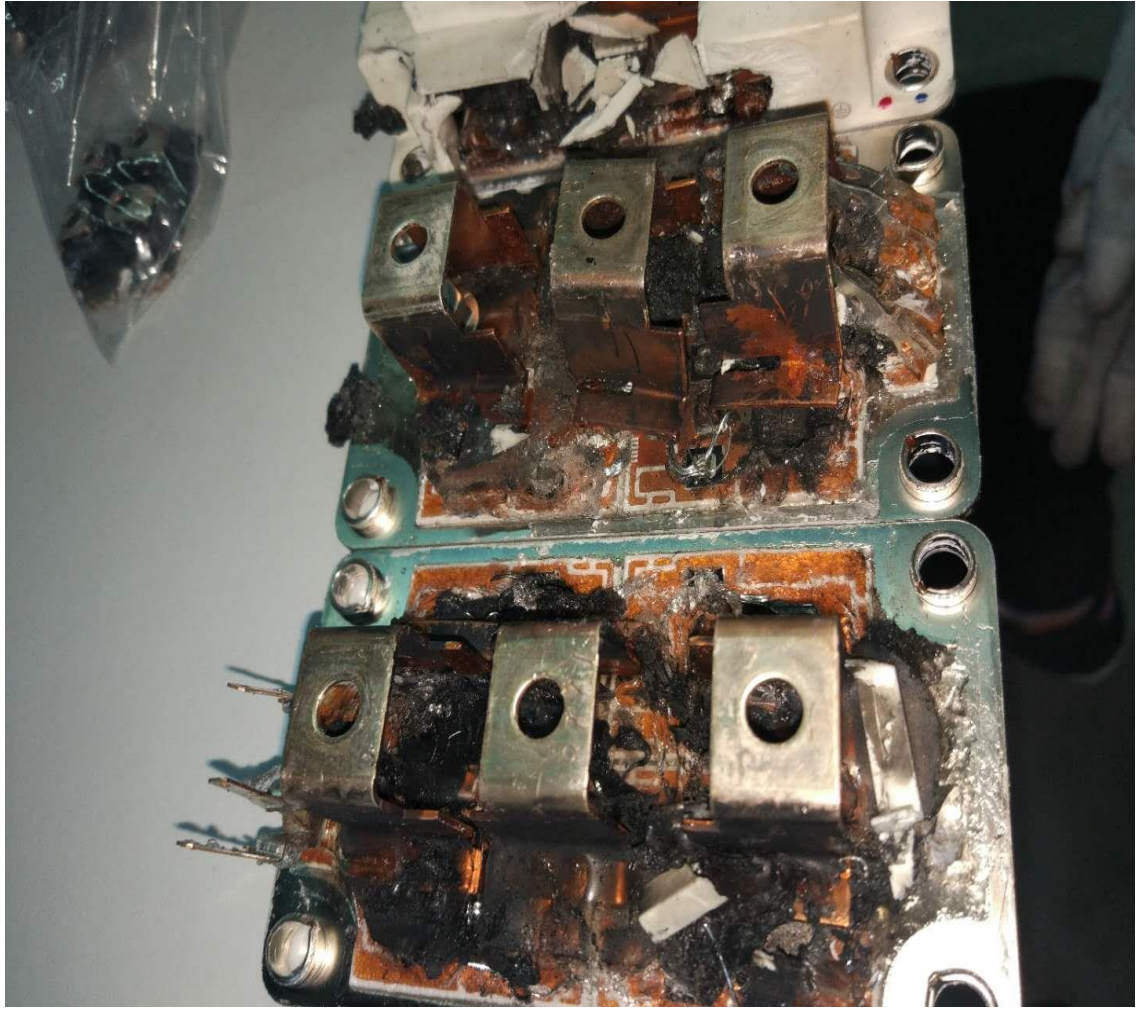
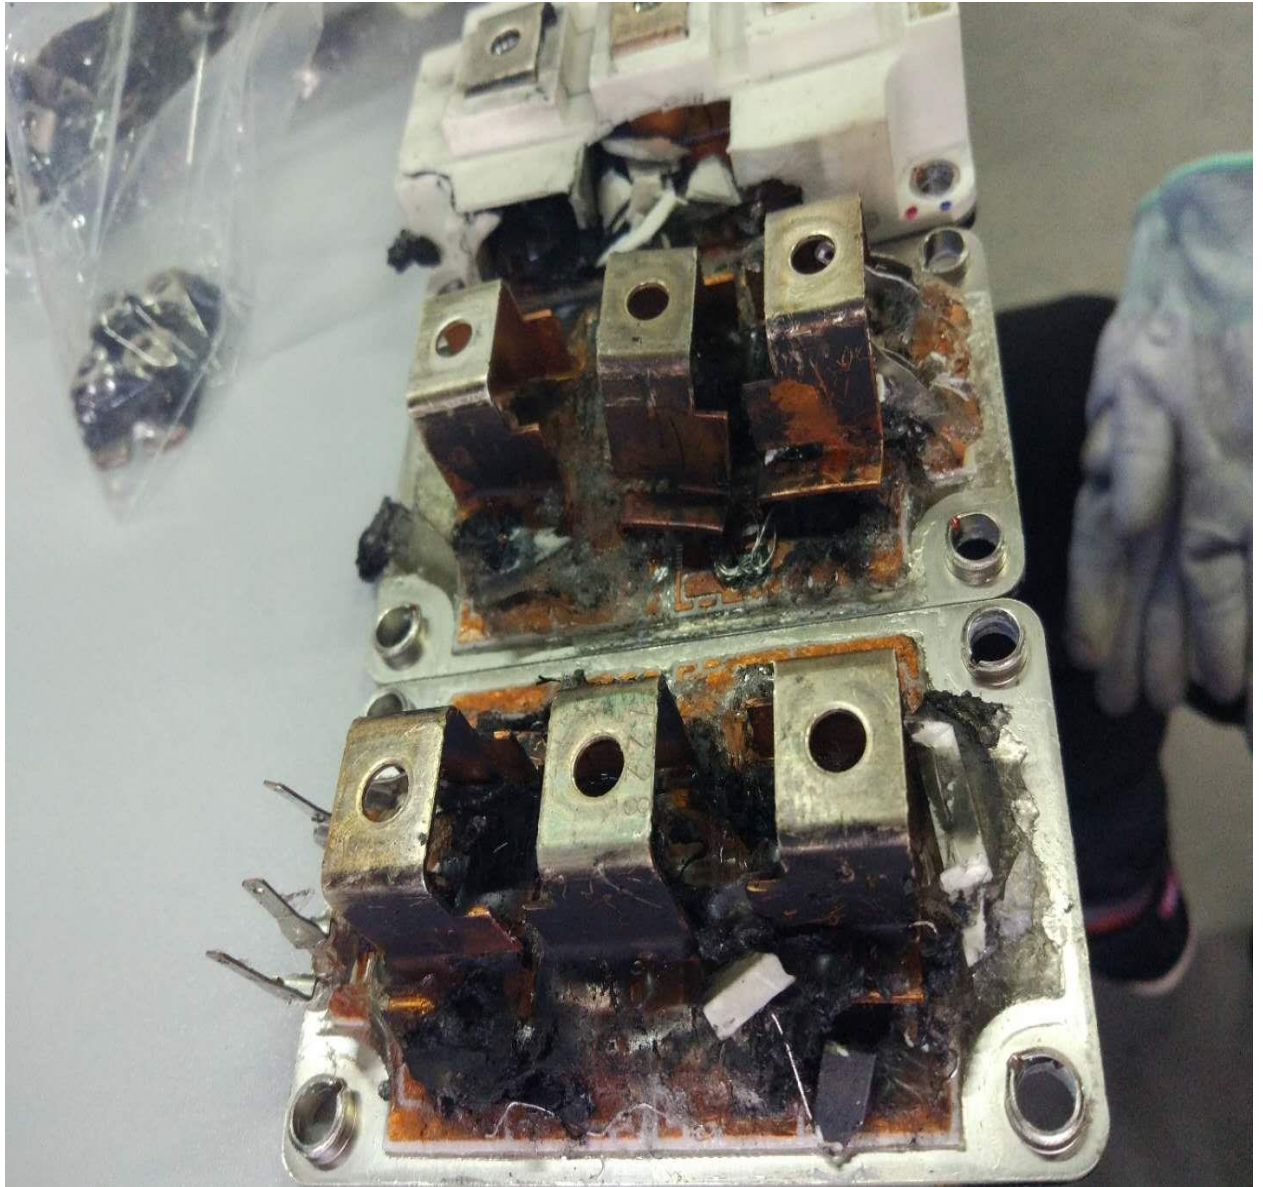
The following picture shows the phenomenon that IGBTs are blown up during the working process of our products. From the point of view of the damage, our analysis believes that the drive end has been damaged, the internal blackening, and some of the drive lines inside the IGBT have been blown.
