UCC25630-1EVM-291 (IC changed to UCC256302) LLC load transient response evaluation

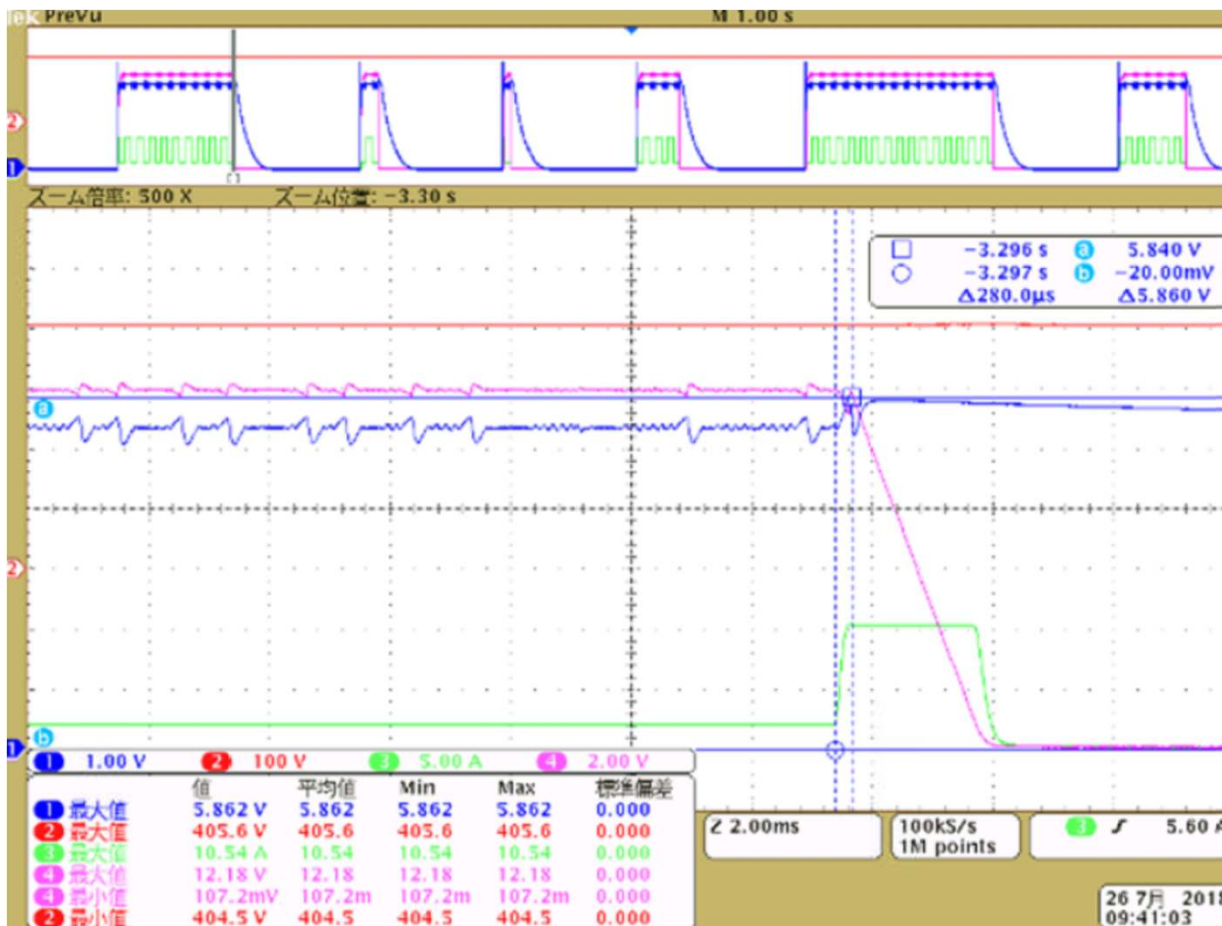
1. LLC load sudden change test 1 (when **R14 = 2 MΩ** mounted)

As a result, immediately after the LLC output suddenly changes from 0% load to 100% load, the output was stopped.

When evaluating with only LLC, the problem of load fluctuation occurred in case of the input voltage is higher than DC 390 V.

<Test condition> LLC input voltage _ **DC 405 V**, LLC output: DC 12 V 10 A (rated load)

12V output load sudden change: 2A (20%) ⇔ 12 A (100%), **sudden change cycle: 10 Hz**, duty: 50%

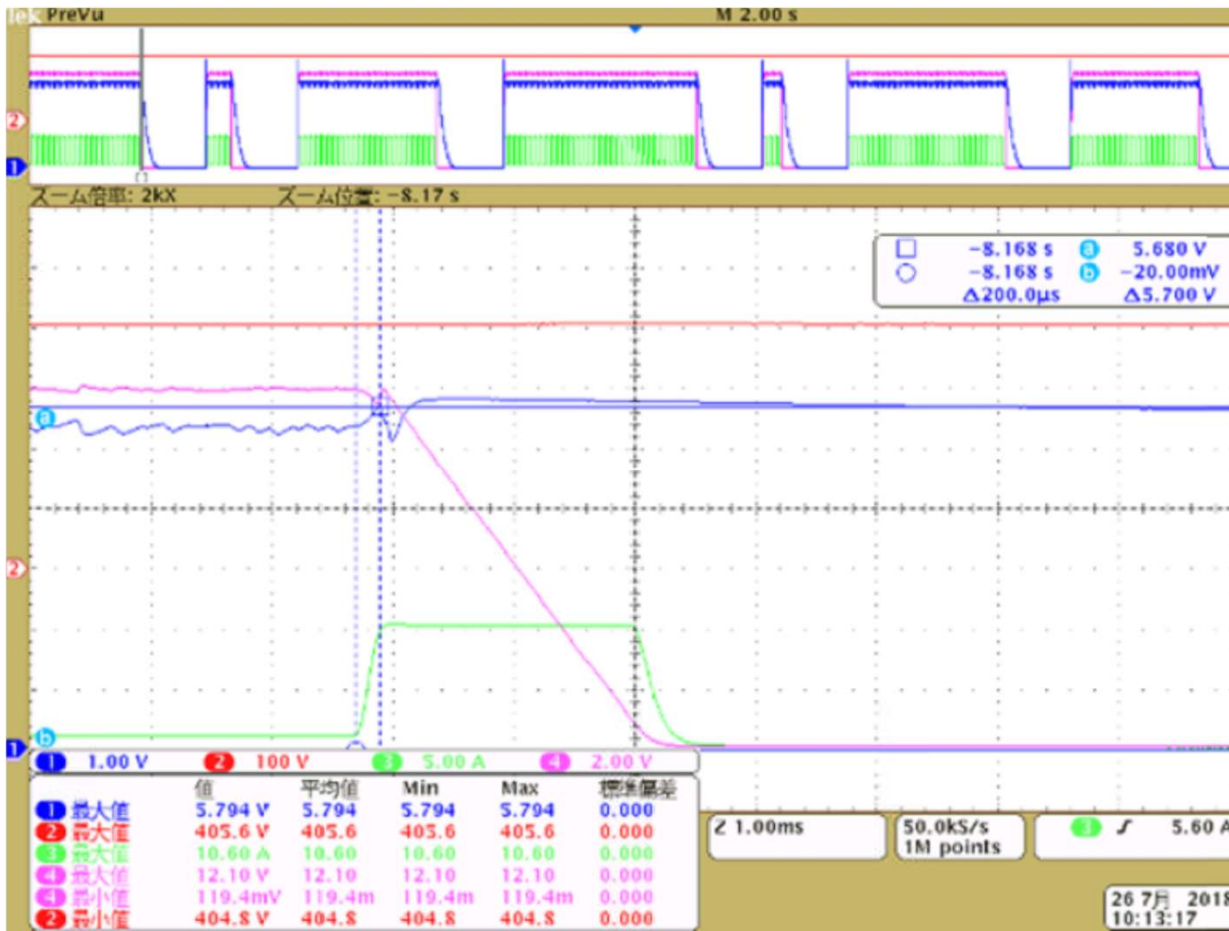
2. LLC load sudden change test 1 (when **R14 = 840kΩ** board **default** mounted)

<Test condition> LLC input voltage _ **DC 405 V**, LLC output: DC 12 V 10 A (rated load)

12V output load sudden change: 1A (10%) \Leftrightarrow 12 A (100%), **sudden change cycle: 10 Hz**, duty: 50%
