LMR14050-Q1 Interference issue

Problem Description

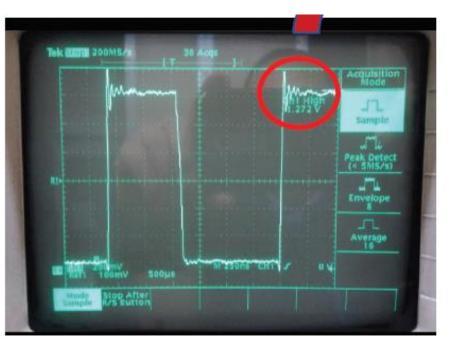
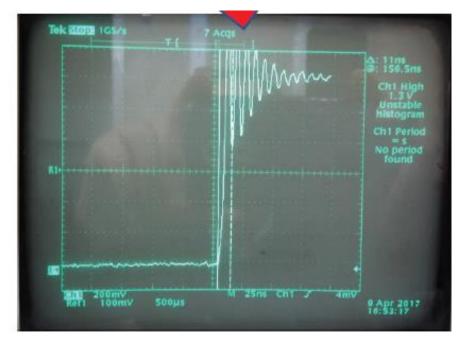
- LMR14050-Q1 of TI (Current : 5A max)
 - Location No : IC601
 - Observed ringing, overshoot and undershoot at rising and falling edge
 - Especially FM reception sensitivity can not meet customer spec
