Low Yield Rate
Fox-1 MPPT's
Rev 1.1

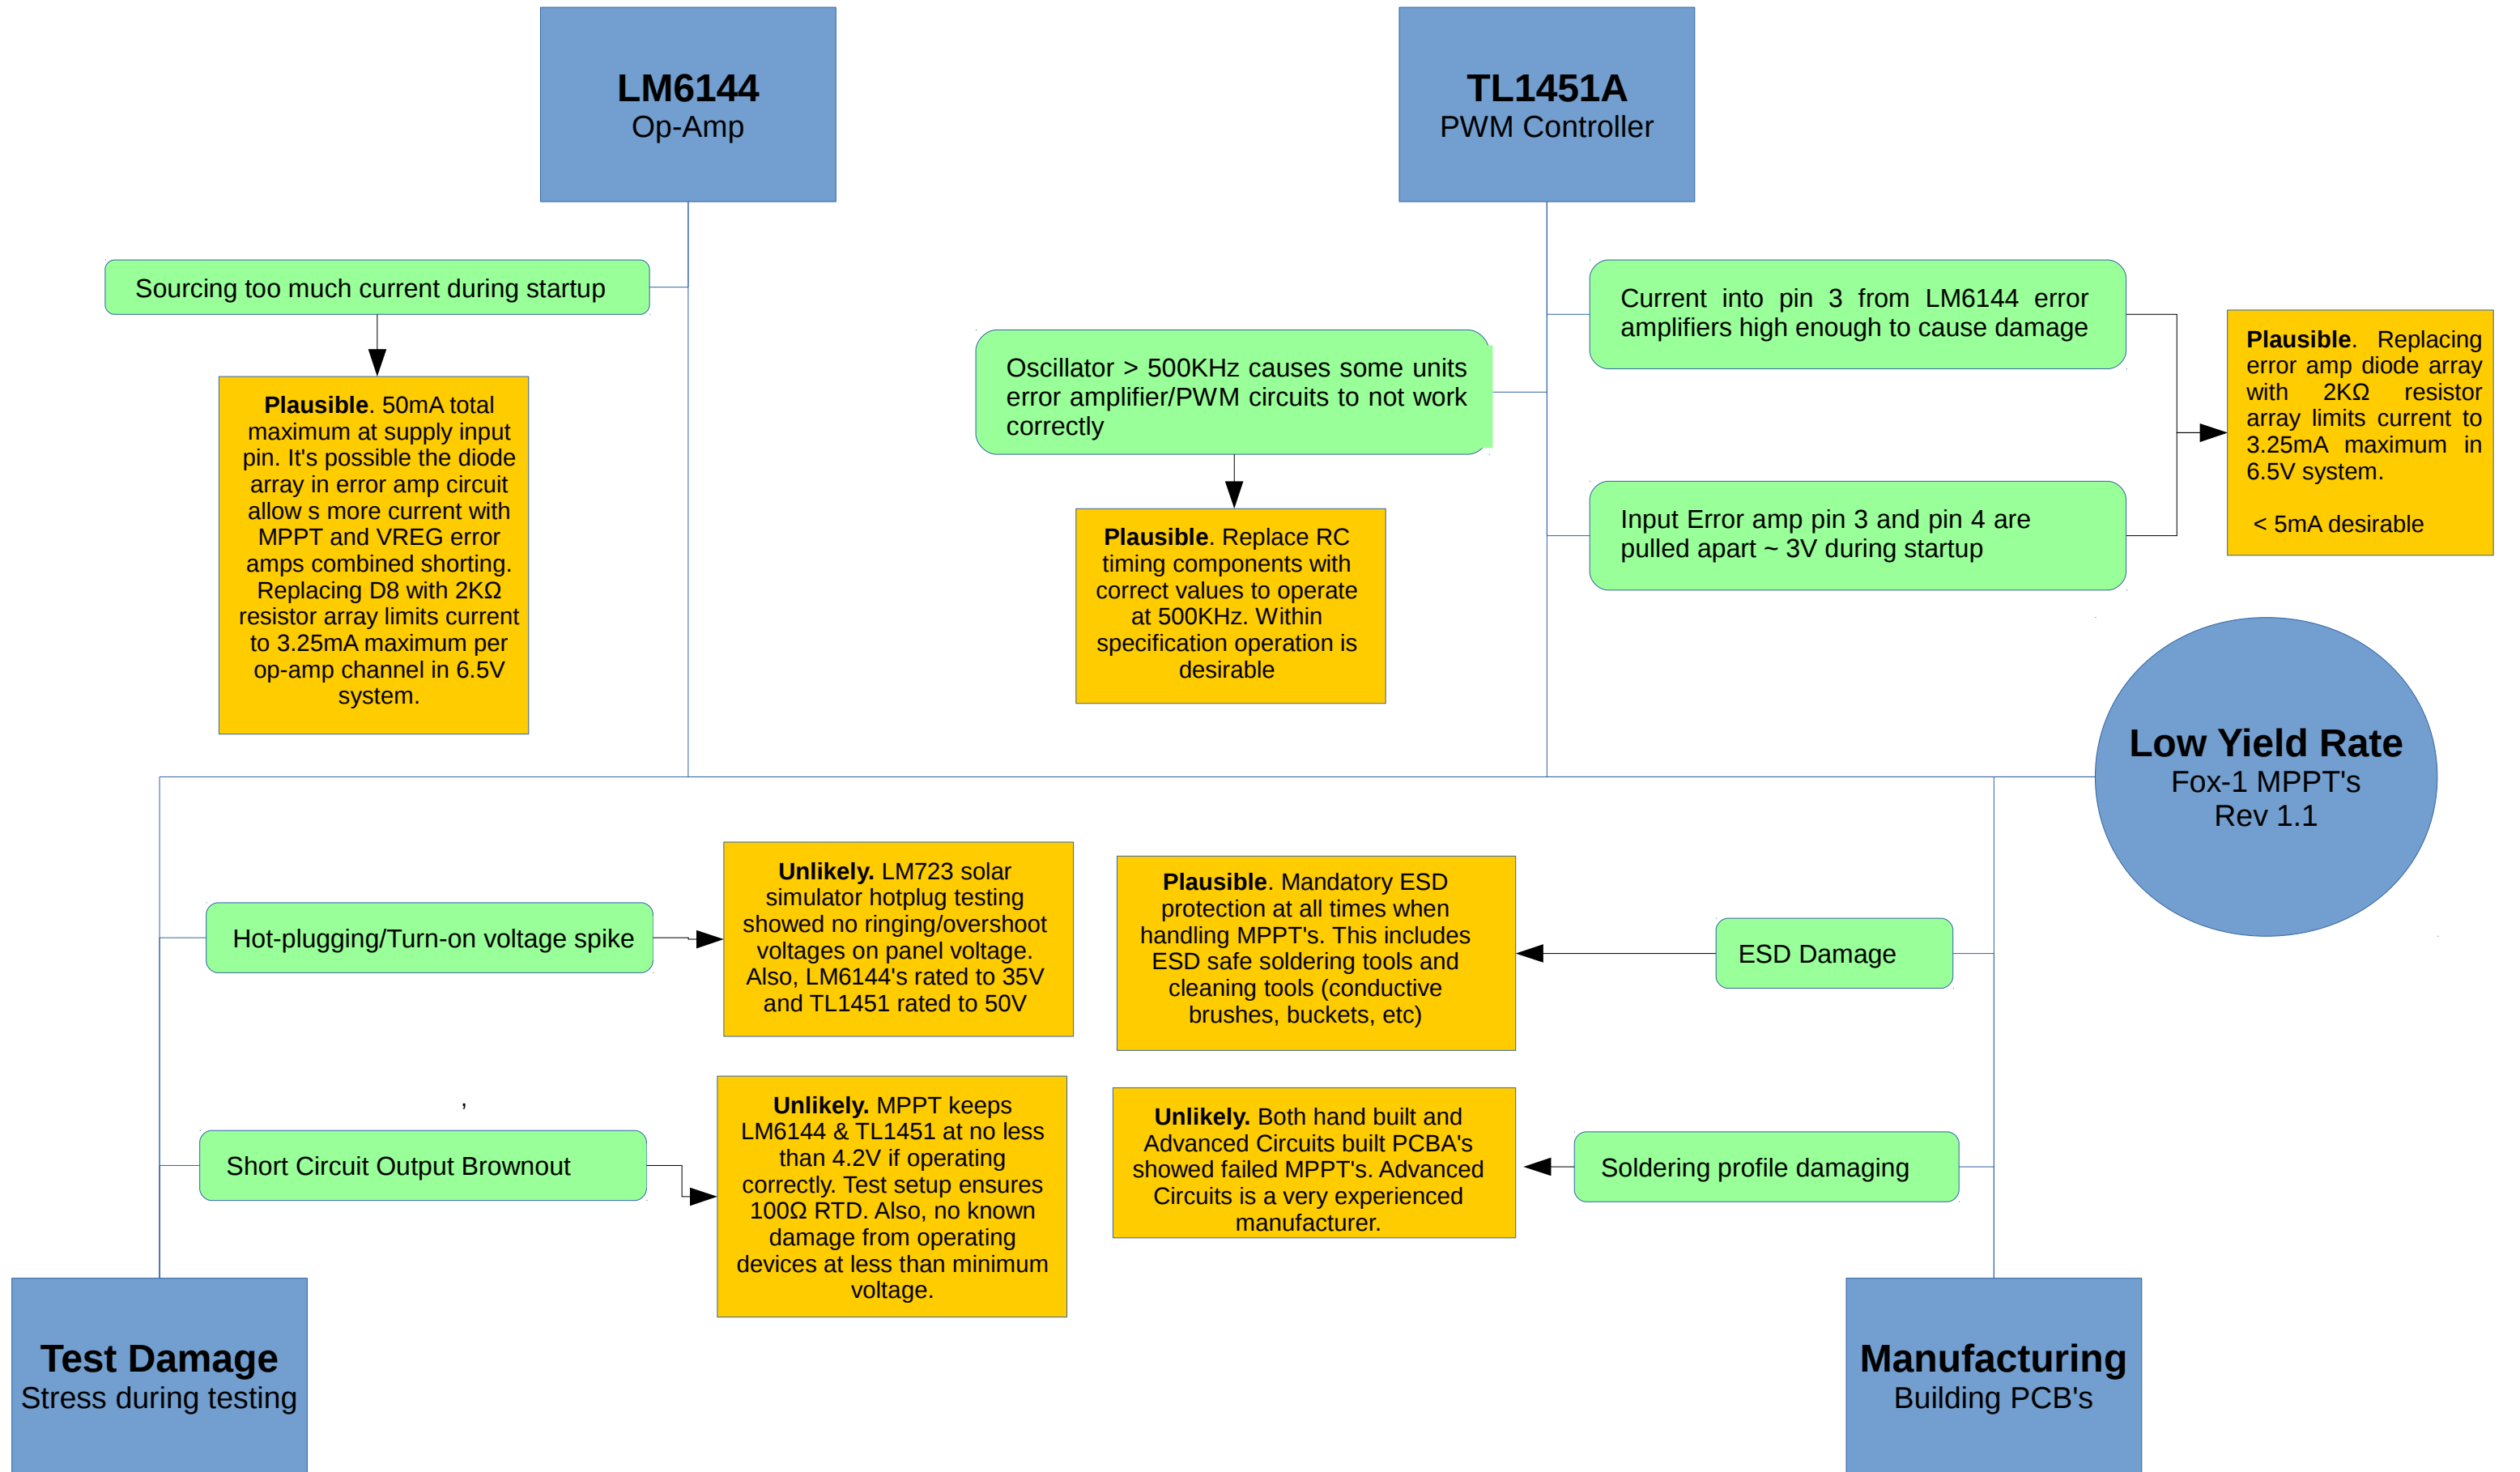
Sourcing too much current during startup

Plausible. 50mA total maximum at supply input pin. It's possible the diode array in error amp circuit allow s more current with MPPT and VREG error amps combined shorting. Replacing D8 with 2KΩ resistor array limits current to 3.25mA maximum per op-amp channel in 6.5V system.

Oscillator > 500KHz causes some units error amplifier/PWM circuits to not work correctly

Plausible. Replace RC timing components with correct values to operate at 500KHz. Within specification operation is desirable

Current into pin 3 from LM6144 error amplifiers high enough to cause damage

Input Error amp pin 3 and pin 4 are pulled apart ~ 3V during startup

Plausible. Replacing error amp diode array with 2KΩ resistor array limits current to 3.25mA maximum in 6.5V system.
< 5mA desirable

Hot-plugging/Turn-on voltage spike

Plausible. Mandatory ESD protection at all times when handling MPPT's. This includes ESD safe soldering tools and cleaning tools (conductive brushes, buckets, etc)

ESD Damage

Short Circuit Output Brownout

Unlikely. MPPT keeps LM6144 & TL1451 at no less than 4.2V if operating correctly. Test setup ensures 100Ω RTD. Also, no known damage from operating devices at less than minimum voltage.

Unlikely. Both hand built and Advanced Circuits built PCBA's showed failed MPPT's. Advanced Circuits is a very experienced manufacturer.

Soldering profile damaging
