Apparent recurring soft start

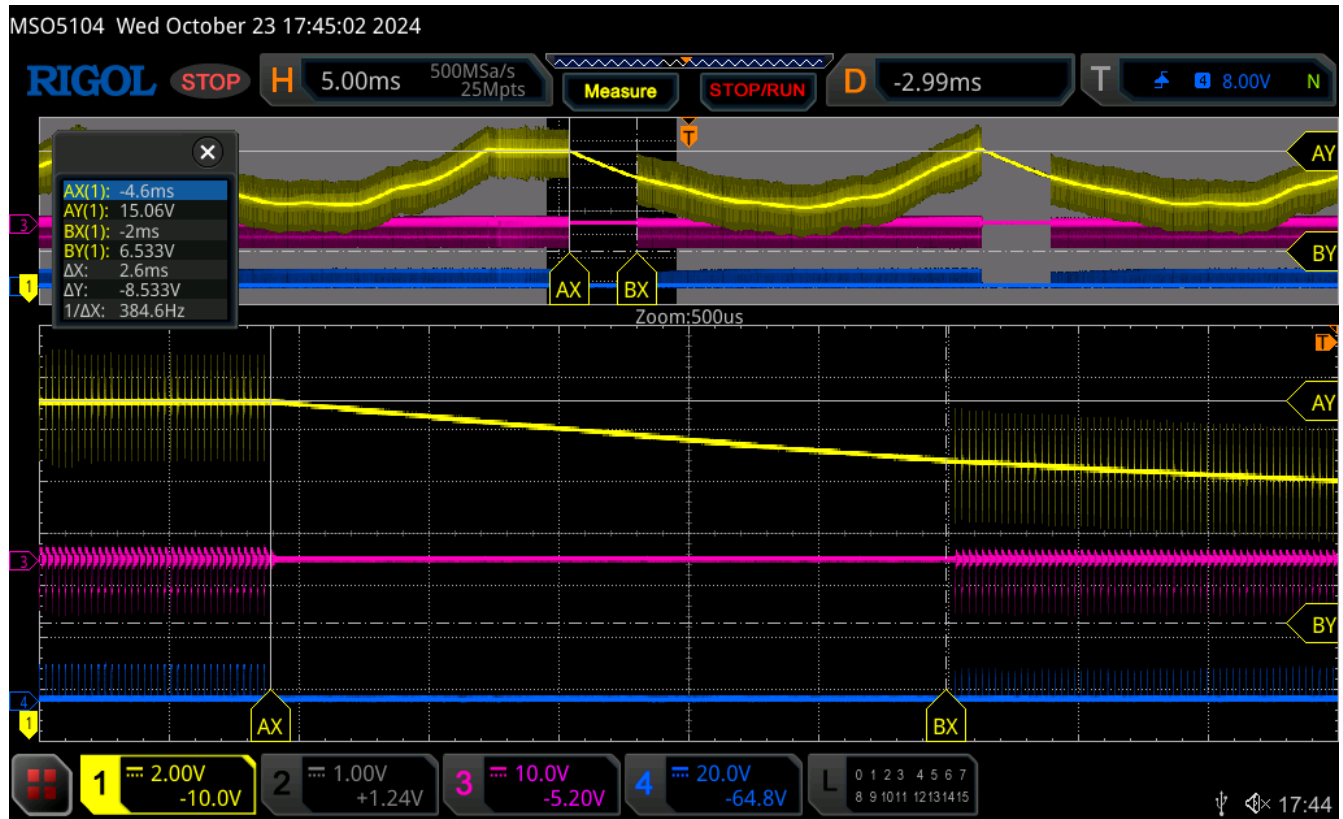
Yellow trace is output SAUX+

Red trace is Bias winding feeding PAUX

Blue trace is gate voltage for Q2

Without obvious reason (the output voltage is at the desired level ~15V) a 2.6ms pause is initiated followed by a period of reduced duty cycle gate pulses.

The reduced width of gate drive can not sustain the output voltage that therefore drop even the converter has started working again (hence the theory of soft starting being involved).

After restoring voltage at desired level only a variable (but short) period elapses before the cycle repeats.
