## Debugging after TI Comments-

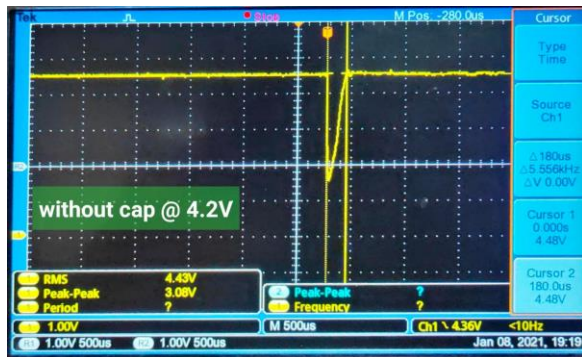
### Glitch due to 220uf-

**TI Comment-** It looks like this glitch would be due to the 470uF cap charging with the MOSFET switch being turned on.

This cap value (470uF) was miss-written. Actual value is 220uf which has been reduced & removed to check impact of surge current-

- With decreasing cap, glitch amplitude does not decrease
- Without cap also, glitch comes.

It seems surge current of Tantalum cap is not impacting much on glitch.

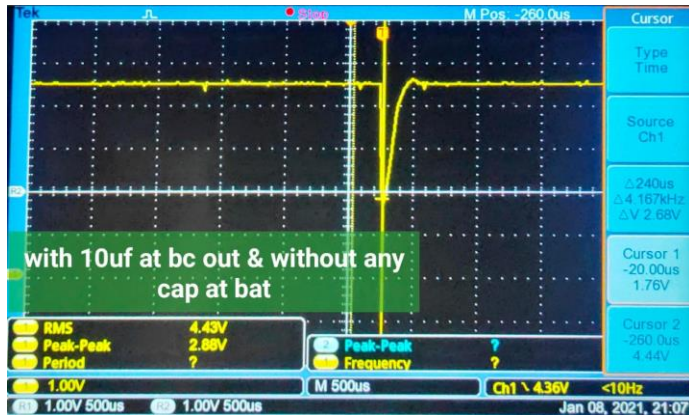
**TI Comment-** With the schematic, this problem may be reduced with capacitors (0.1uF minimum) that are required on the IN and OUT pin.

**P Gupta Comments-** We kept 0.1uf with 10uf at Input and output which is not impacting much on glitch amplitude

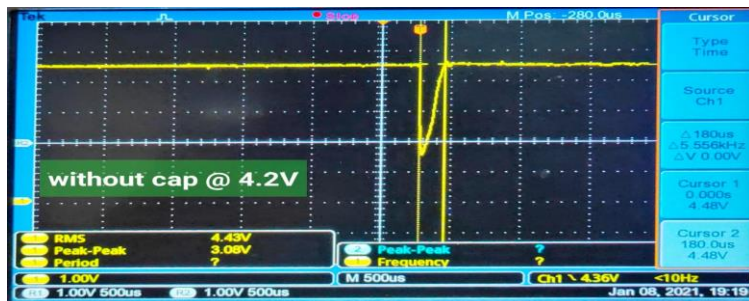
(Without 33uf cap at BAT Pin)

**TI Comment-** We also recommends a 33uF capacitor on the BAT pin for operation when battery is not attached.

**P Gupta Comments-** We tried with 33uf cap at BAT pin. But it is not impacting any in glitch amplitude but increases charging slope.
