LED Current-Limiting Fuse Problem

The LED Driver in the Functional Controller has a redundancy in which an increase the LED current above a safe limit is stopped by an electronic circuit breaker. The chip [LM76202-Q1](#) is used for this purpose and the circuit is described in [FLIO Controller v2 Pre-Assembly Test Protocol | Set Maximum LED Current to 110 mA](#). The problem is that during the [verification tests](#) we always find that the resistor setting the threshold current is far smaller than what the datasheet says.

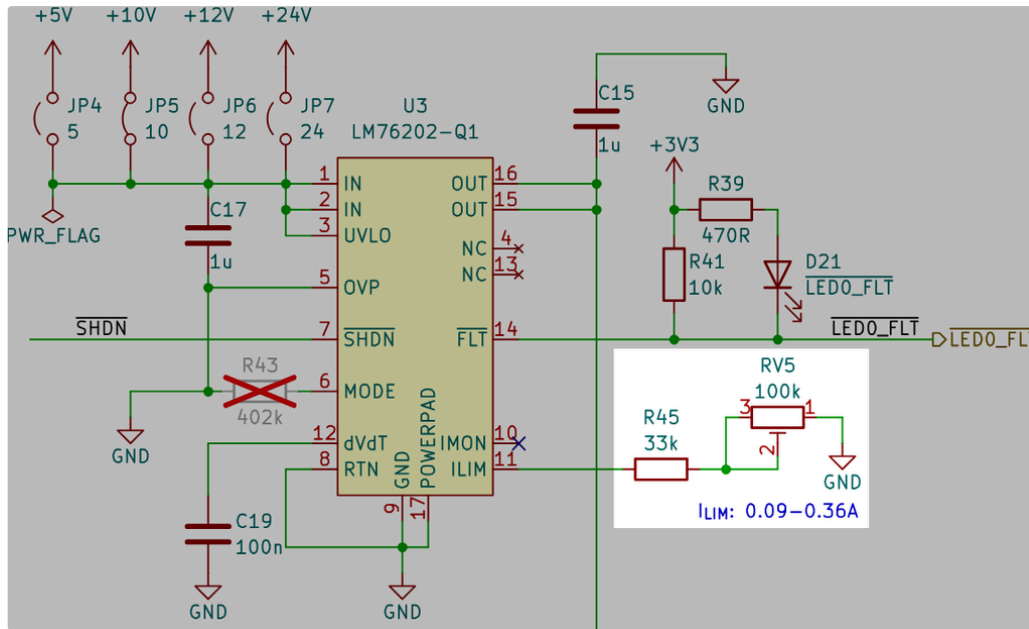
The schematic diagram below shows the circuit-breaker schematics. The important parts for setting the maximum current are the resistor R45 (33 kΩ) and trimmer RV5 (100 kΩ) highlighted in the schematics.

Schematic diagram of the circuit-breaker with the highlighted current-setting resistors.

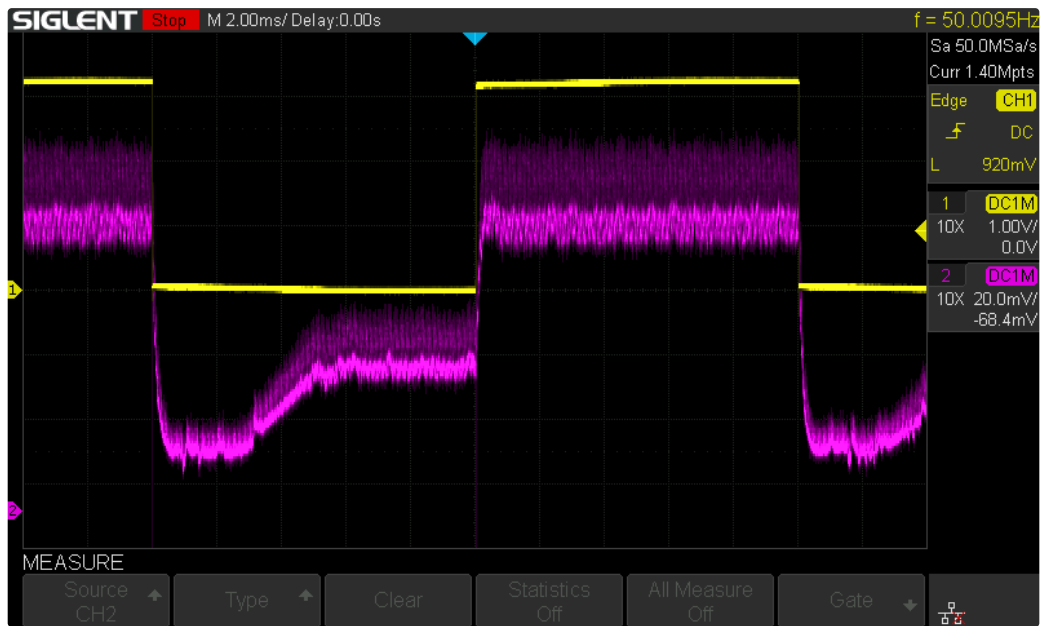
Active high LED enable signal (yellow). I_{10V} current monitor signal (purple).

The oscilloscope curve shows the current monitor output being noisy. Even with nearly zero current draw, when the LED enable signal is LOW, the circuit gives ~20 mV output Voltage. Using the above equation, it suggests a current of 27 mA. This is probably

the base consumption of the microcontroller board, which is not controlled by the circuit breaker, but shares the same power supply. It forms an offset that should be subtracted from the result. When the LED is enabled, the Voltage is ~90 mV, which is equivalent to 119 mA, by subtracting the 27 mA offset, we get ~95 mA. This is within the accuracy [TPS259474](#) with the programmed LED current of ~90 mA.

There is no obvious current spike measured on the I_{10V} current monitoring test point TP12 when the LED is turned on. This could be because the current monitor is too slow to capture it or because there is no current surge when the LED is turned on or both.

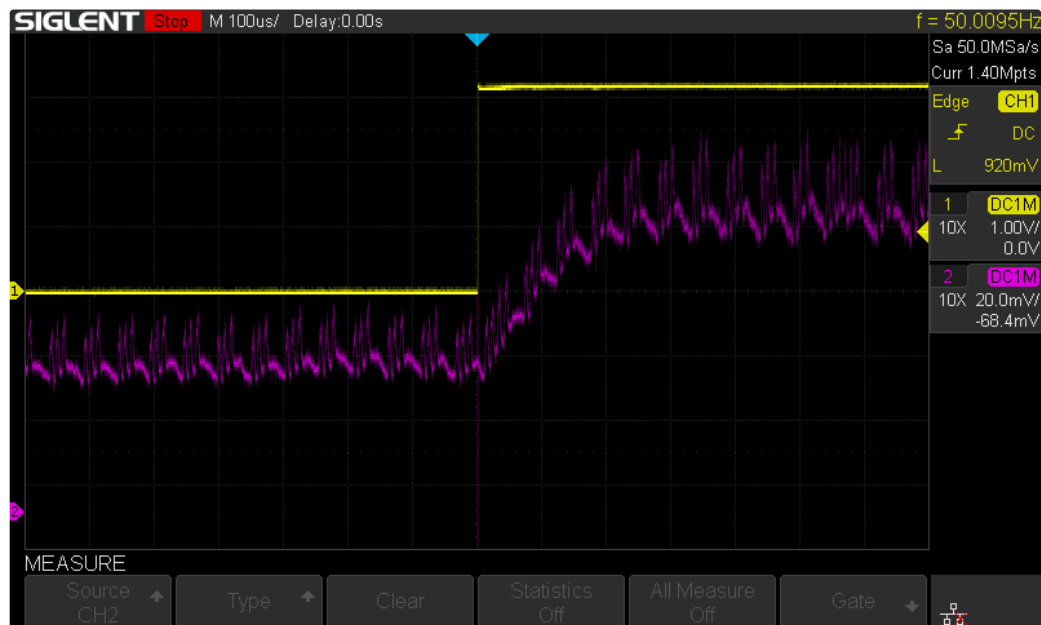
Zooming on the rising-edge transition reveals that the current monitor in the [TPS259474](#) is slow to capture a fast current transient if it was present. The current certainly rises much quicker than the ~200 μ s it takes the [TPS259474](#) chip to report it.

LED on transition (yellow) and gradual rise of Voltage on the I_{10V} current monitor test point.

In conclusion, the [TPS259474](#) chip is too slow in its response to verify whether there is an inrush current on the LED driver that could trip the circuit breaker.

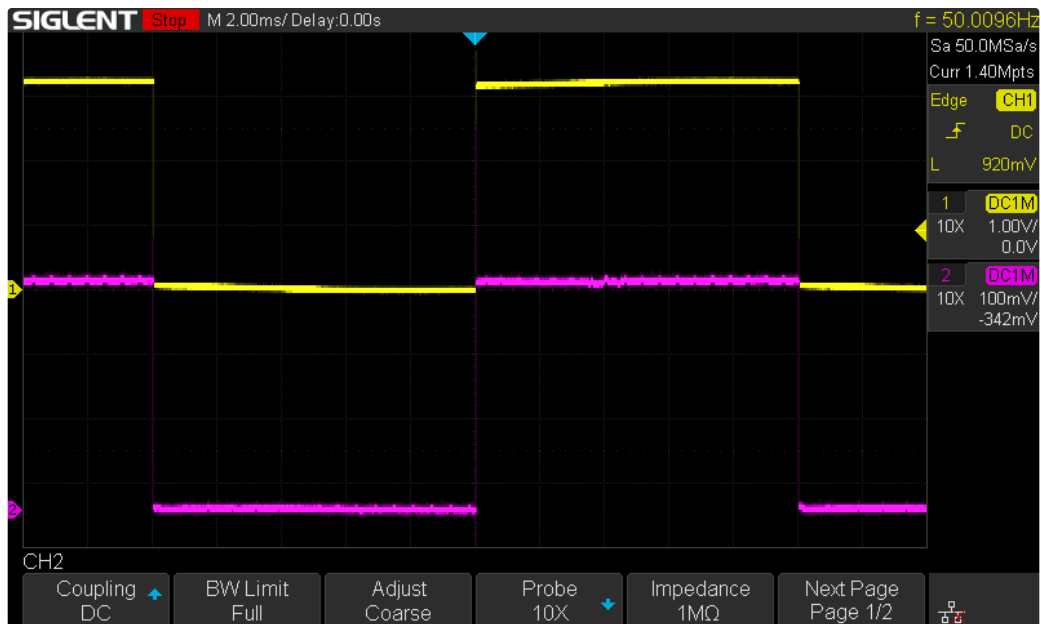
LED enable signal (yellow). LED current (purple)

The above oscilloscope measurement shows that the LED current is nice and square at ~ 96 mA, consistent with the measurement using the [TPS259474](#) chip current monitor capability discussed above. Zooming in on the rising edge reveals a short (~5 μ s) spike in the current consumption. The spike peaks at ~150 mA. However the circuit breaker should not trip on this spike. It has a 4 ms FLT assertion delay $t_{CB(dly)}$ in circuit breaker mode. Furthermore, the bypass capacitors are going to take most of the current spike away from the circuit breaker and the chip will not experience such high current increase as seen on the oscilloscope. It will be a small-hardly measurable wobble. The capacitor current draw cannot be measured on the PCB, but the Voltage on the capacitor can and is done in the next step.

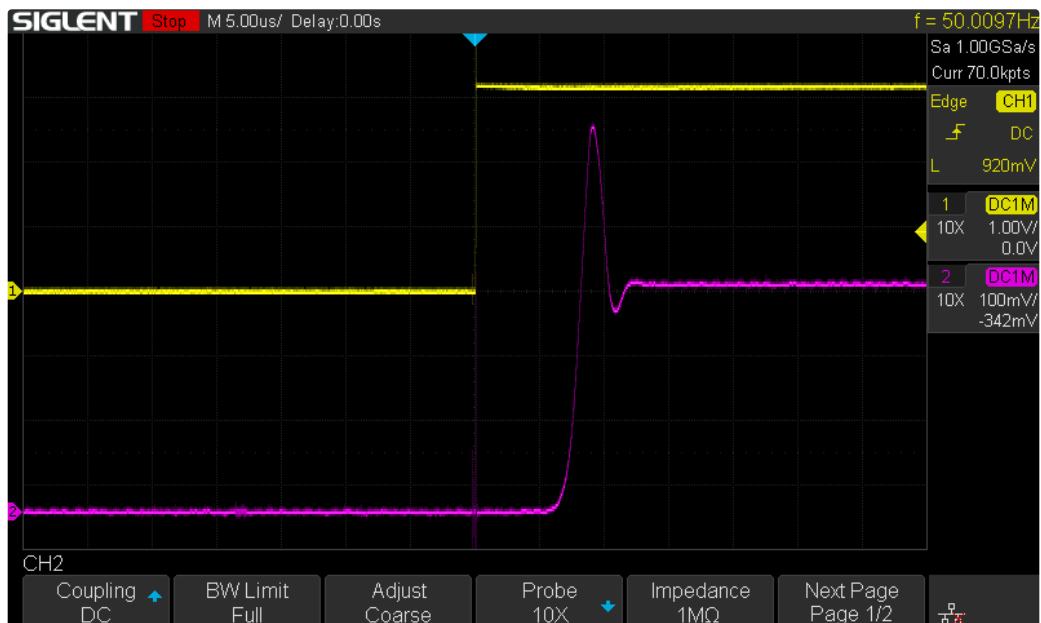
LED enable signal (yellow). LED current (purple)

In conclusion, there appears to be indication of substantial in-rush current into the LED that should cause the circuit breaker to trip.

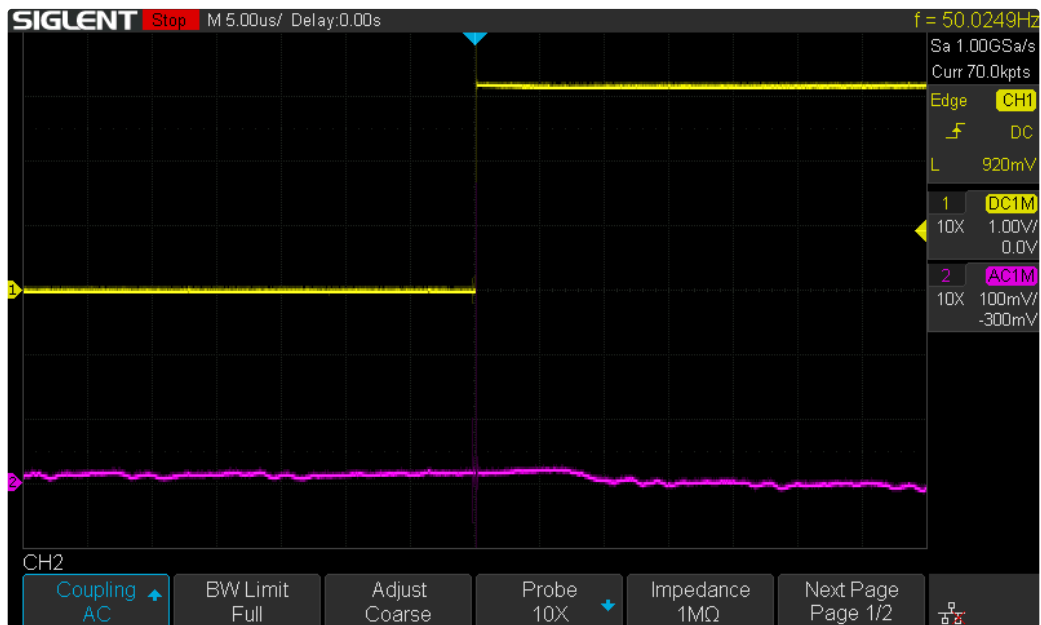
when the LED is turned on. This could be indicative of capacitors drawing current through the circuit breaker. There is a small (~ 10 mV) drop of the supply Voltage once the LED is on, but that is constant and does not return to the value before the LED has been turned on. This means there is no droop that would suggest the bypass capacitors will be drawing current to recharge once the LED was turned on.

LED enable signal (yellow). 10 V power supply on AC coupling (purple)

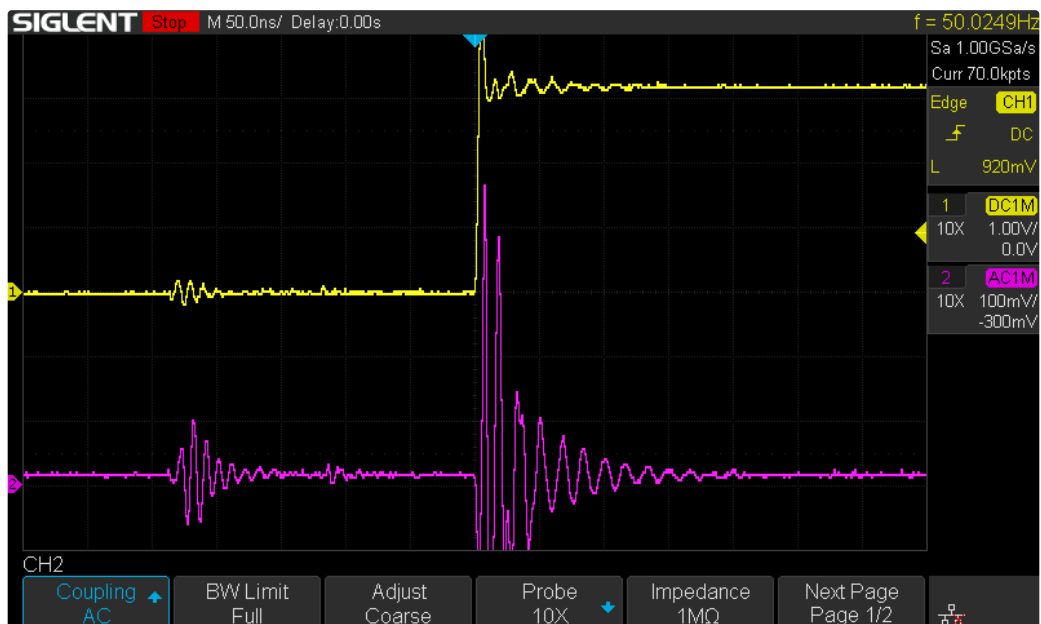
We measure substantial ringing on the rising edge for the LED control signal and the +10 V power supply. This ringing is very fast and dissipates within 150 ns. I expect some ringing, but I also think it is likely an artefact of poor connection of the oscilloscope, cross-talk, and ground loops. Given the fact that the LED current start rising $\sim 8 \mu\text{s}$ after the LED control signal rising edge, but the ringing appears within a fraction of a microsecond, I think it is more an artefact than a real thing. In any event, the circuit breaker has the 4 ms FLT assertion delay $t_{CB(dly)}$ that should filter all these fast transients out.

LED enable signal (yellow). 10 V power supply on AC coupling (purple)

In conclusion, it does not appear that extra current required to recharge the bypass capacitors is causing the trip of the circuit breaker at lower LED current than set by the threshold current-setting resistors.

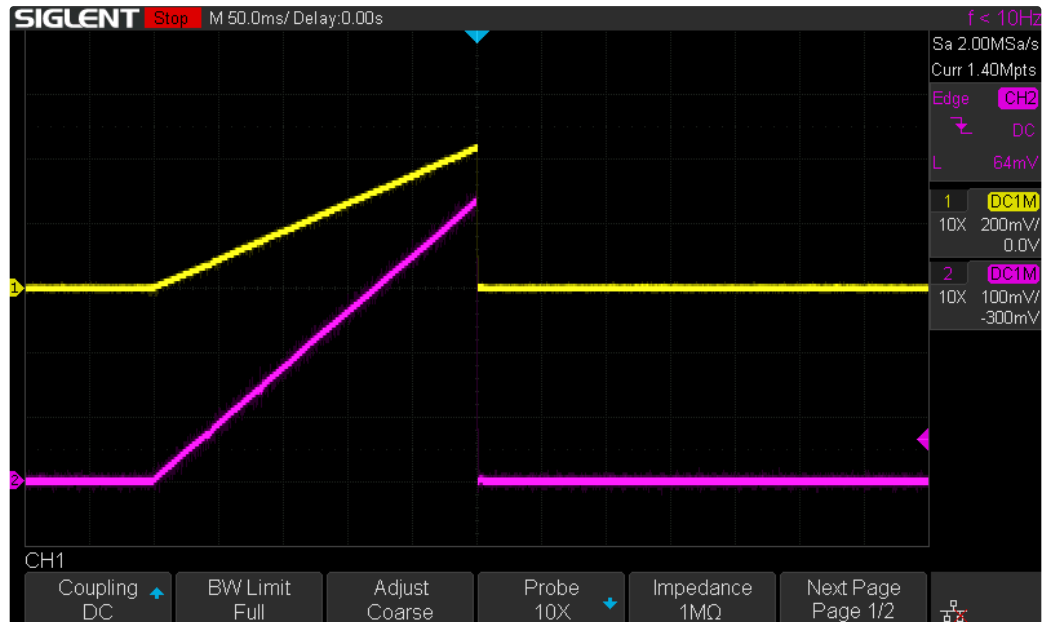
None of the above investigations 100 % ruled out that there is some effect that transiently increases the current through the circuit breaker to a higher value than we think. Therefore a measurement was derived where the current was slowly increased up to a point and decreased again. The LED current was increased linearly up to a maximum value, then the LED was turned off for 2 seconds and it was linearly increased again. The maximum value was varied by changing the MCU firmware and the highest value was found that did not trip the circuit breaker. Below are the oscilloscope traces showing the buildup of the Voltage on the $3.9\ \Omega$ current sensing resistor R61 on channel 1 (yellow) and the driving Voltage on the output of the control DAC on channel 2 (purple). Both traces show gradual linear increase until a sudden drop programmed into the firmware. The maximum code of the DAC at the peak was 372. Increasing the DAC code to 373 resulted in the circuit breaker tripping.

This measurement demonstrated that with a gradual increase of current over 250 ms, where any transient effects can be ruled out, the circuit breaker trips with DAC code 373 and the current-sense resistor Voltage of $\sim 430\text{ mV}$.

Gradual current increase: Current sense resistor Voltage (yellow). DAC driving Voltage (purple).

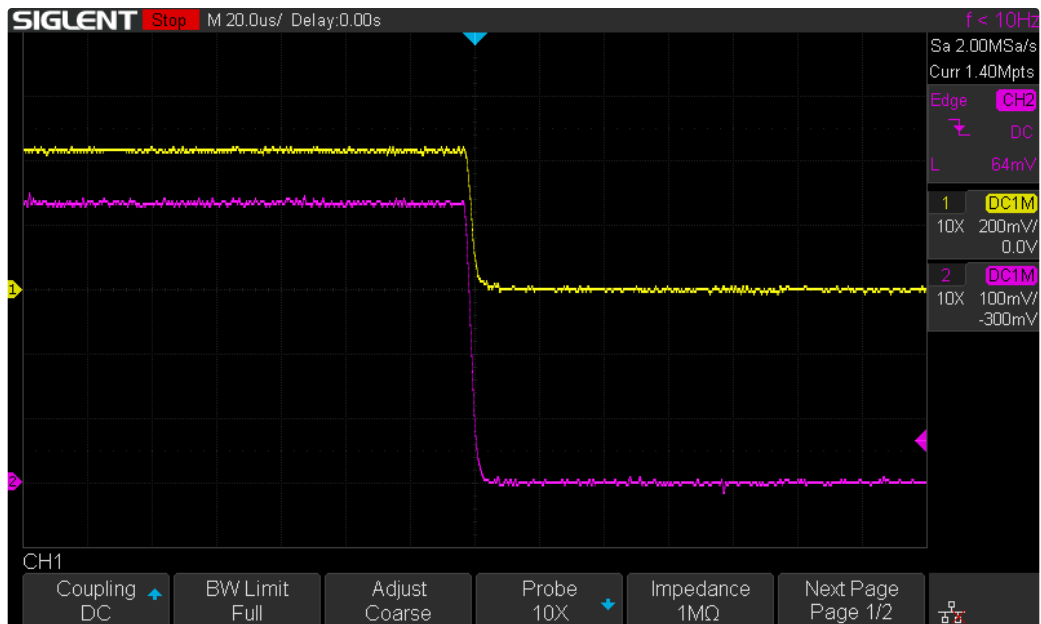
Just to make sure there is no strange effect going on when the DAC code drops from 372 to 0, a zoomed oscilloscope traces are shown in the image below. There is no surprise, the Voltage over the current-sensing resistor closely follows the DAC driving Voltage without any ringing or other problems.

Falling edge: Current sense resistor Voltage (yellow). DAC driving Voltage (purple).

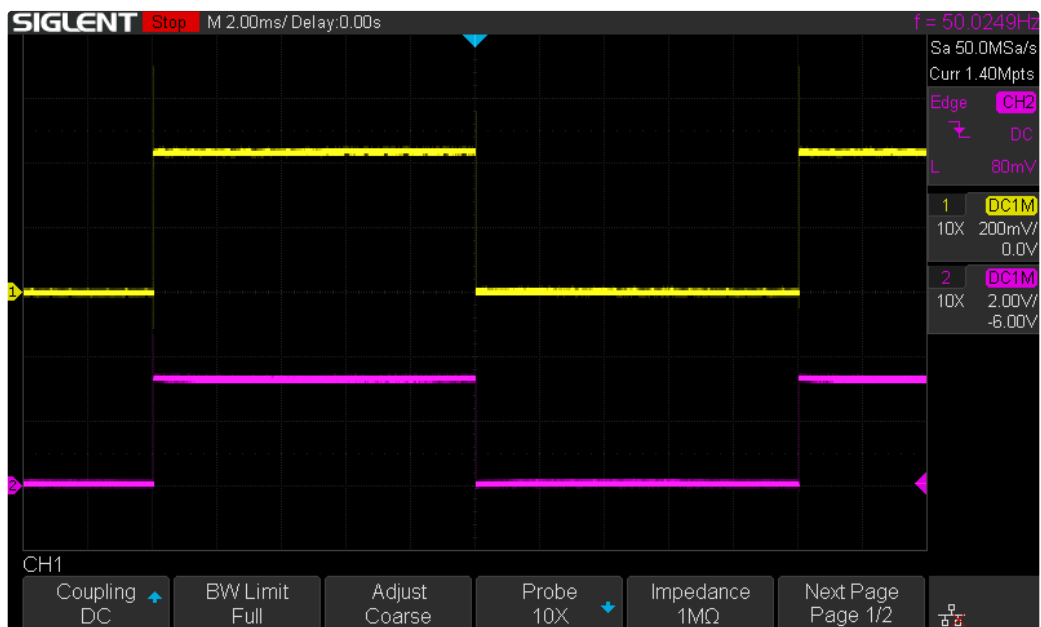
The measurement was compared to the step measurement, where the current was abruptly turned on by the analog switch. The DAC code was programmed to a constant value, but the LED control switch was toggled. The DAC code was varied until the highest value was found that did not trip the circuit breaker. It was 372, exactly the same as with the gradual increase of the current.

Step current increase: Current sense resistor Voltage (yellow). DAC driving Voltage (purple).

These measurements conclude that any potential transitional spikes in current associated with the switching on of the LED driver were **not** the cause of the tripping. The circuit breaker works exactly the same way whether the LED is suddenly turned on, or the current is gradually ramped up.
